Age-Friendly Walk Audit Report

Site: The Historic District of the City of Dublin | Date: April 7, 2023

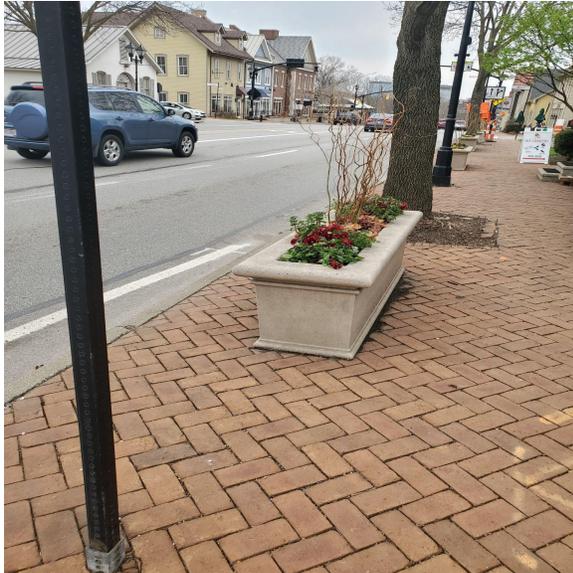
Image 1: Rectangular, cement planters line the walkway along Bridge Street. They are set back from the road by about 2-3 feet, effectively narrowing the pedestrian walkway.

- **Sidewalks:** Well-maintained, wider sidewalks make for a safer and more accessible avenue for travel as a pedestrian. There are planters lined along sidewalks that narrow the path and force some pedestrians to detour around the planters and toward the curb and passing traffic—a prime example of how the environment influences people’s actions and behaviors. In-ground planters are placed outside the Starbucks. One participant with a background in planning suggested replacing the in-ground planters with fencing to help create divisions while widening the walkway and removing a potential tripping hazard. The old-style brick pathways are visually appealing and contribute to the overall identity of the space. Participants did note that some tree roots and access tunnels to the sewage system have caused bricks to dislodge, crack, or become raised, which may become a tripping hazard for pedestrians.

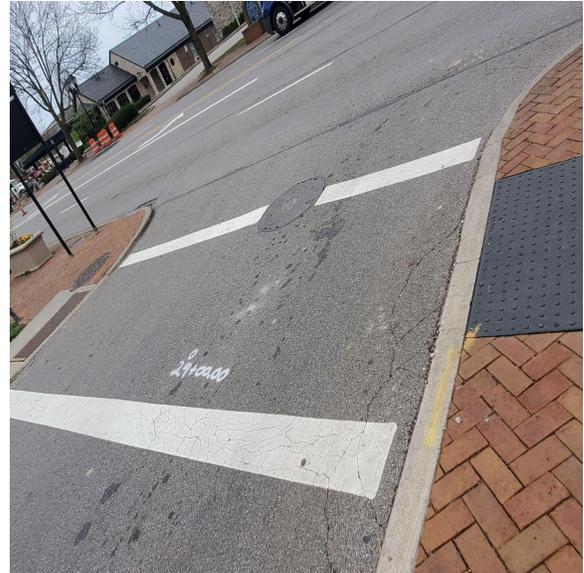
Image 2: Tactile panels are in the direction of travel.

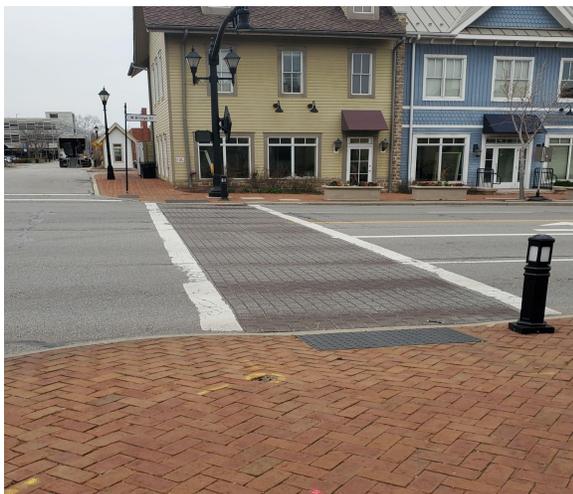
Image 3: Pedestrian crosswalk to cross Bridge Street. Crosswalk is well-marked with tactile panels positioned in the direction of travel.

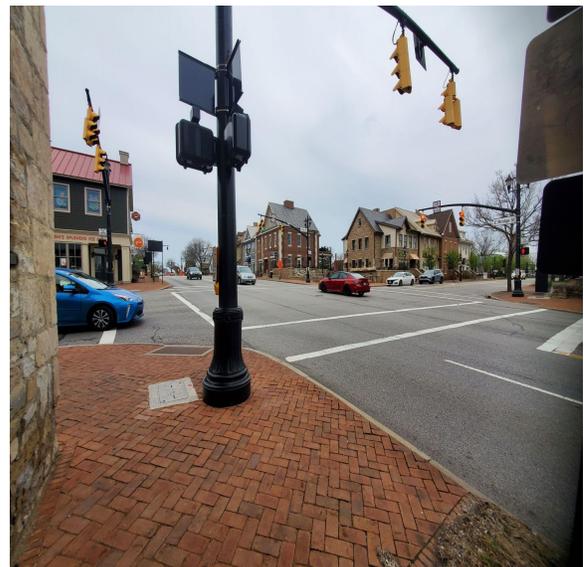
Image 4: Intersection of High Street and Bridge Street (OH-161)

- **ADA Detectable Warnings - Truncated Domes:** Participants noted the tactile panels are not ADA-compliant at the intersection of High Street and Bridge Street. More contrast is needed between the panel and the surrounding surface. Furthermore, ADA requires the panels to be placed in the direction of travel; since intersections are marked with crosswalks that are perpendicular to one another, a single panel between the two is insufficient according to ADA standards.

- To read the full report, please visit <https://agefriendlycolumbus.org/>.
- **Scramble Light at the Intersection of High and Bridge Streets:** A walk audit participant suggested installing a scramble light at this intersection to allow for enhanced pedestrian mobility. The existing intersection has a four-way traffic light and crosswalks with audible and visual cues to support the pedestrian right of way. Participants noted the time allotted to cross Bridge Street (~20 seconds to cross), which some participants felt was too quick. However, crossing North or South High Street had a much longer crossing time (~50 seconds) even though there were fewer lanes of traffic. Installing a scramble light may be a safer, more convenient alternative to manage pedestrian and motor vehicle traffic while increasing efficiency.

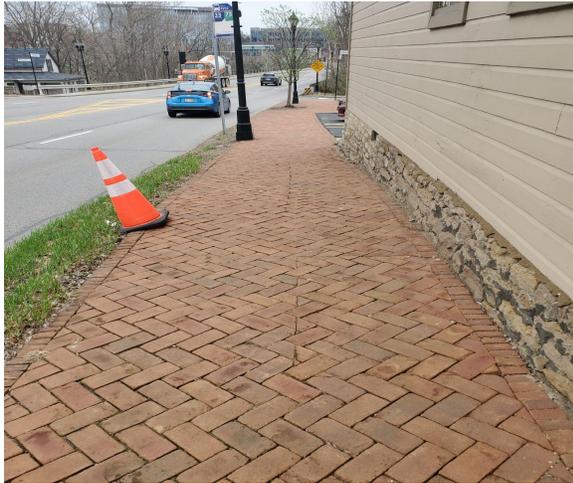
Image 5: Sidewalk on the eastbound side of Bridge Street. The path is well-maintained. A bus stop, a single sign in the ground, is placed roughly two feet from the road. It does not have a shelter, bench, or trashcan. There is no curb or buffer between traffic lanes and the edge of the road. Only 2-3 feet of grass separates this walkway and the road's edge.

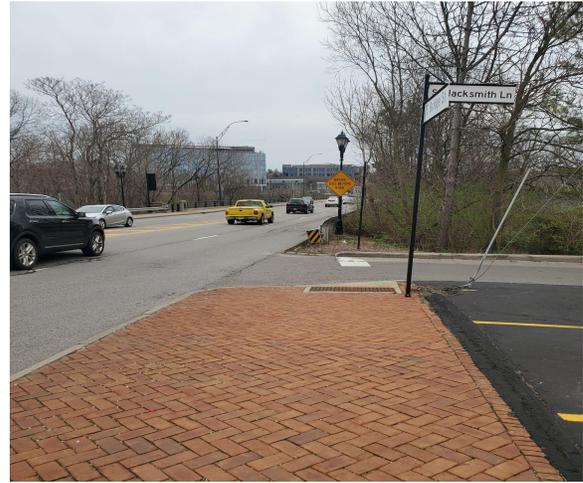
Image 6: The eastbound sidewalk along Bridge Street abruptly ends just before the bridge.

- **Bridge Crossing Scioto River:** Pedestrians felt exposed when walking along this bridge while facing oncoming traffic. Seasonal planters are placed along the edge of the sidewalk. These were not present on the date of this audit. While this bridge allows pedestrians to cross the river to access the updated Bridgeway District, many participants did not feel safe either crossing this bridge or the roundabout. It was suggested signage is installed to guide pedestrians toward the footbridge as a safer alternative path. It is recommended this signage is placed by N. High Street and encourages pedestrians to detour down N. High Street as this has the most inclusive and walkable infrastructure. Residents and Dublin personnel also noticed the staircase to the path underneath the bridge is inaccessible for those using a wheeled-mobility device (or even a mother with a stroller).

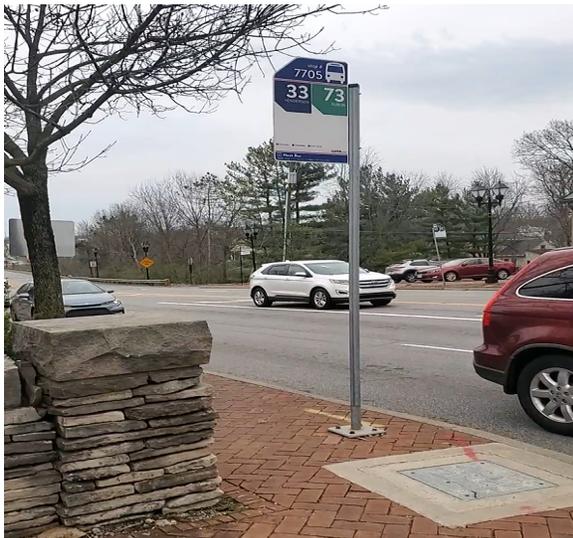
Image 7: Bus Stop #7705, Lines 33 and 73; the stop lacks a shelter, trashcan, or stop-specific lighting. There is no place for pedestrians to sit at this stop.

- **COTA Bus Stop:** Stop #7705 does not have a shelter or bench; however, one participant suggested a bench could be placed in the space just behind the stop on the corner of High Street and Bridge Street. Per the Age-Friendly Innovation Center’s 2022 Age-Friendly Transit report, community members identified shelters, lighting, and trashcans as important pieces of infrastructure to include at transit stops. Shelters were recognized as especially important among community members, both in surveys and focus groups. Besides physical comfort and protection from the weather, individuals who are visually impaired have a place to direct service animals or become more spatially aware through the use of auditory cues as sound bounces off the shelter better than a pole.⁴

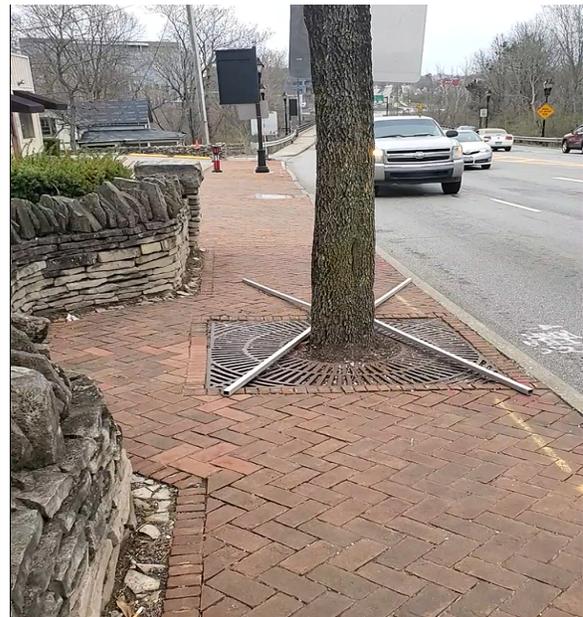
Image 8: Construction signage is placed along roadways but obstructs the walkway for pedestrians, becoming a possible trip hazard. Individuals using a mobility device (wheelchair, walker, scooter, stroller, etc.) would have difficulty navigating this walkway.

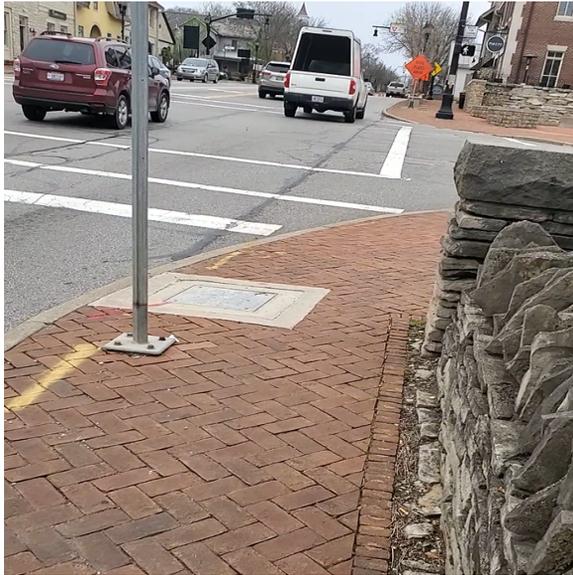
Image 9: The intersection at High Street and Bridge Street includes well-marked crosswalks. Tactile panels are not ADA-compliant. A Dublin walk audit participant suggested implementing a scramble light for this intersection.

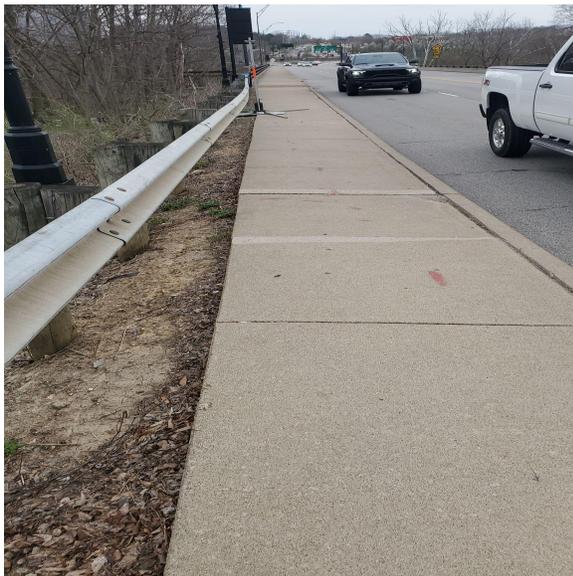
Image 11: The sidewalk along OH-161 is wider and generally well-maintained.

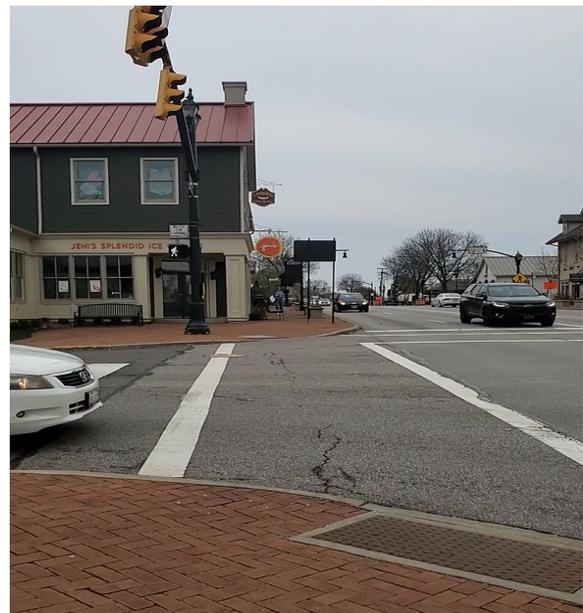
Image 12: The tactile panels are not ADA-compliant.
