Stormwater BMPs for Buildings and Grounds

National Pollutant Discharge Elimination System (NPDES) Phase I Stormwater Permit

City Hall Green Roof

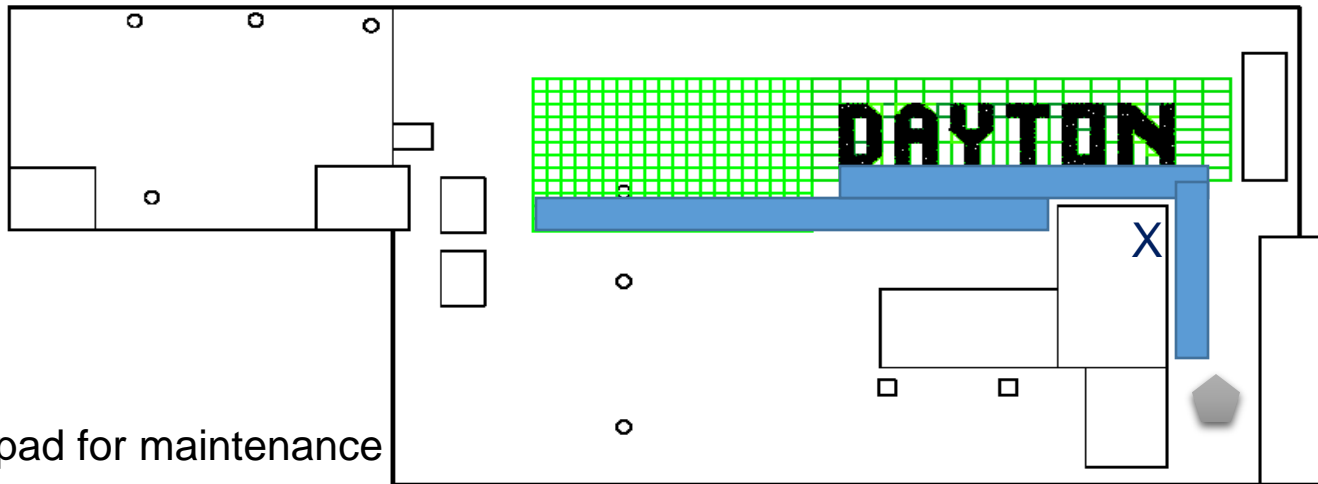
FIGURE 1

Schematic of Green Roof

Size: ~2,000 sq. ft.

■ – Walk pad for maintenance

X – Doorway to roof area

■ – Roof drain to Storm Sewer

ROOF PLAN
1/16" = 1'-0"

- ▲ GreenGrid(R) 2'x2'x4" TRIANGLE MODULE (10) – ECOBALLAST
- GreenGrid(R) 2'x2'x4" MODULE (58) – ECOBALLAST
- ▲ GreenGrid(R) 2'x2'x4" TRIANGLE MODULE (10)
- GreenGrid(R) 2'x2'x2.5" MODULE (240)
- GreenGrid(R) 2'x2'x4" MODULE (10)
- GreenGrid(R) 2'x4'x4" MODULE (81)

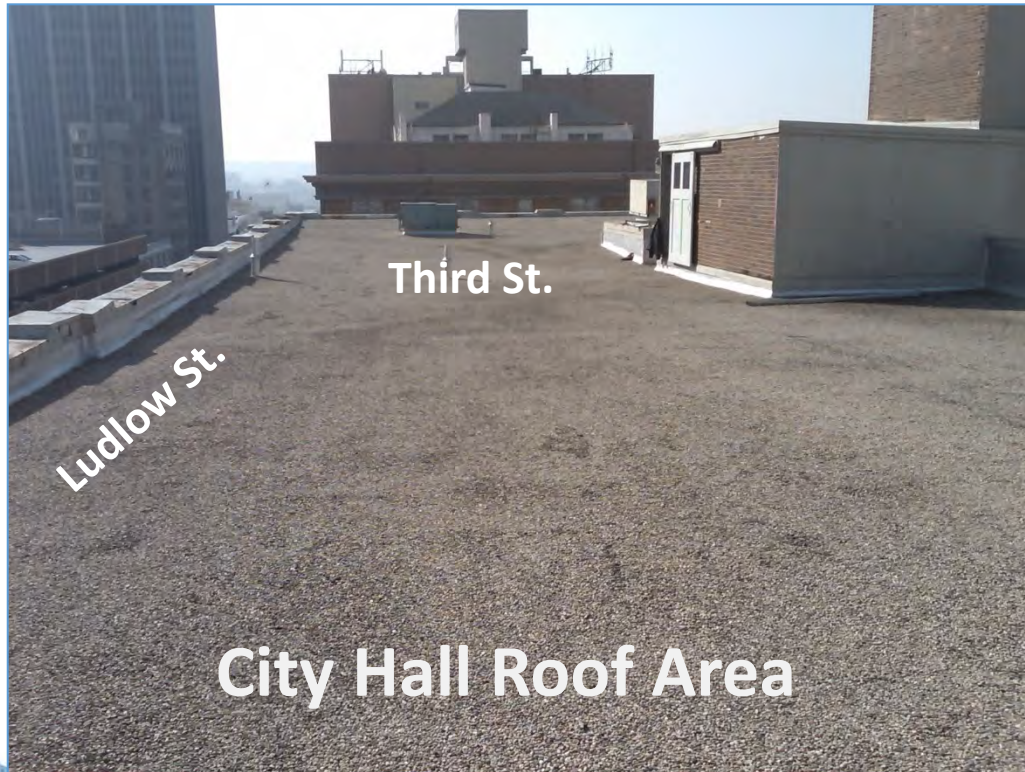
Pre and Post Installation Storm Water Quality Sampling

Sample runoff for:

- Volatile Organic Compounds (VOCs)
- General Chemistry – Phosphate, Nitrate
- Total Metals

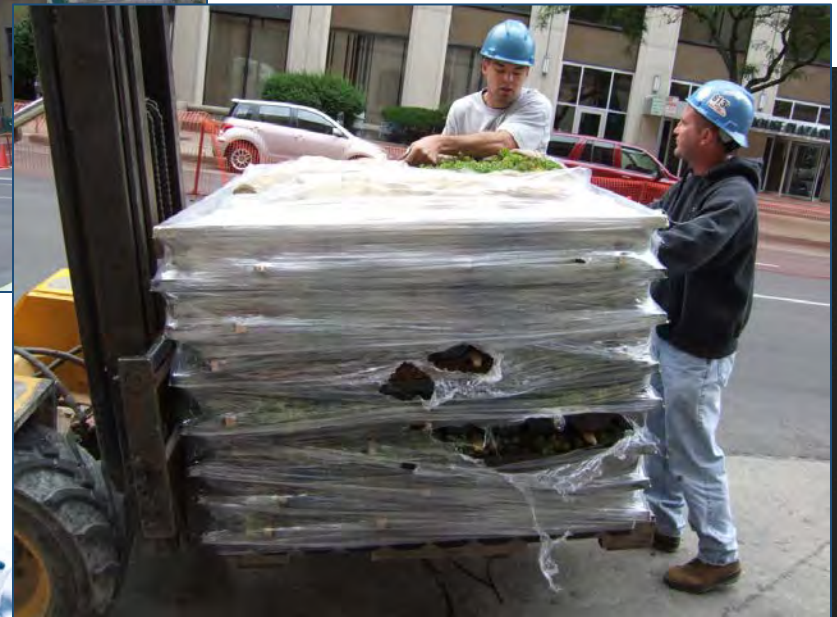
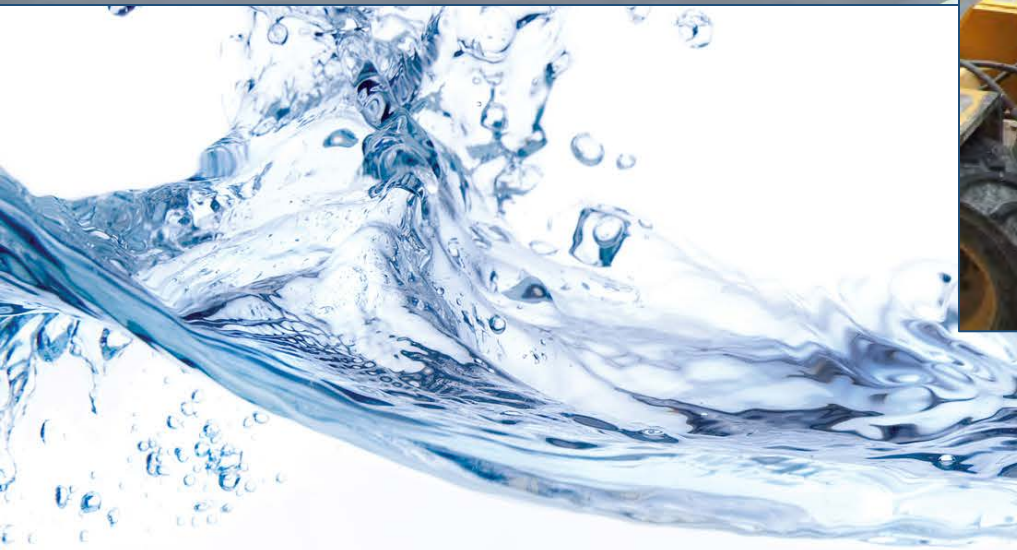
Installed
June 13, 2009

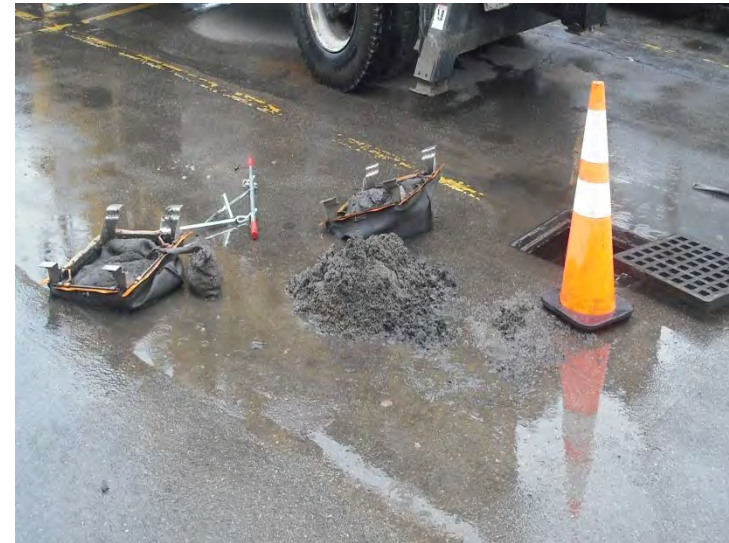
Sediment captured by the Flex-Storm Filter

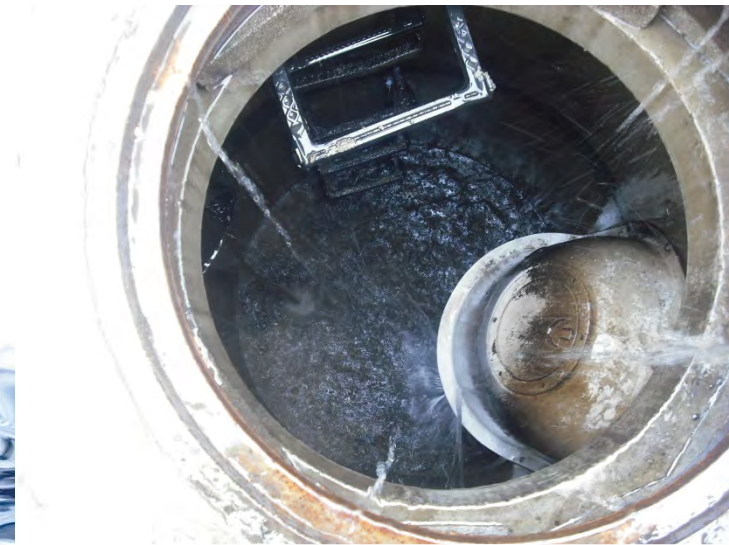
Cleaned manhole showing "Snout" over outlet

The upgrade included placing custom made Flexstorm® inlet filters in all three catch basins and enlarging the outlet catch basin with a manhole structure to create a sump for the capture of sediments. A Nyloplast® Snout® Structure has been installed on the discharge pipe to prevent oils and other floatables from discharging to the MS4.

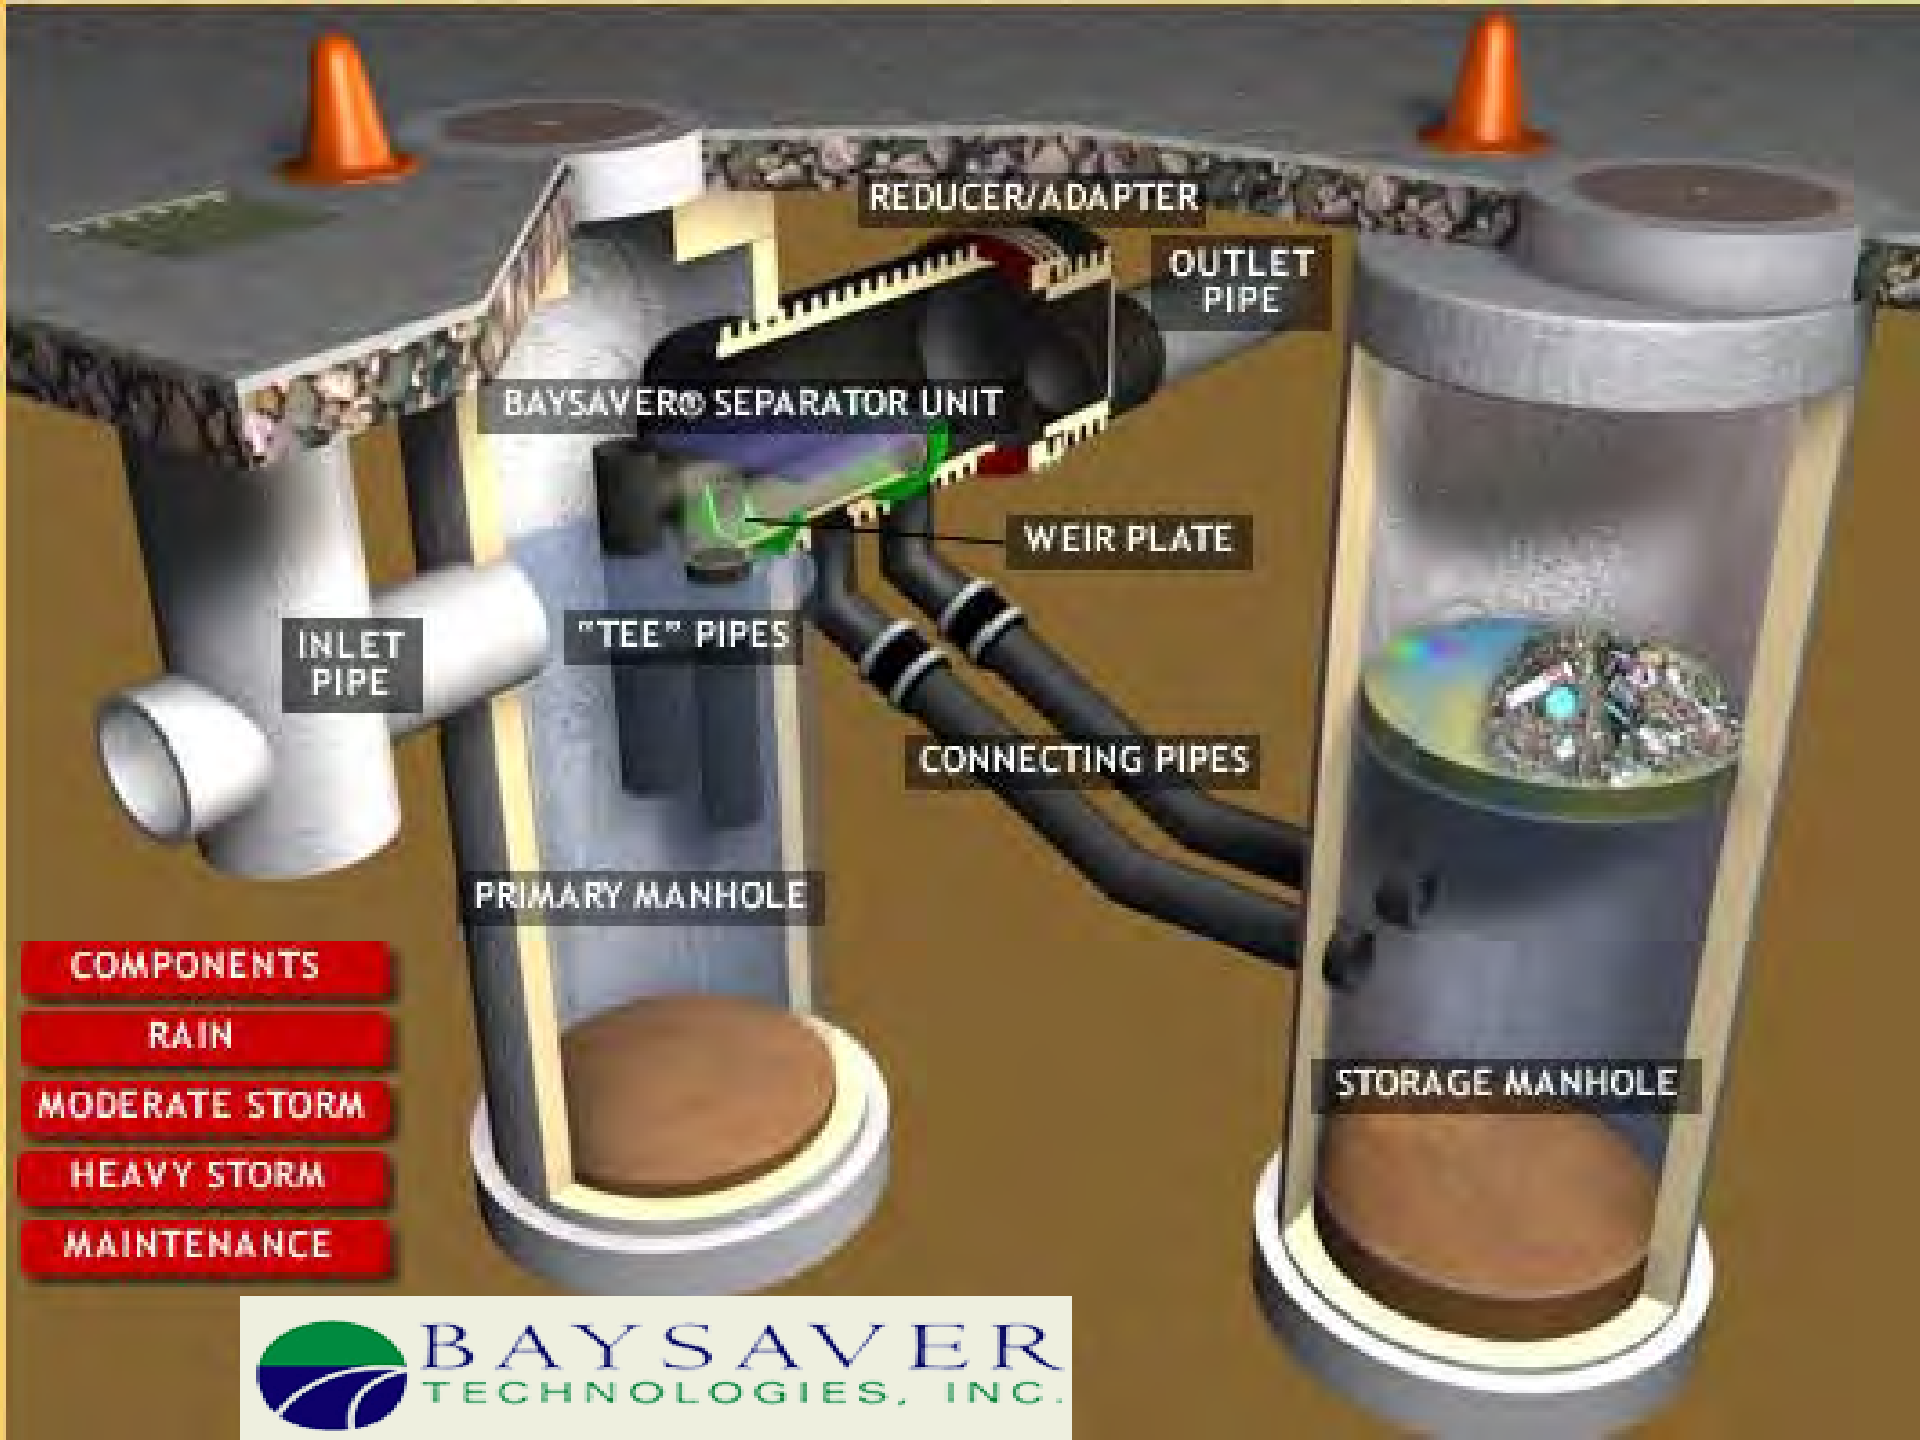
REDUCER/ADAPTER

OUTLET
PIPE

BAYSAVER® SEPARATOR UNIT

WEIR PLATE

"TEE" PIPES

CONNECTING PIPES

INLET
PIPE

PRIMARY MANHOLE

STORAGE MANHOLE

COMPONENTS

Baysaver Performance

The unit is effective at capturing both solids and oil from the storm water run-off of the “Packer Lot”.

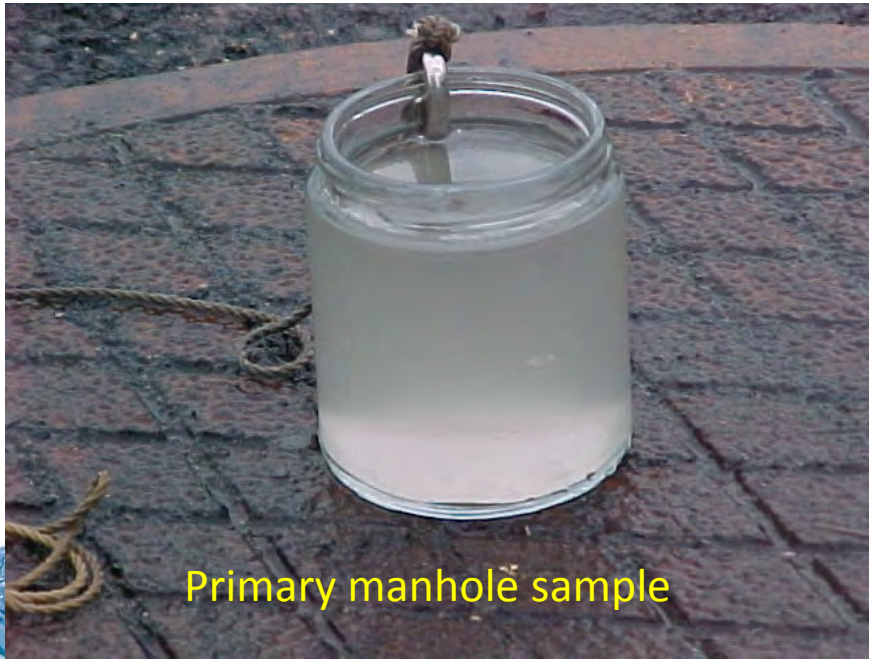
Primary manhole sample

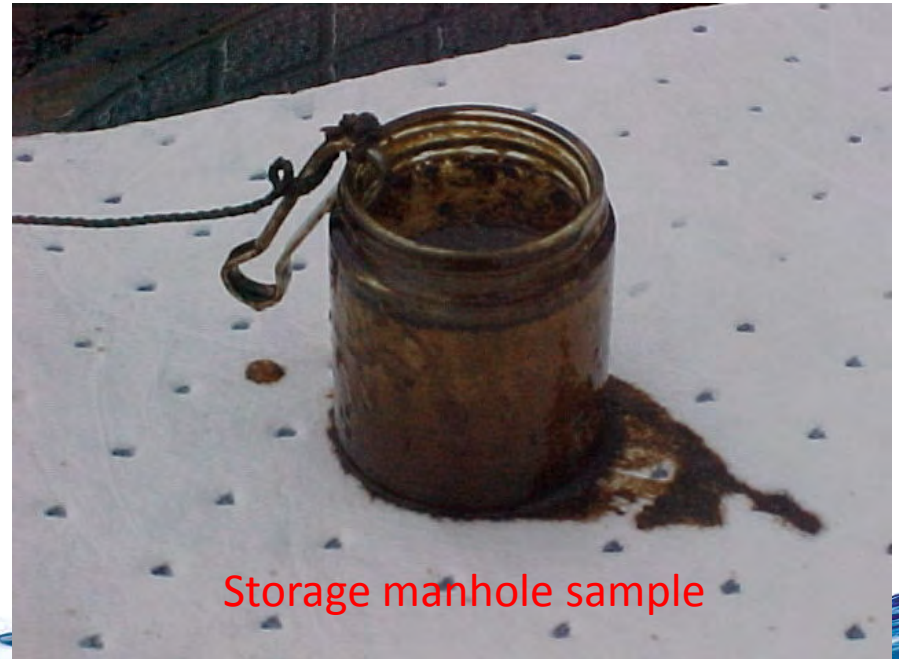
Storage manhole sample

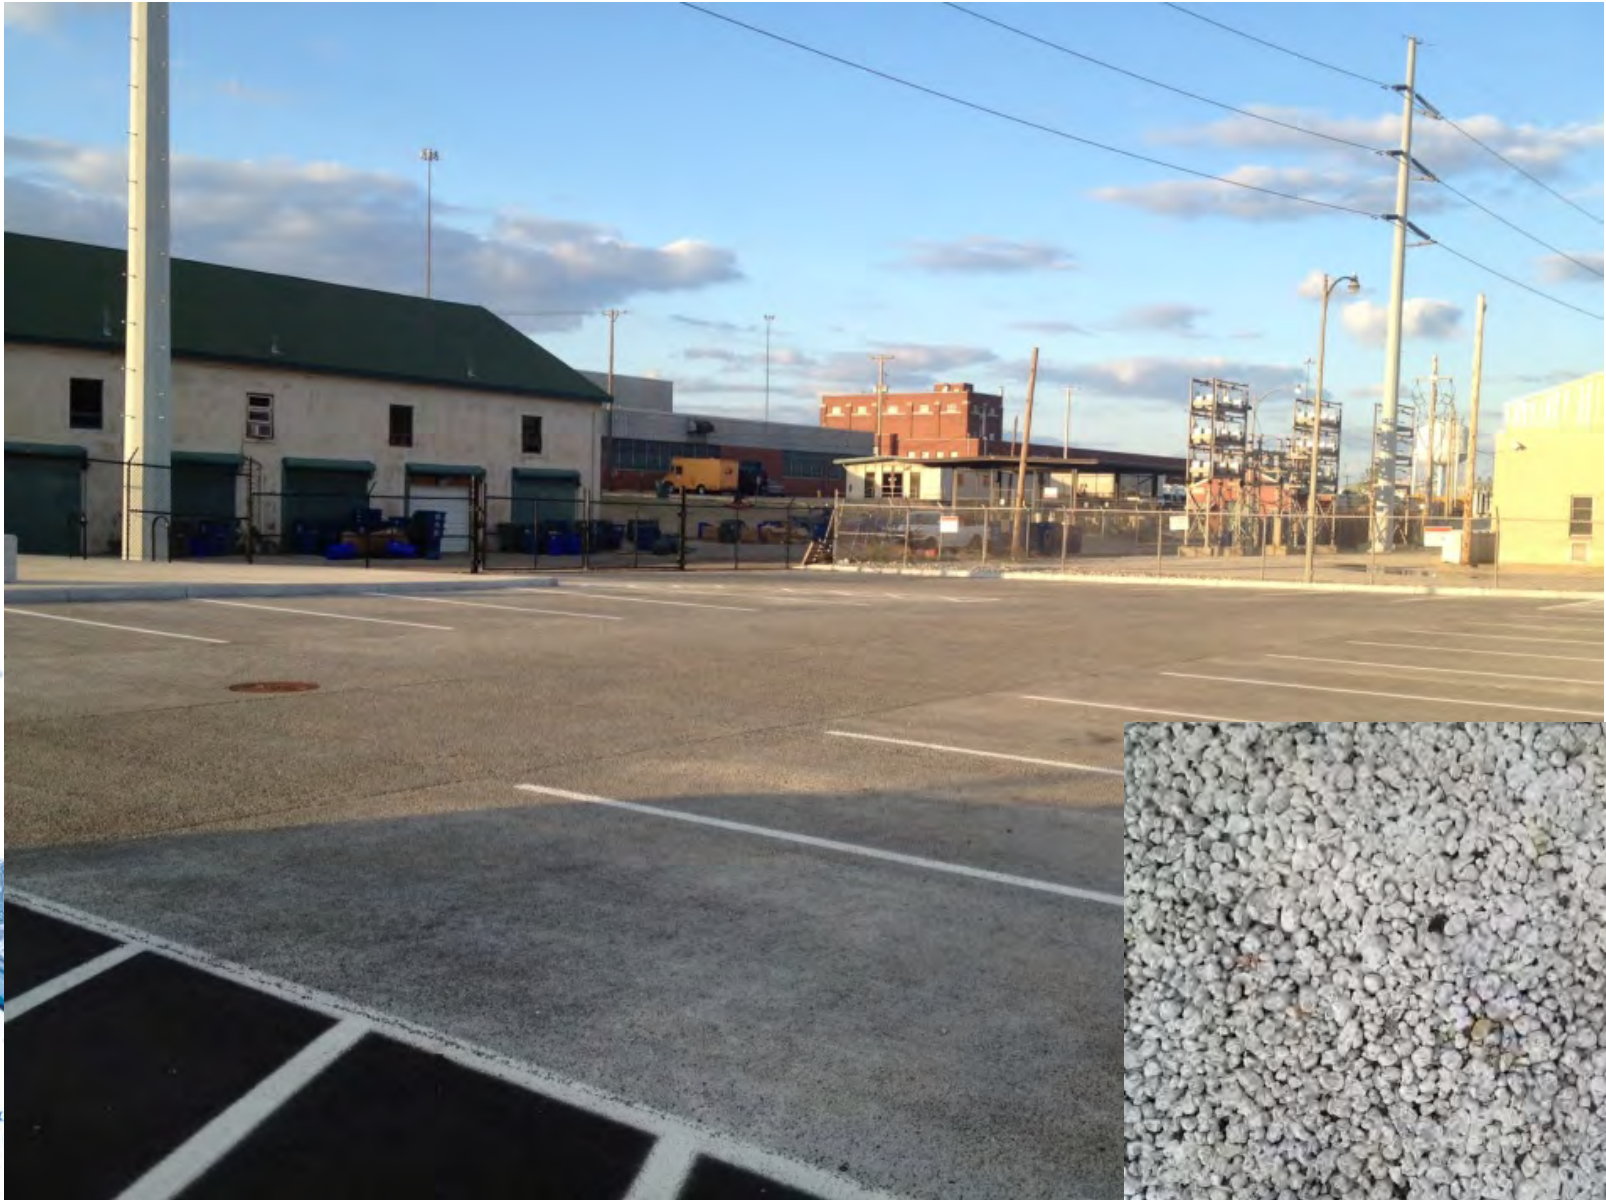
Employee Parking Lot – Pervious Concrete

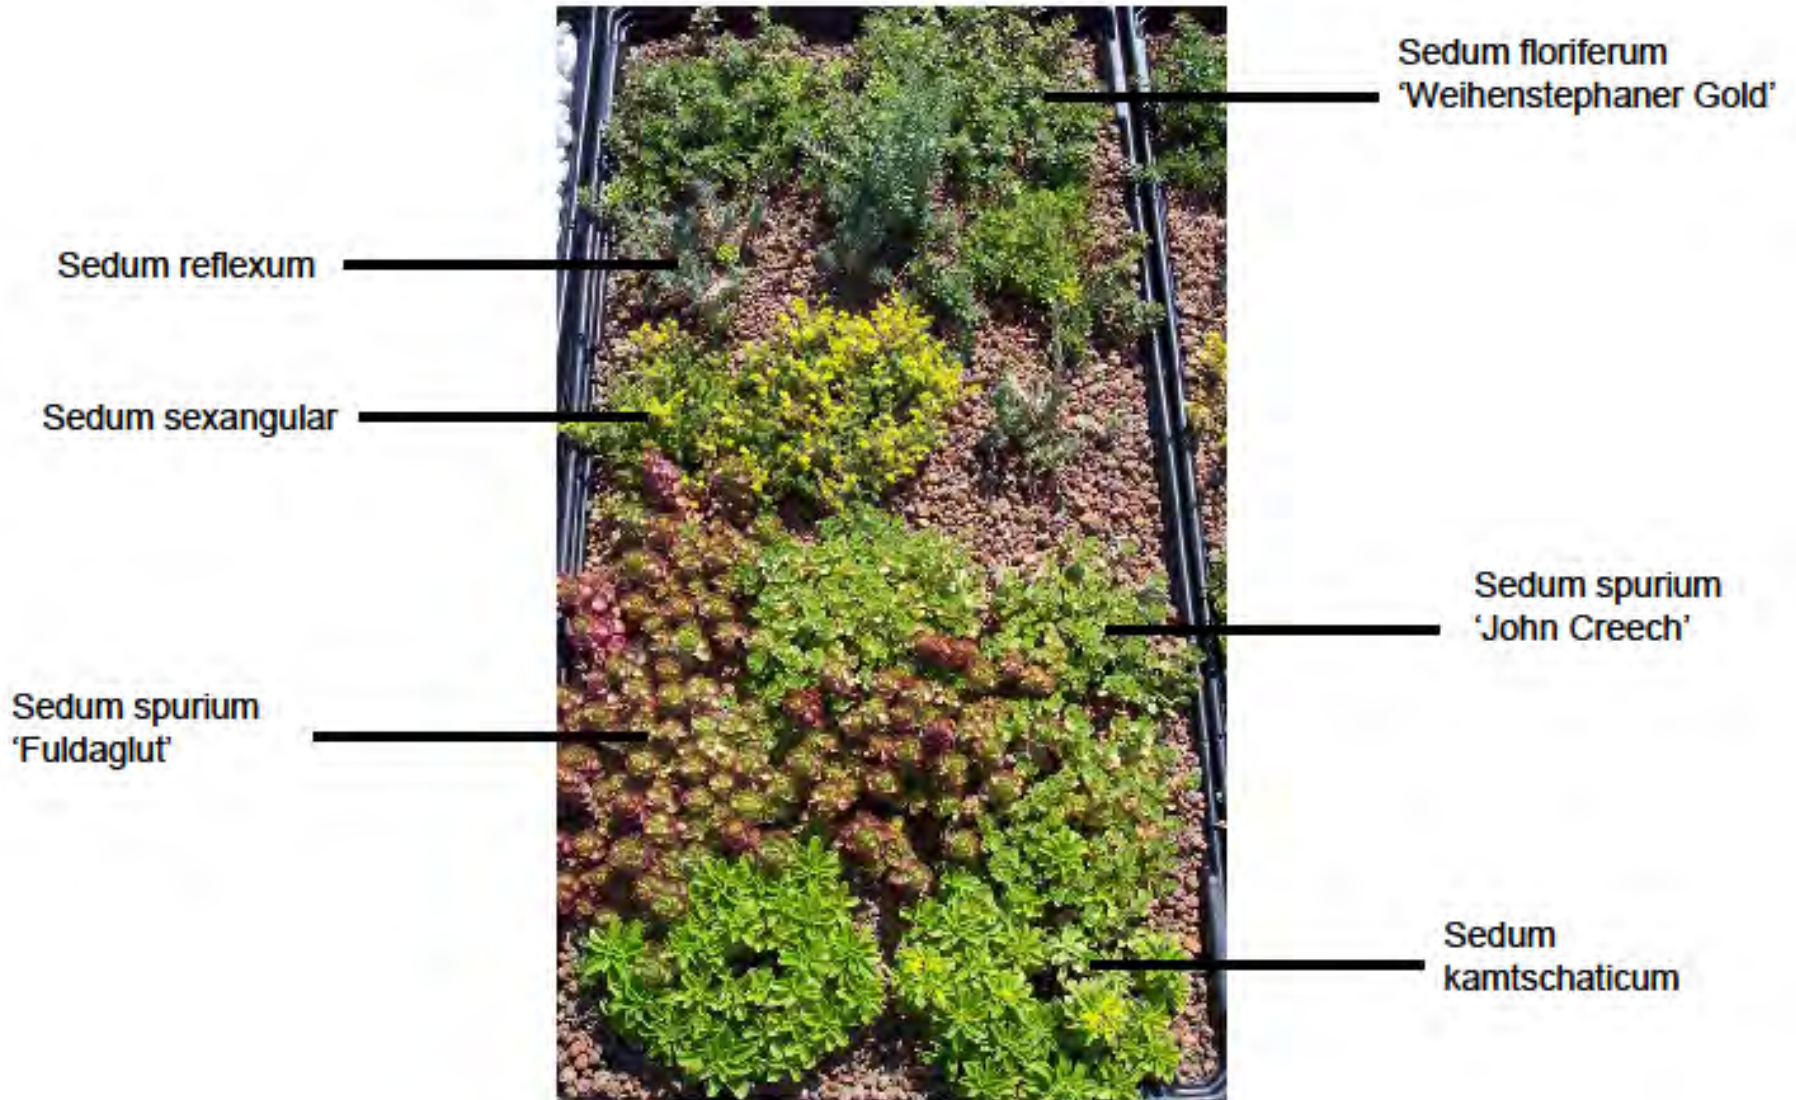
INSTALLATION

- Modules arrive pre-planted, palletized, and shrink-wrapped for stability.
- Palletized modules hoisted to the roof (crane).
- Delivery of Materials by a 53-foot Tractor Trailer
- Crane set up along on Ludlow (east end of building)
