City of Dayton Dry Weather Screening Program

Dayton's Storm Sewer System

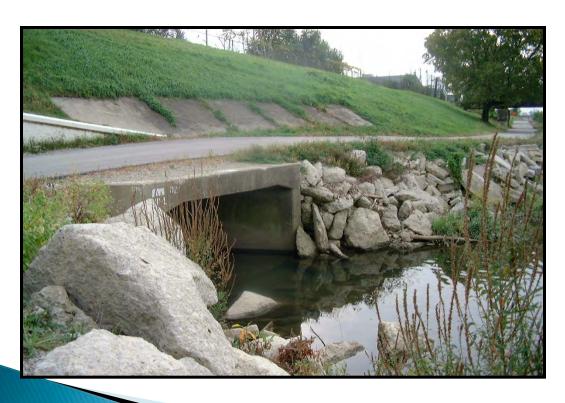
Visual Observations

- Flow/No Flow
- Color
- Clarity
 - -cloudy, opaque, solids
- Floatables
 - -sheen, trash, foam, sewage
- Animal
 - -fish, amphibian, crustacean
- Biological
 - -algae, mosquito, bacteria
- Deposits
 - -oily, sediment
- Structure
 - -cracking, corrosion

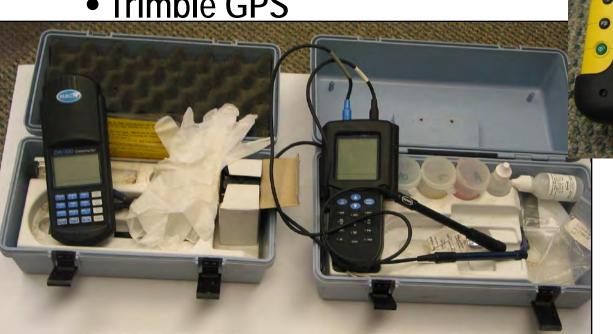
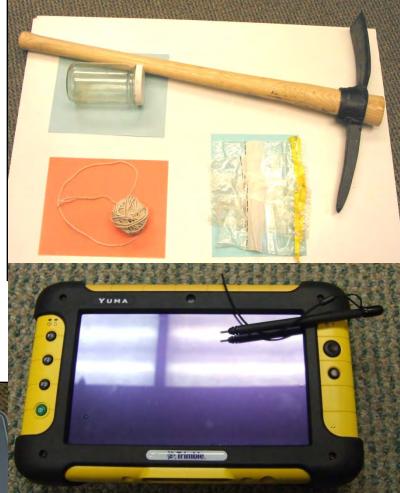
Tools of the Trade

- SOPs
- Training
- •Pick or "Easy Lift"
- String
- Sample Jar
- Sample bag
- Trimble GPS

- Hach Portable colorimeter
- Hach Sension

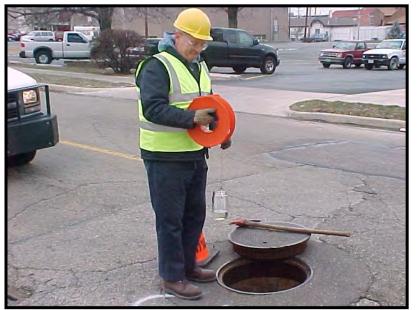
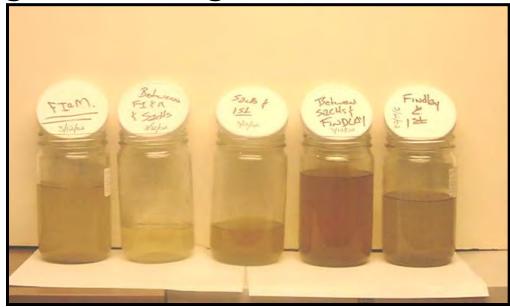
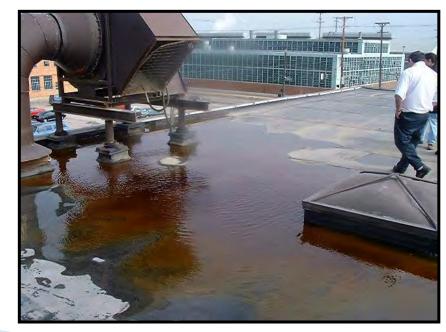
Illicit Discharge Investigations

- •3 out of range samples
- Narrow area of investigation
- Conduct facility inspections
- Report to OEPA
