MIAMI VALLEY

Sustainability Roundtable:

Storm Water Management for Buildings and Grounds

September 26, 2018

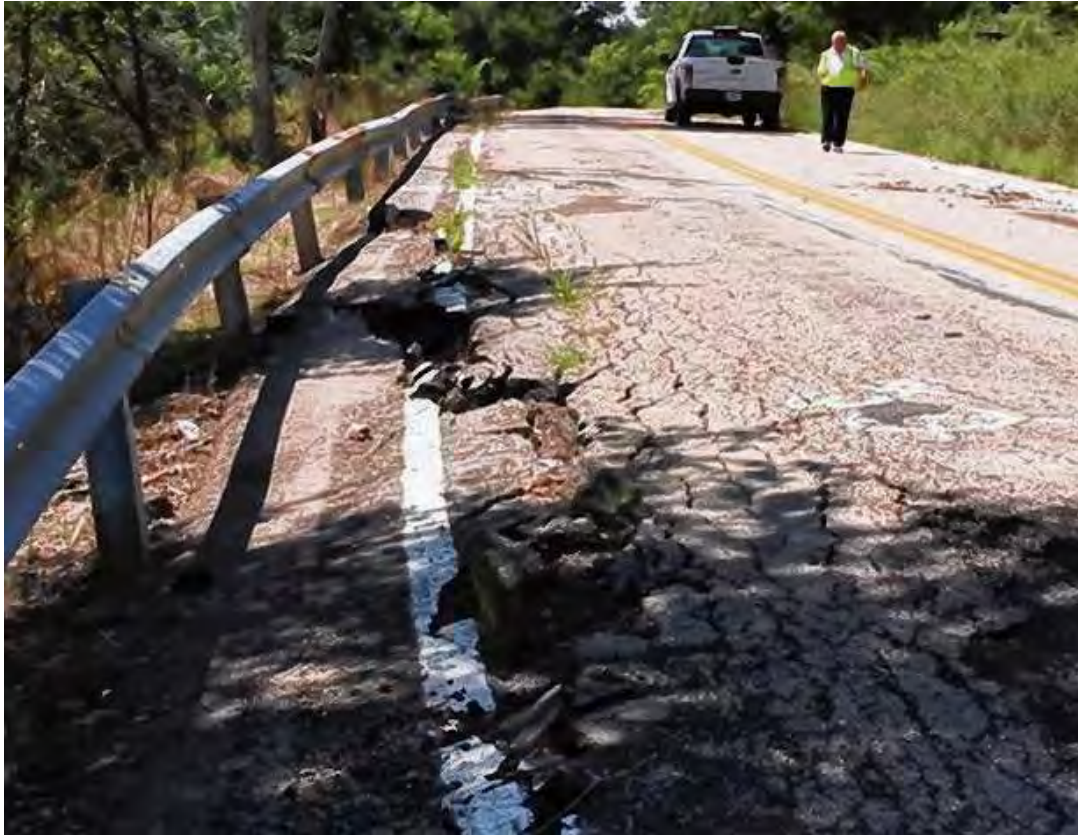
Lower Miamisburg Road, Montgomery County.
Photo: Dayton Daily News

Miamisburg City Engineer Bob Stanley said the hillside terrain near the road's edge and **heavy spring rains** were contributing factors in causing the asphalt to buckle and separate - several inches in some cases.

“It’s a fairly significant failure as you can see from the drop in elevation,” Stanley said. “It’s mainly **the water, the saturation, the heavy rain.**”

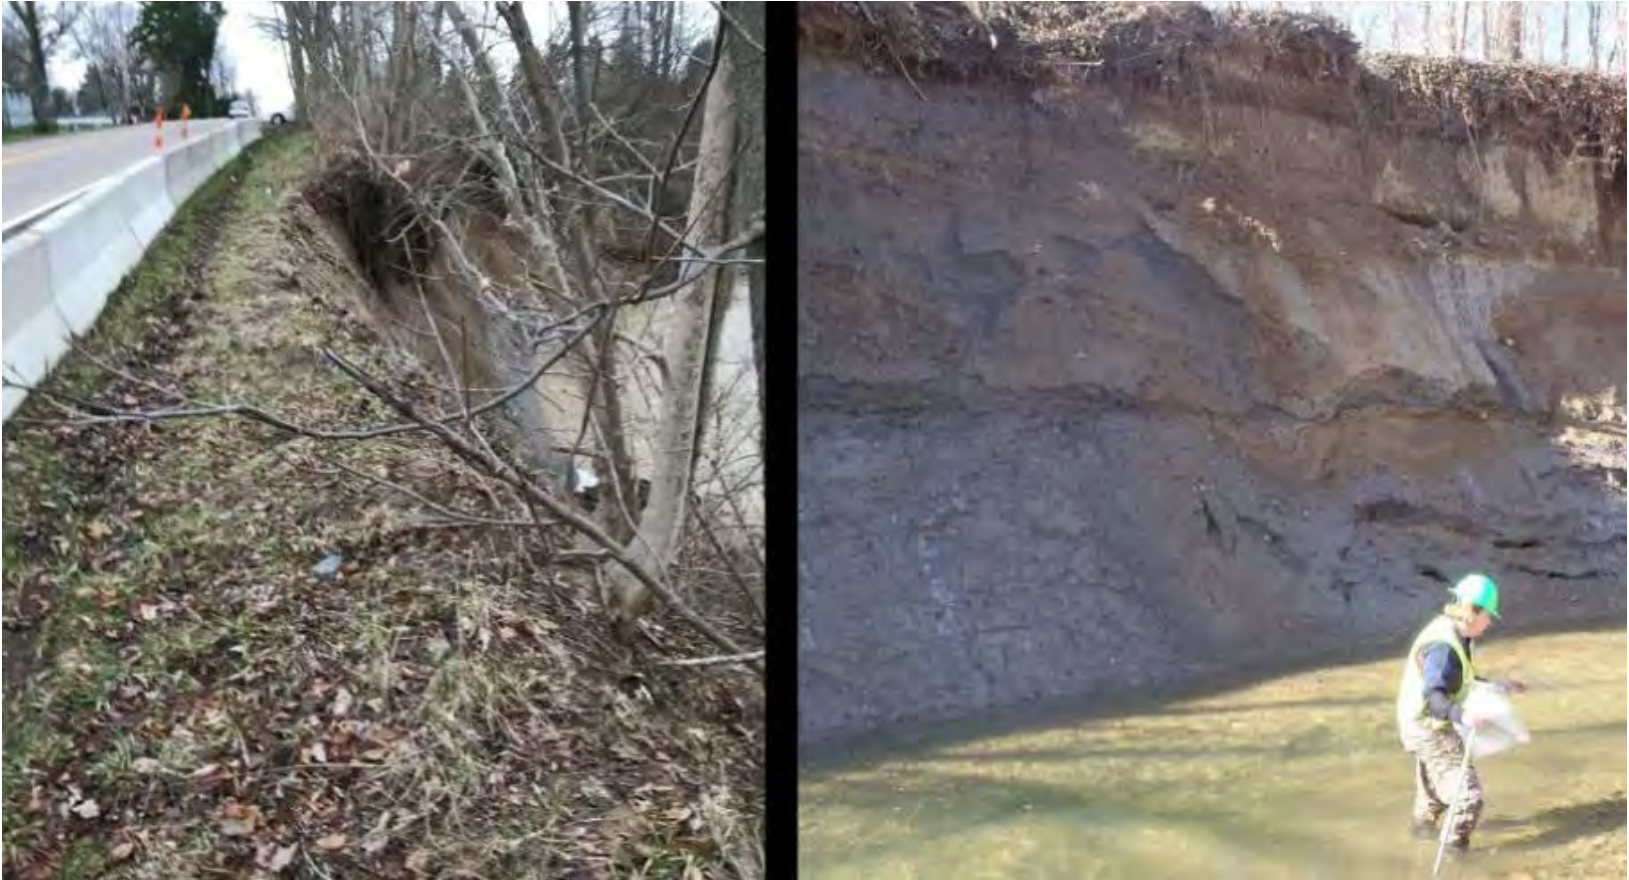
Manning Road, Montgomery County.
Photo: Dayton Daily News

“The work is necessary because **erosion — increasing due to large rain events** — left a 30-foot drop off just off the shoulder, compromising the integrity of the roadway, said Joseph Dura, senior engineer in the Montgomery County Engineer’s Office.”

\$800K to stabilize Little Twin
Creek so it doesn't wash away
Manning Road.
