Eureka-Fremont Flooding Pre-Clean
Corner of Broad Street and Terrace Avenue from June 2015 Rain Event

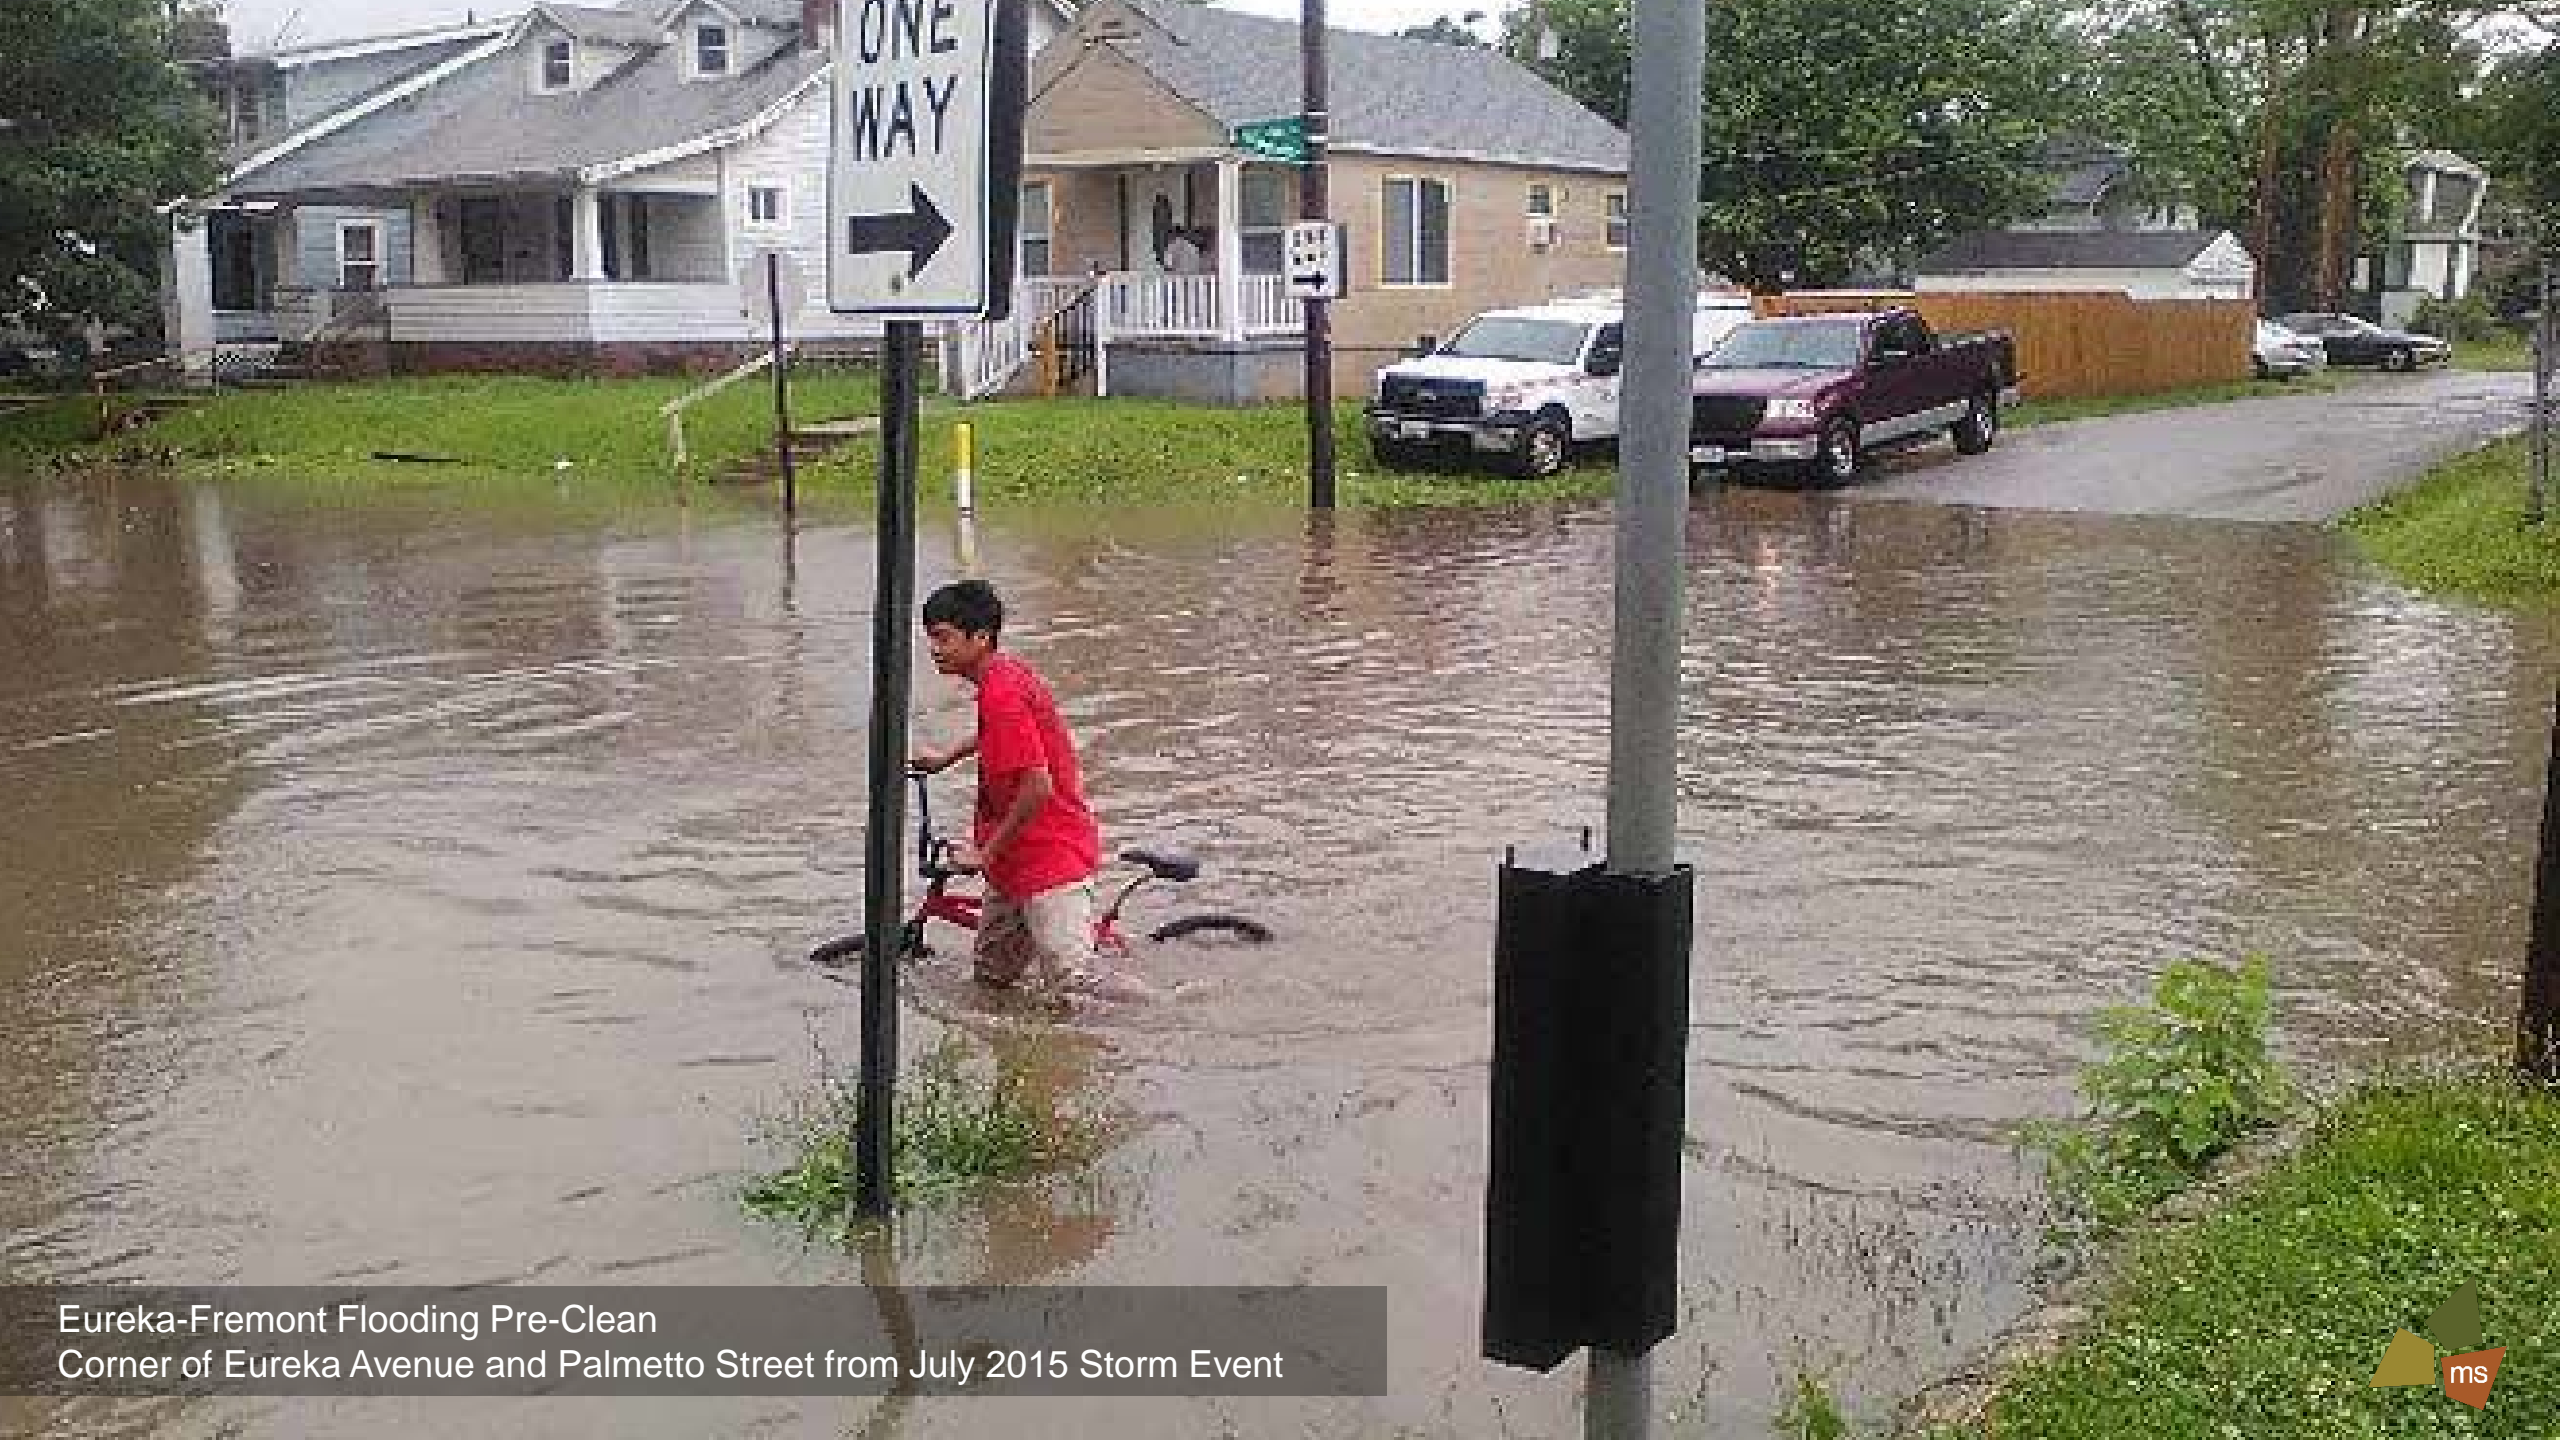
Eureka-Fremont Flooding Pre-Clean
Corner of Eureka Avenue and Palmetto Street from July 2015 Storm Event

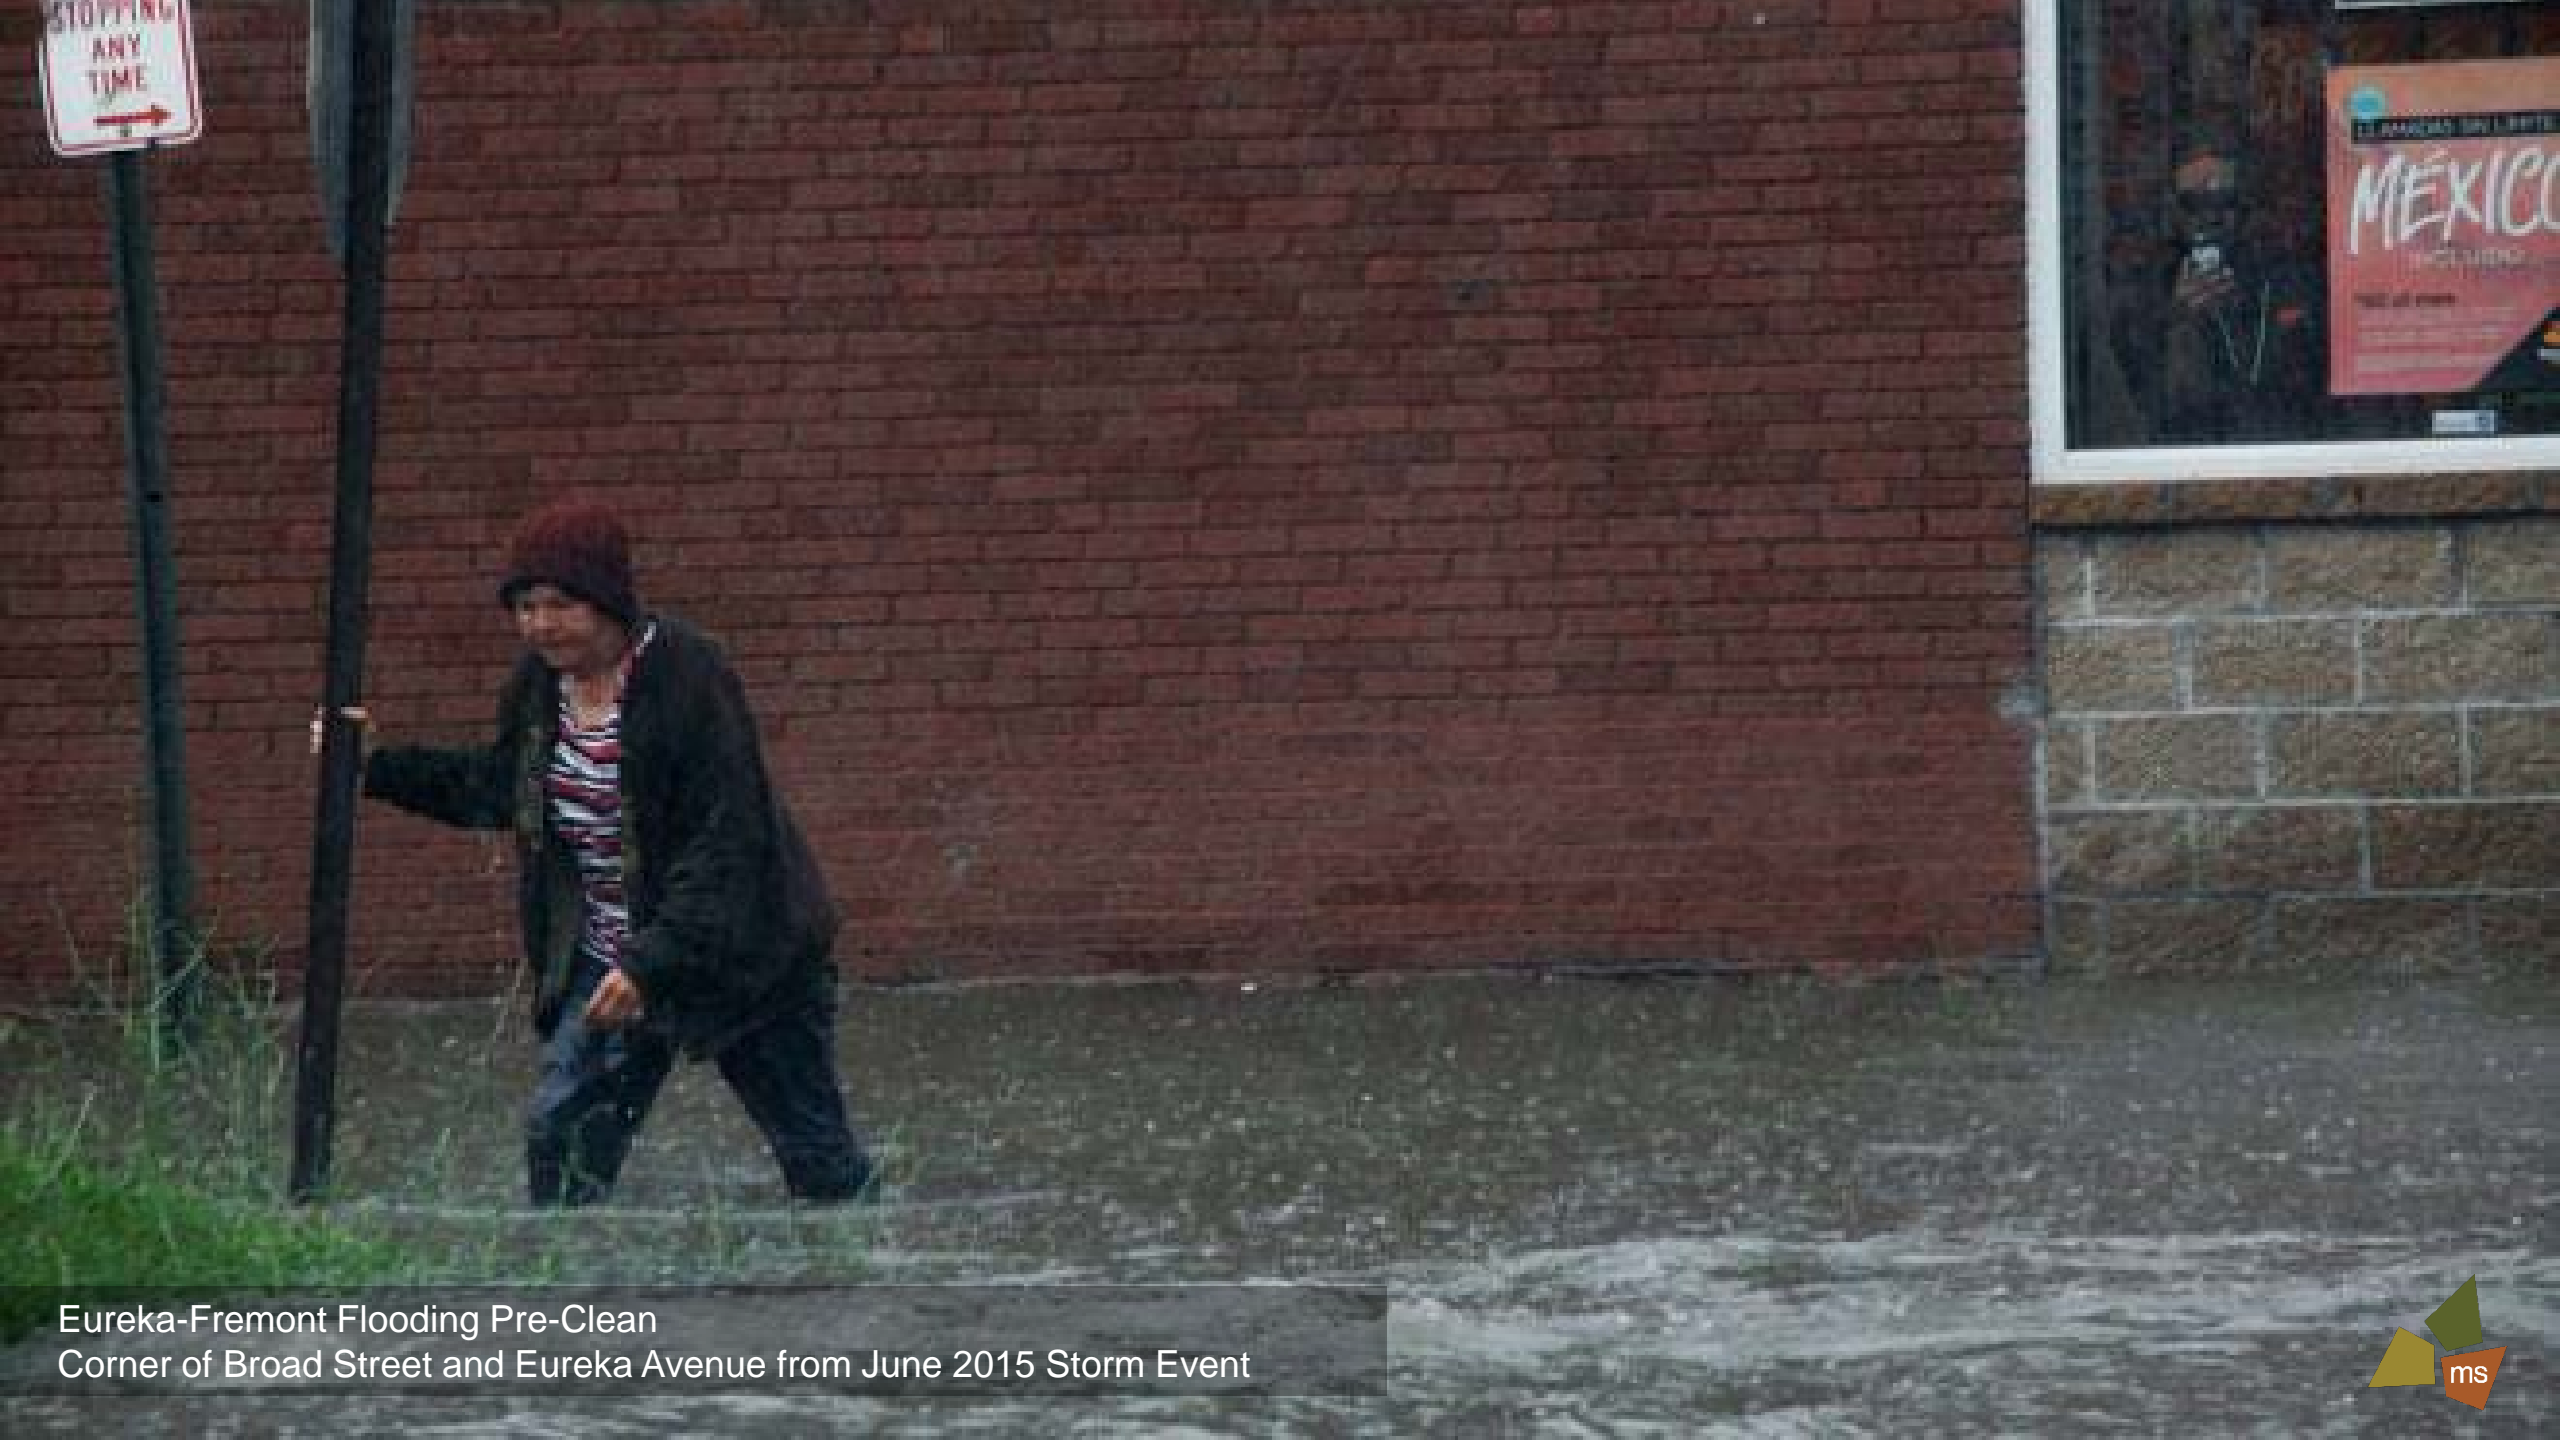
Eureka-Fremont Flooding Pre-Clean
Corner of Broad Street and Eureka Avenue from June 2015 Storm Event

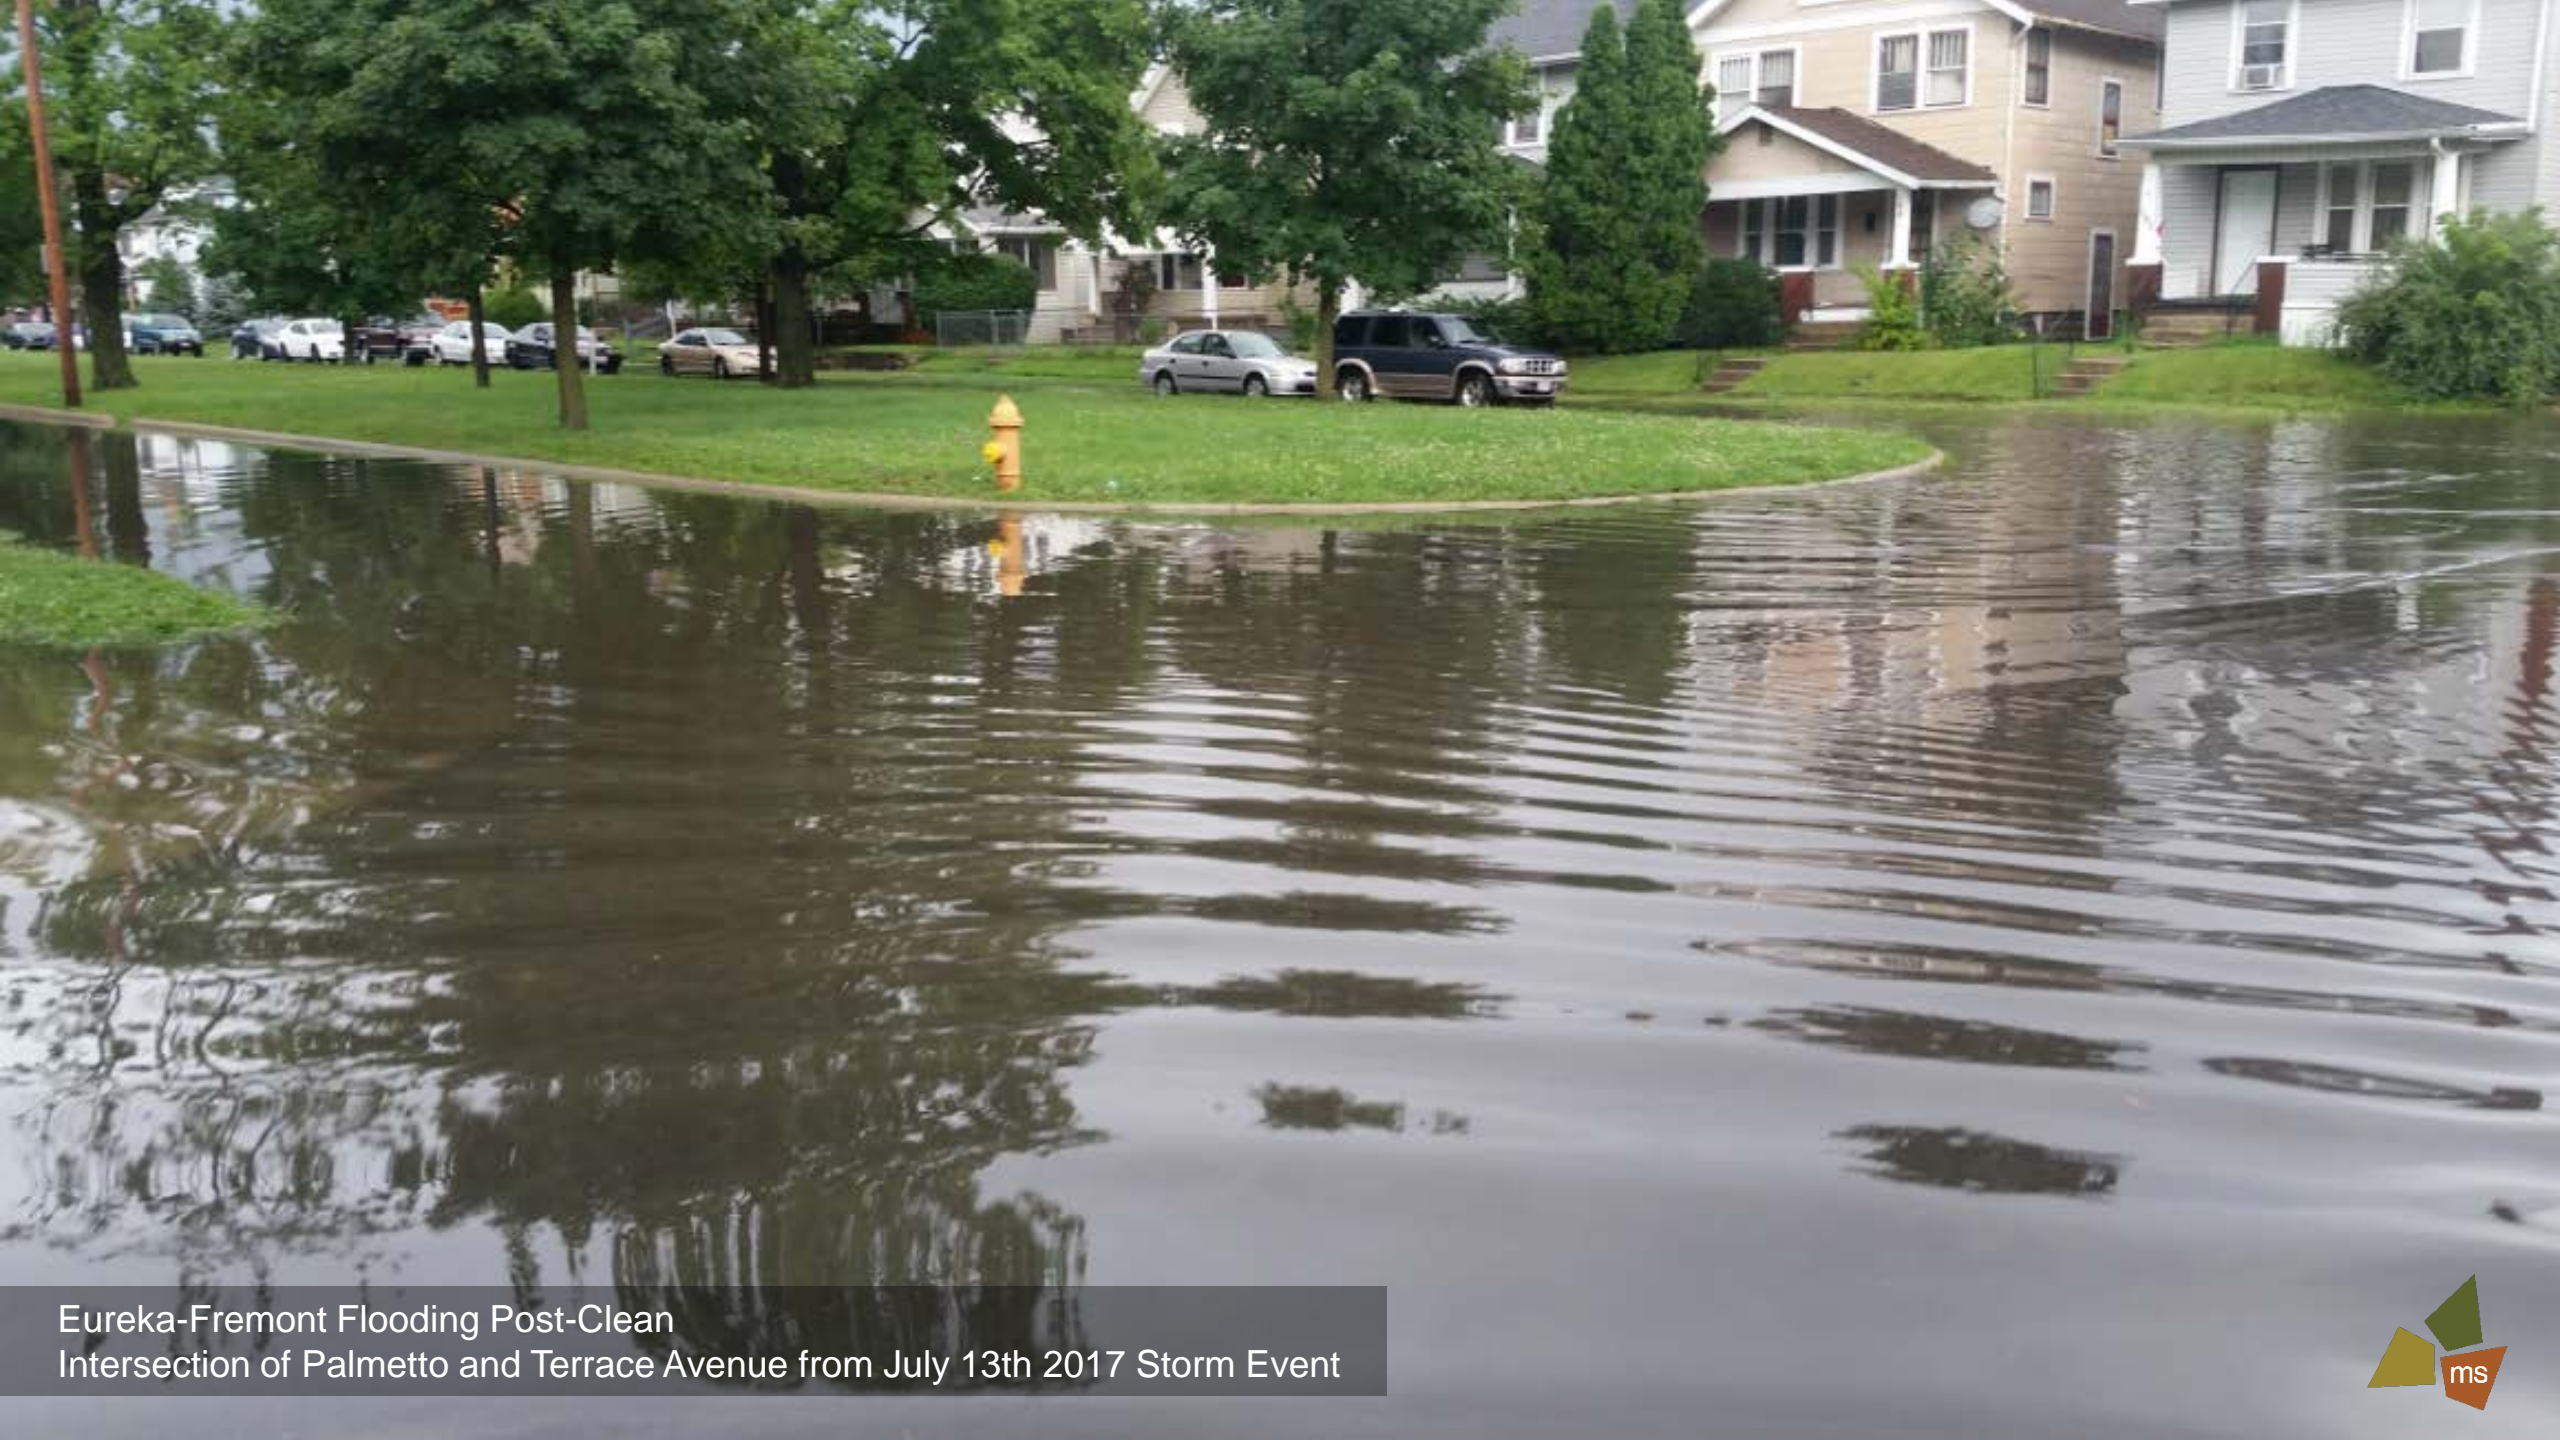
Eureka-Fremont Flooding Post-Clean
Intersection of Palmetto and Terrace Avenue from July 13th 2017 Storm Event

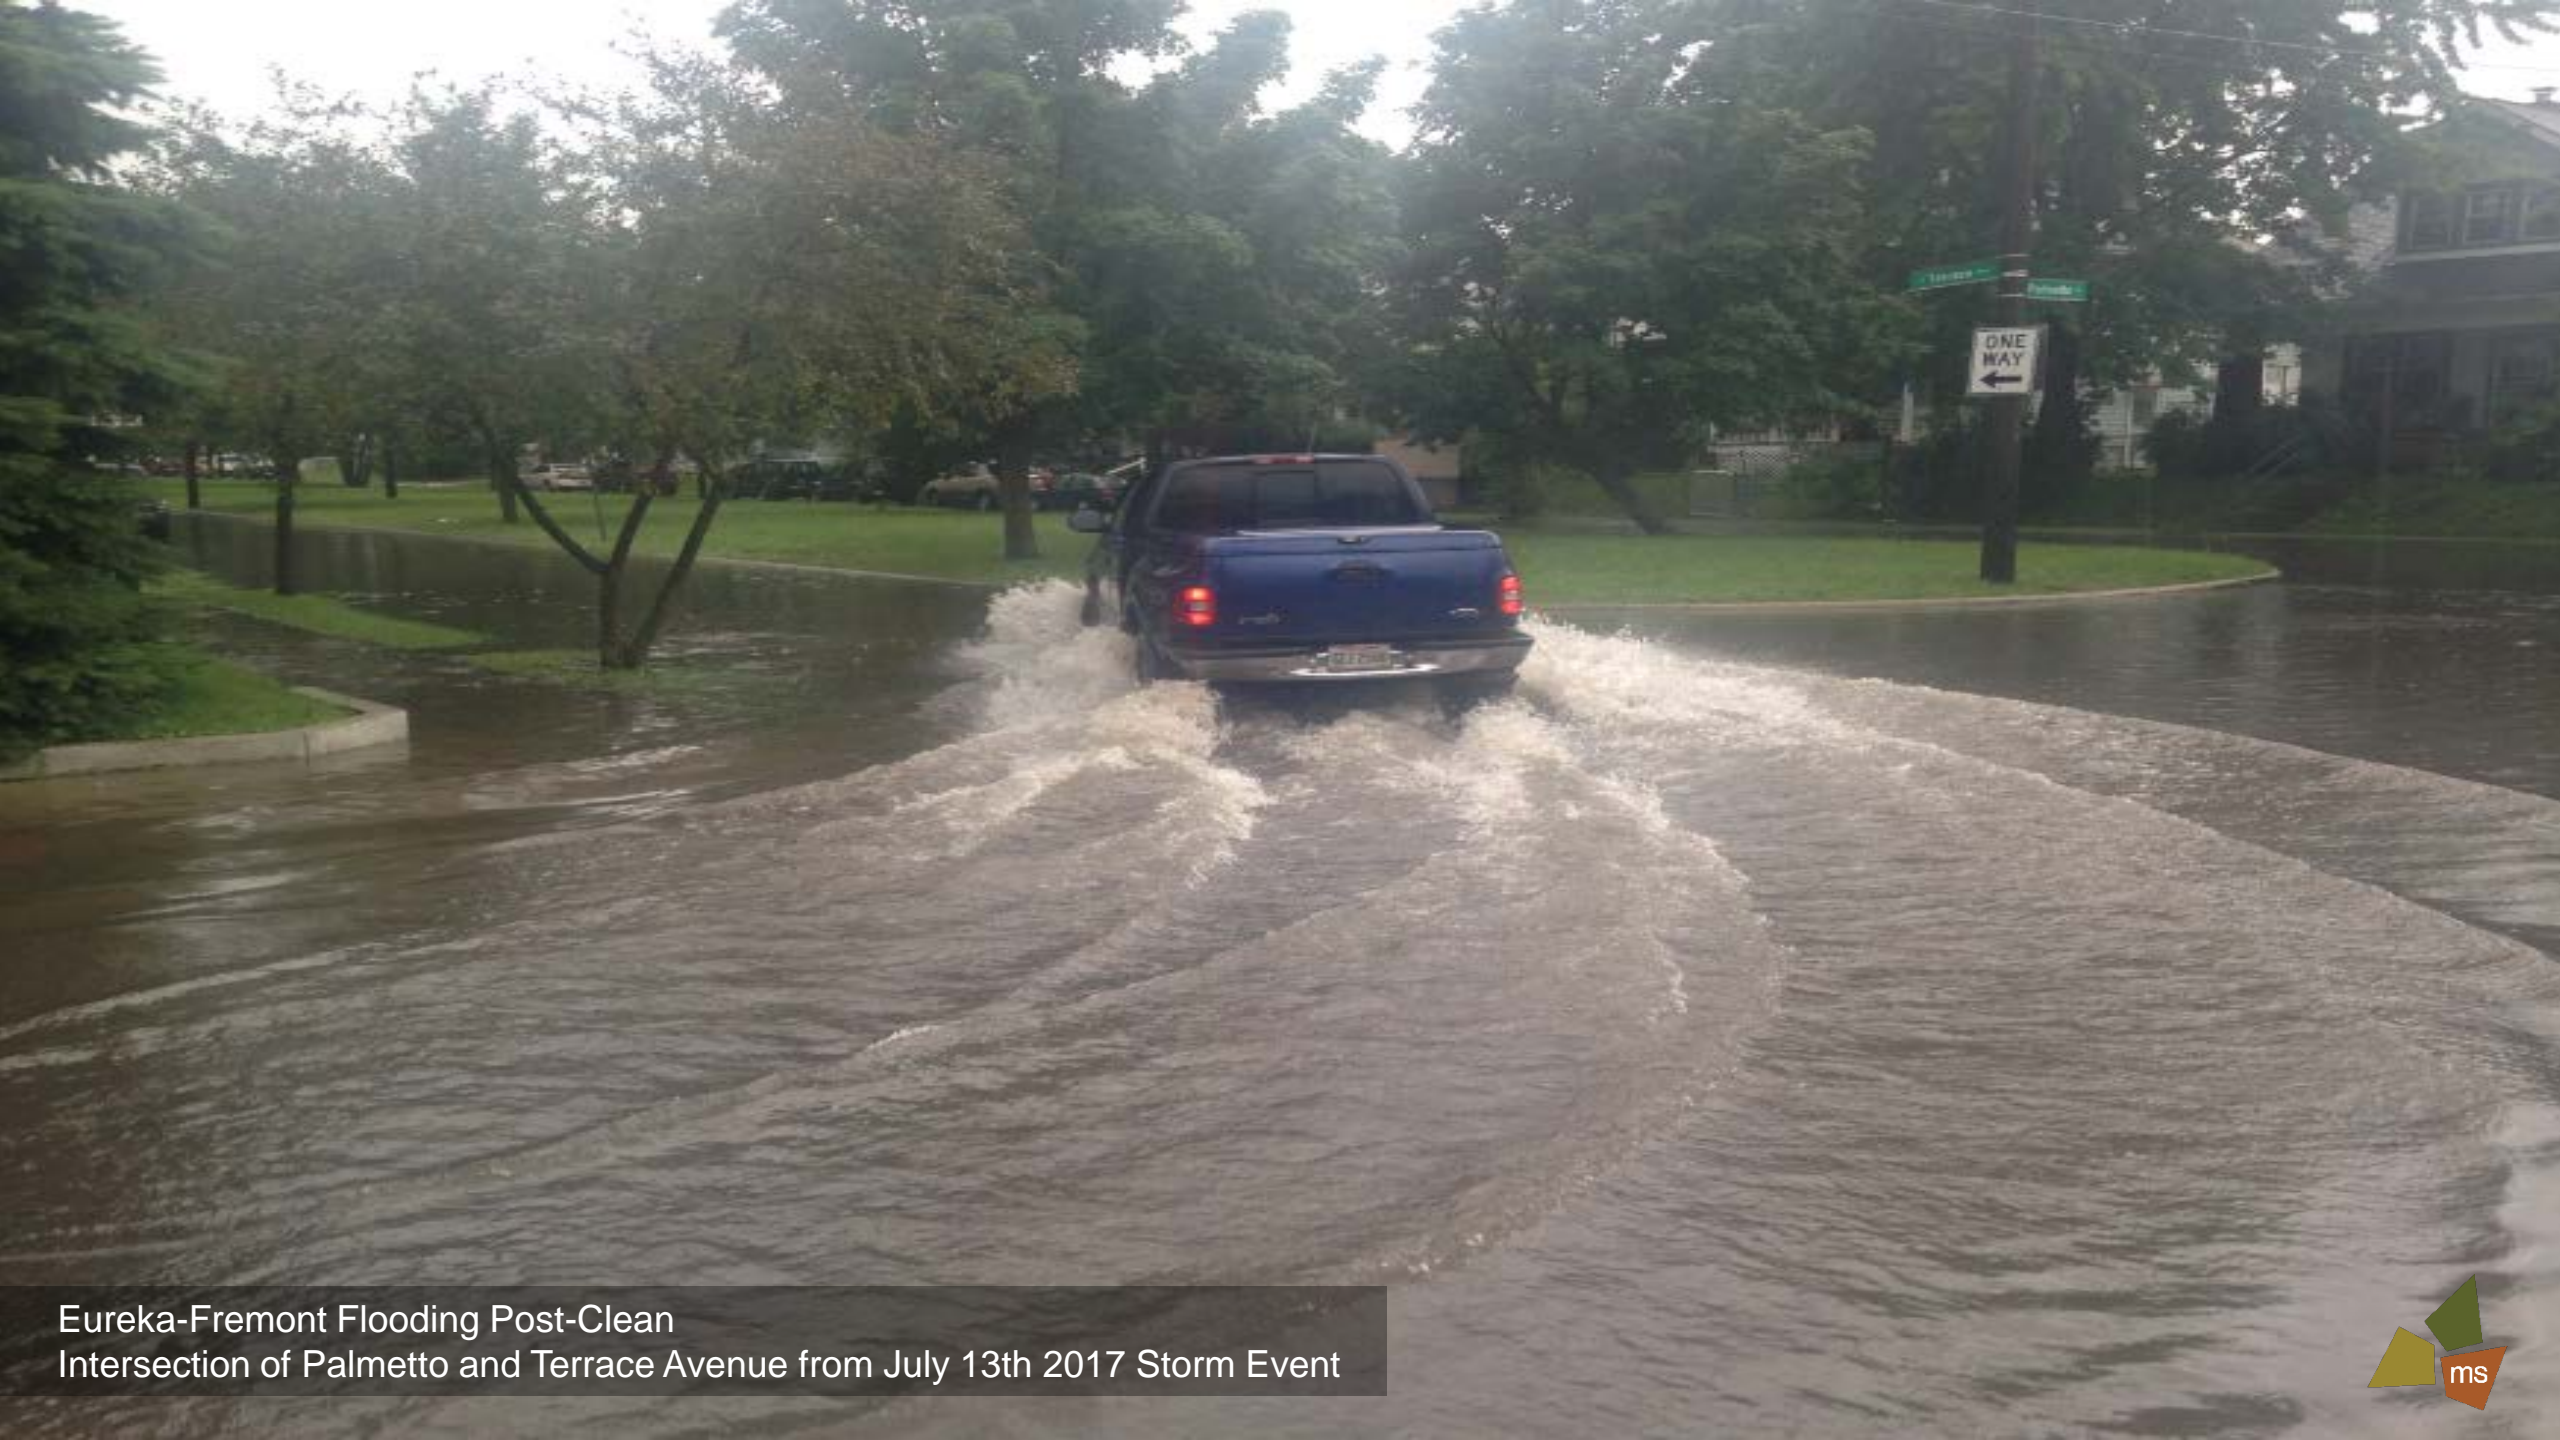
Eureka-Fremont Flooding Post-Clean
Intersection of Palmetto and Terrace Avenue from July 13th 2017 Storm Event

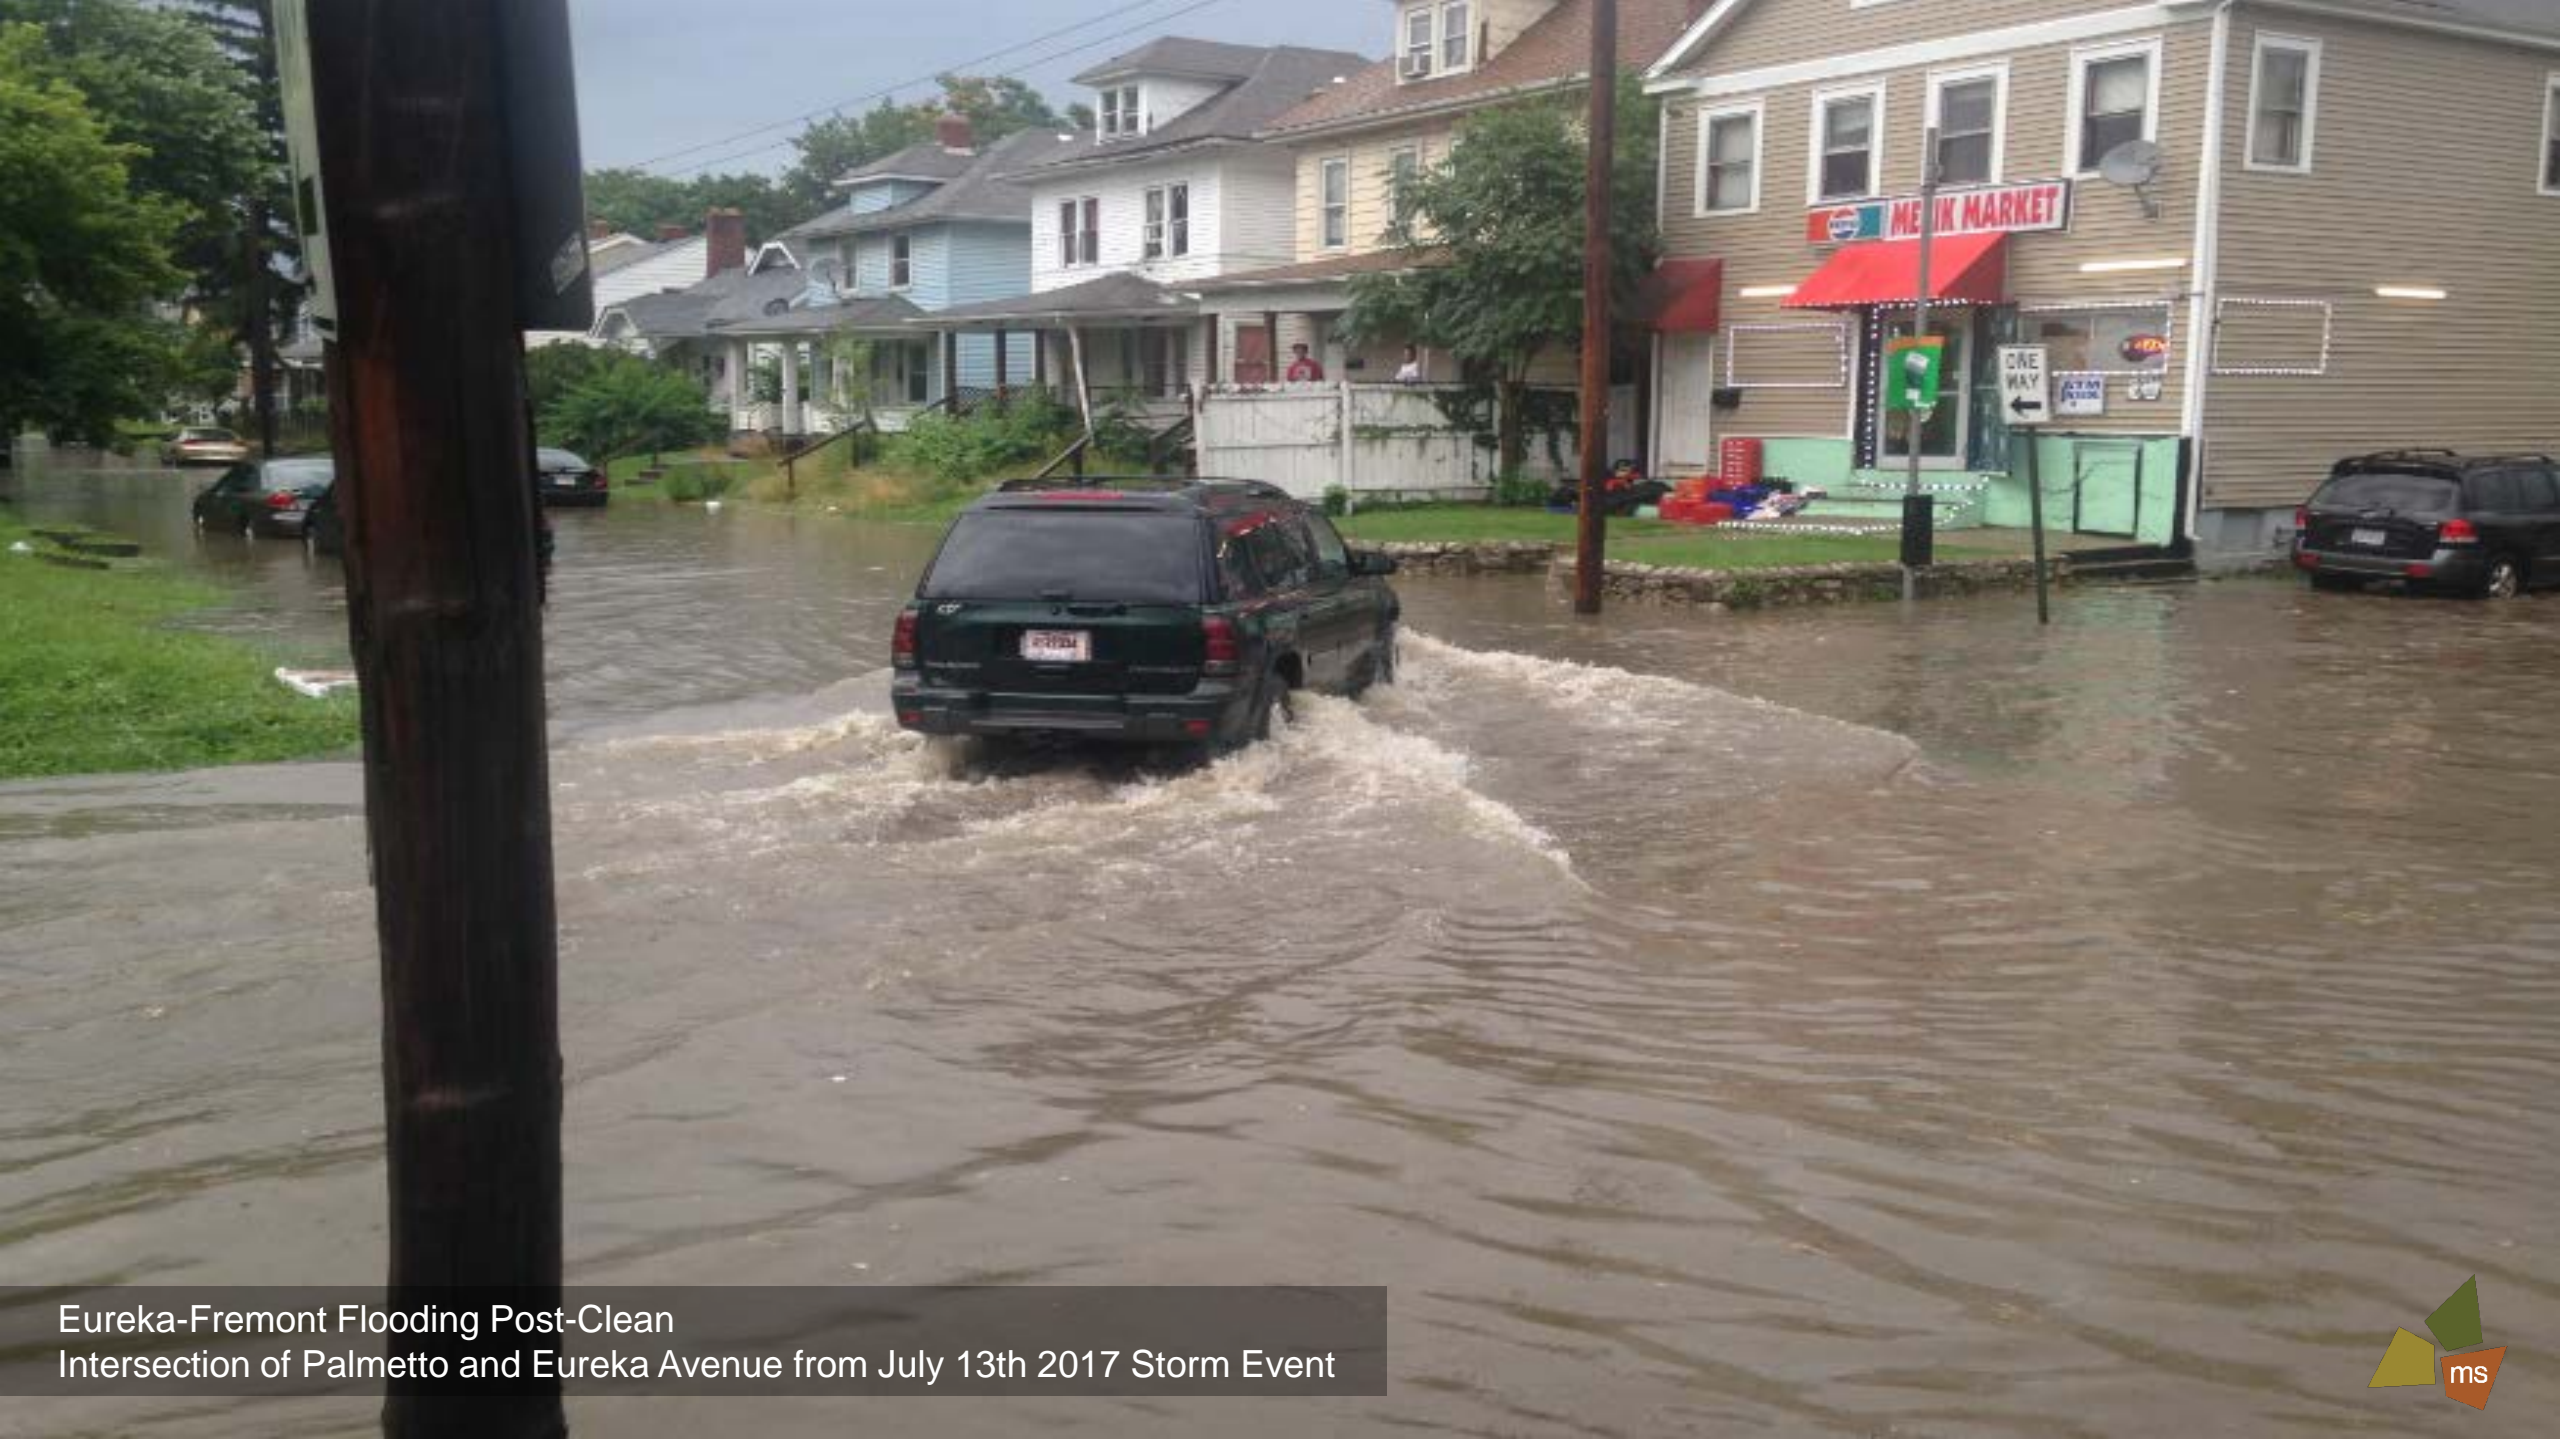
Eureka-Fremont Flooding Post-Clean
Intersection of Palmetto and Eureka Avenue from July 13th 2017 Storm Event

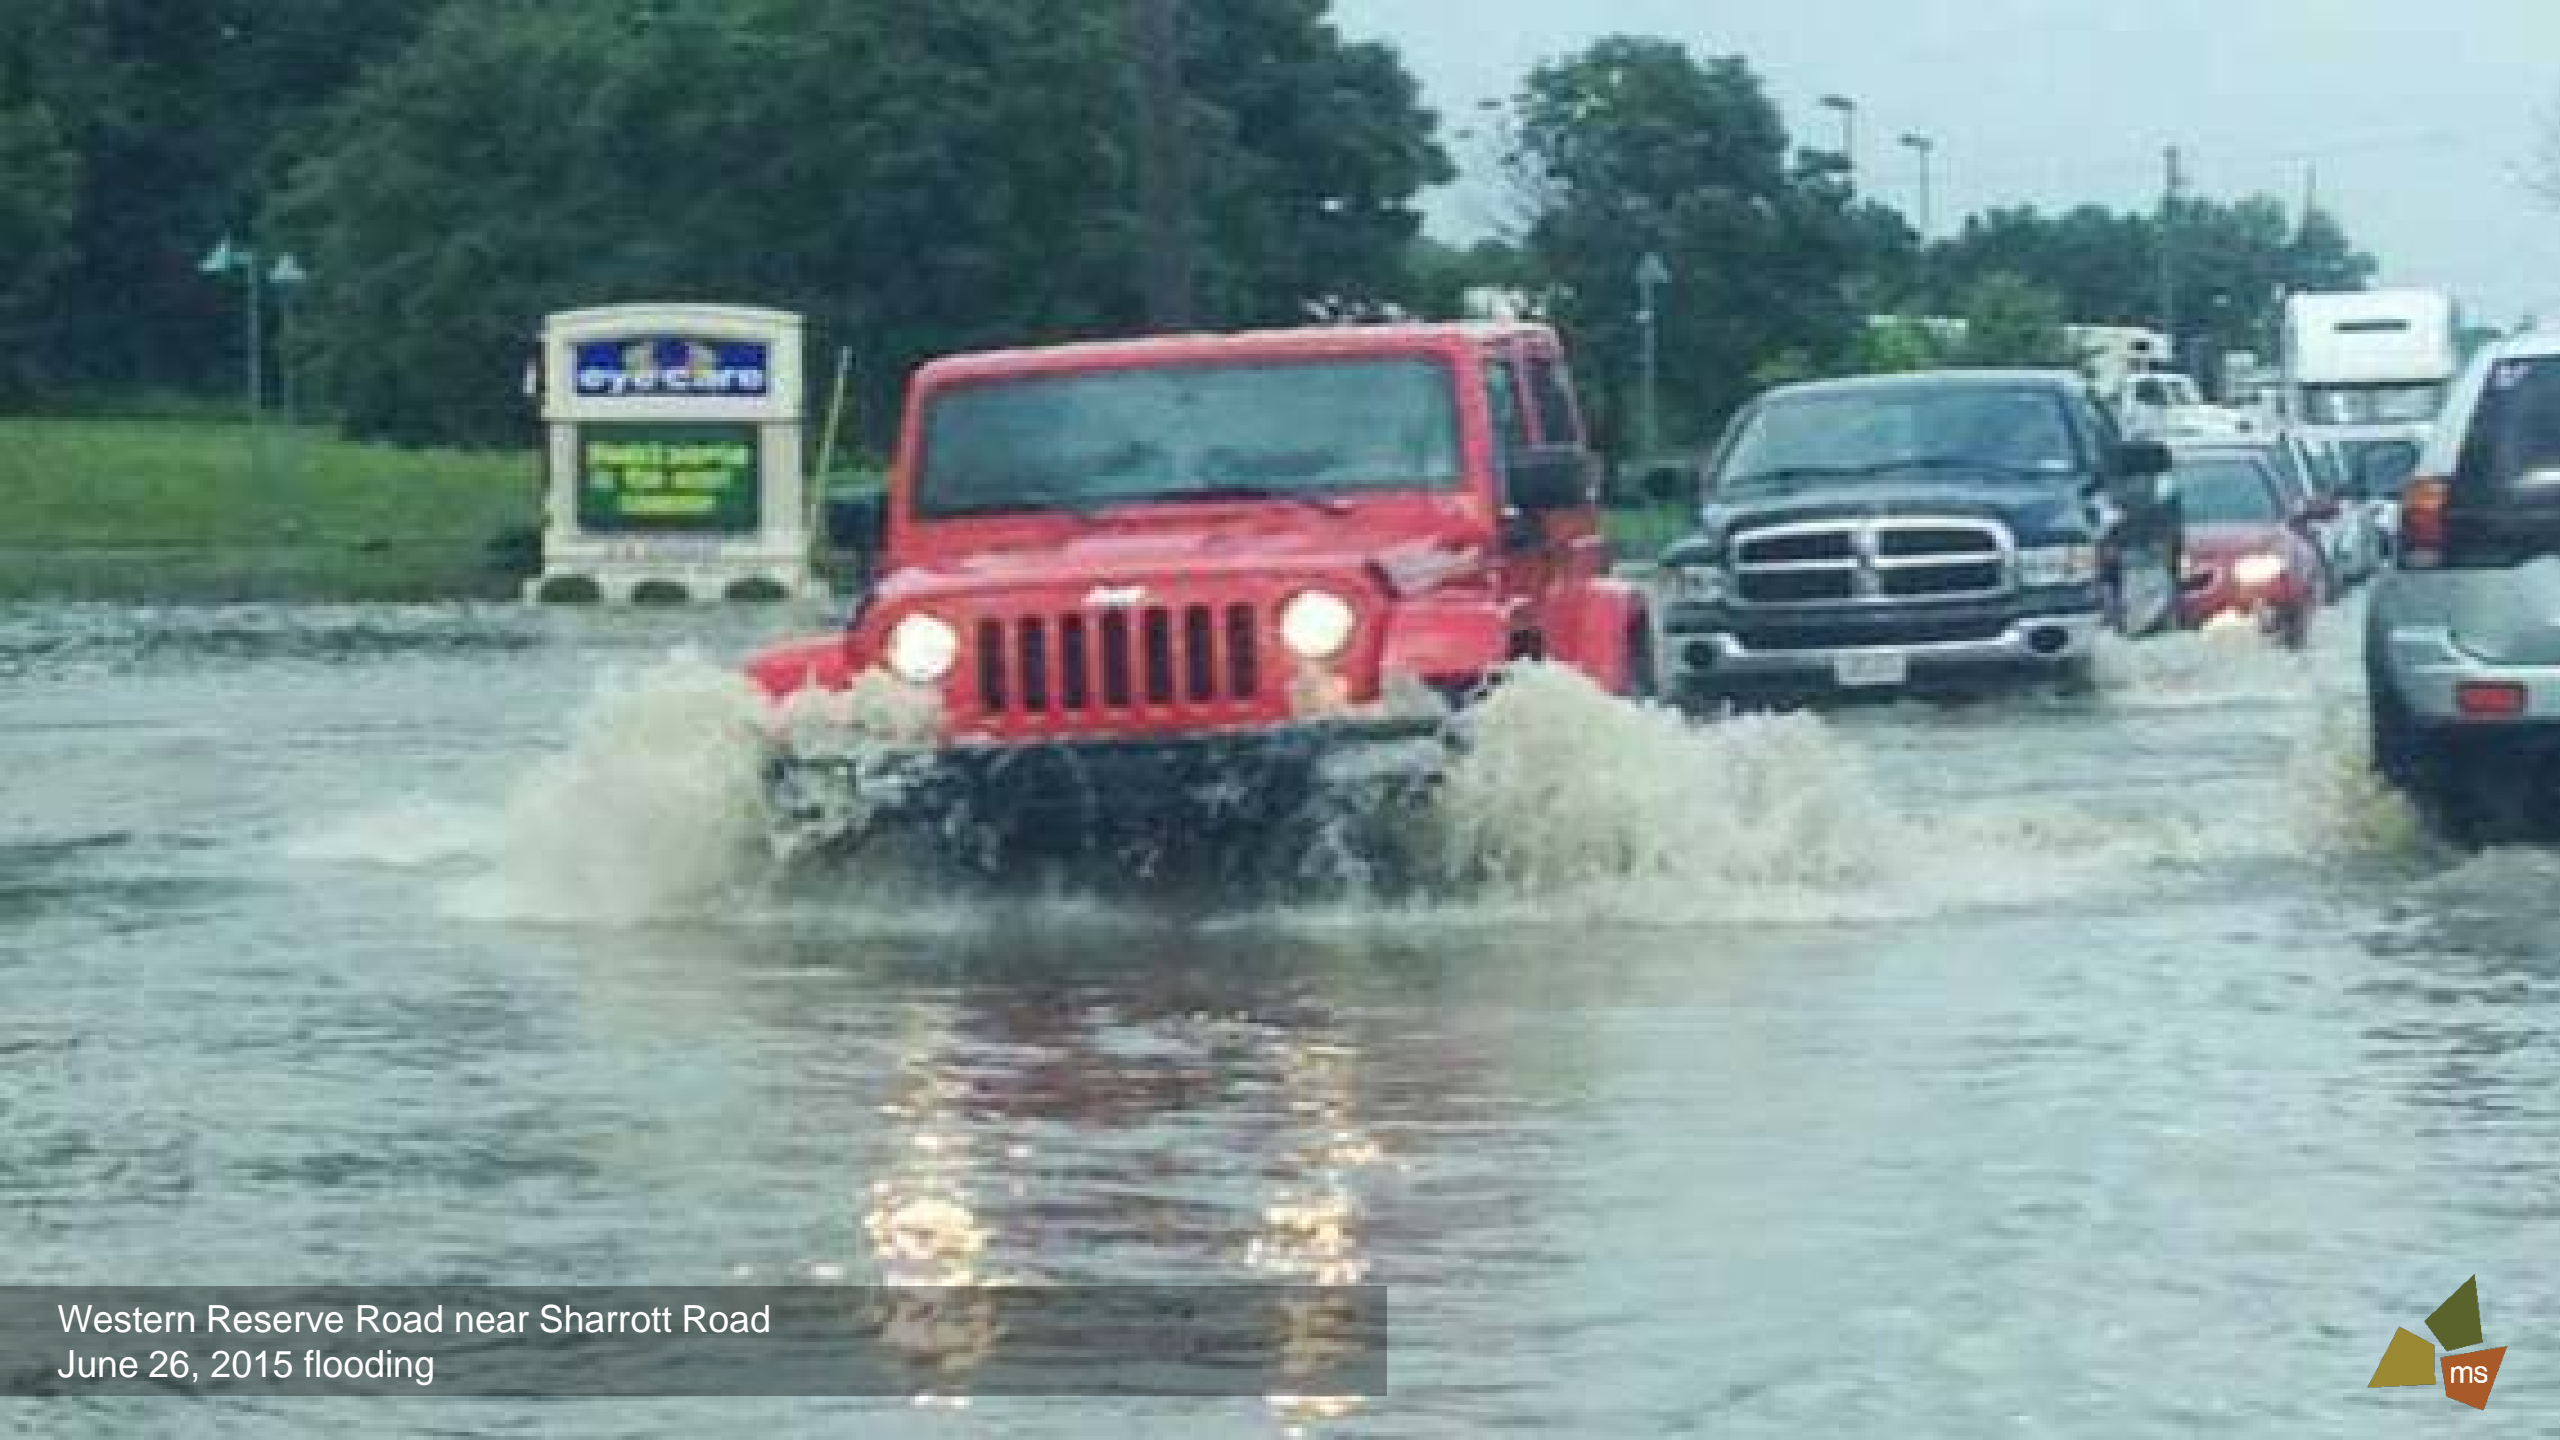
Western Reserve Road near Sharrott Road
June 26, 2015 flooding
