Eureka-Fremont Flooding Pre-Clean
Corner of Broad Street and Terrace Avenue from June 2015 Rain Event

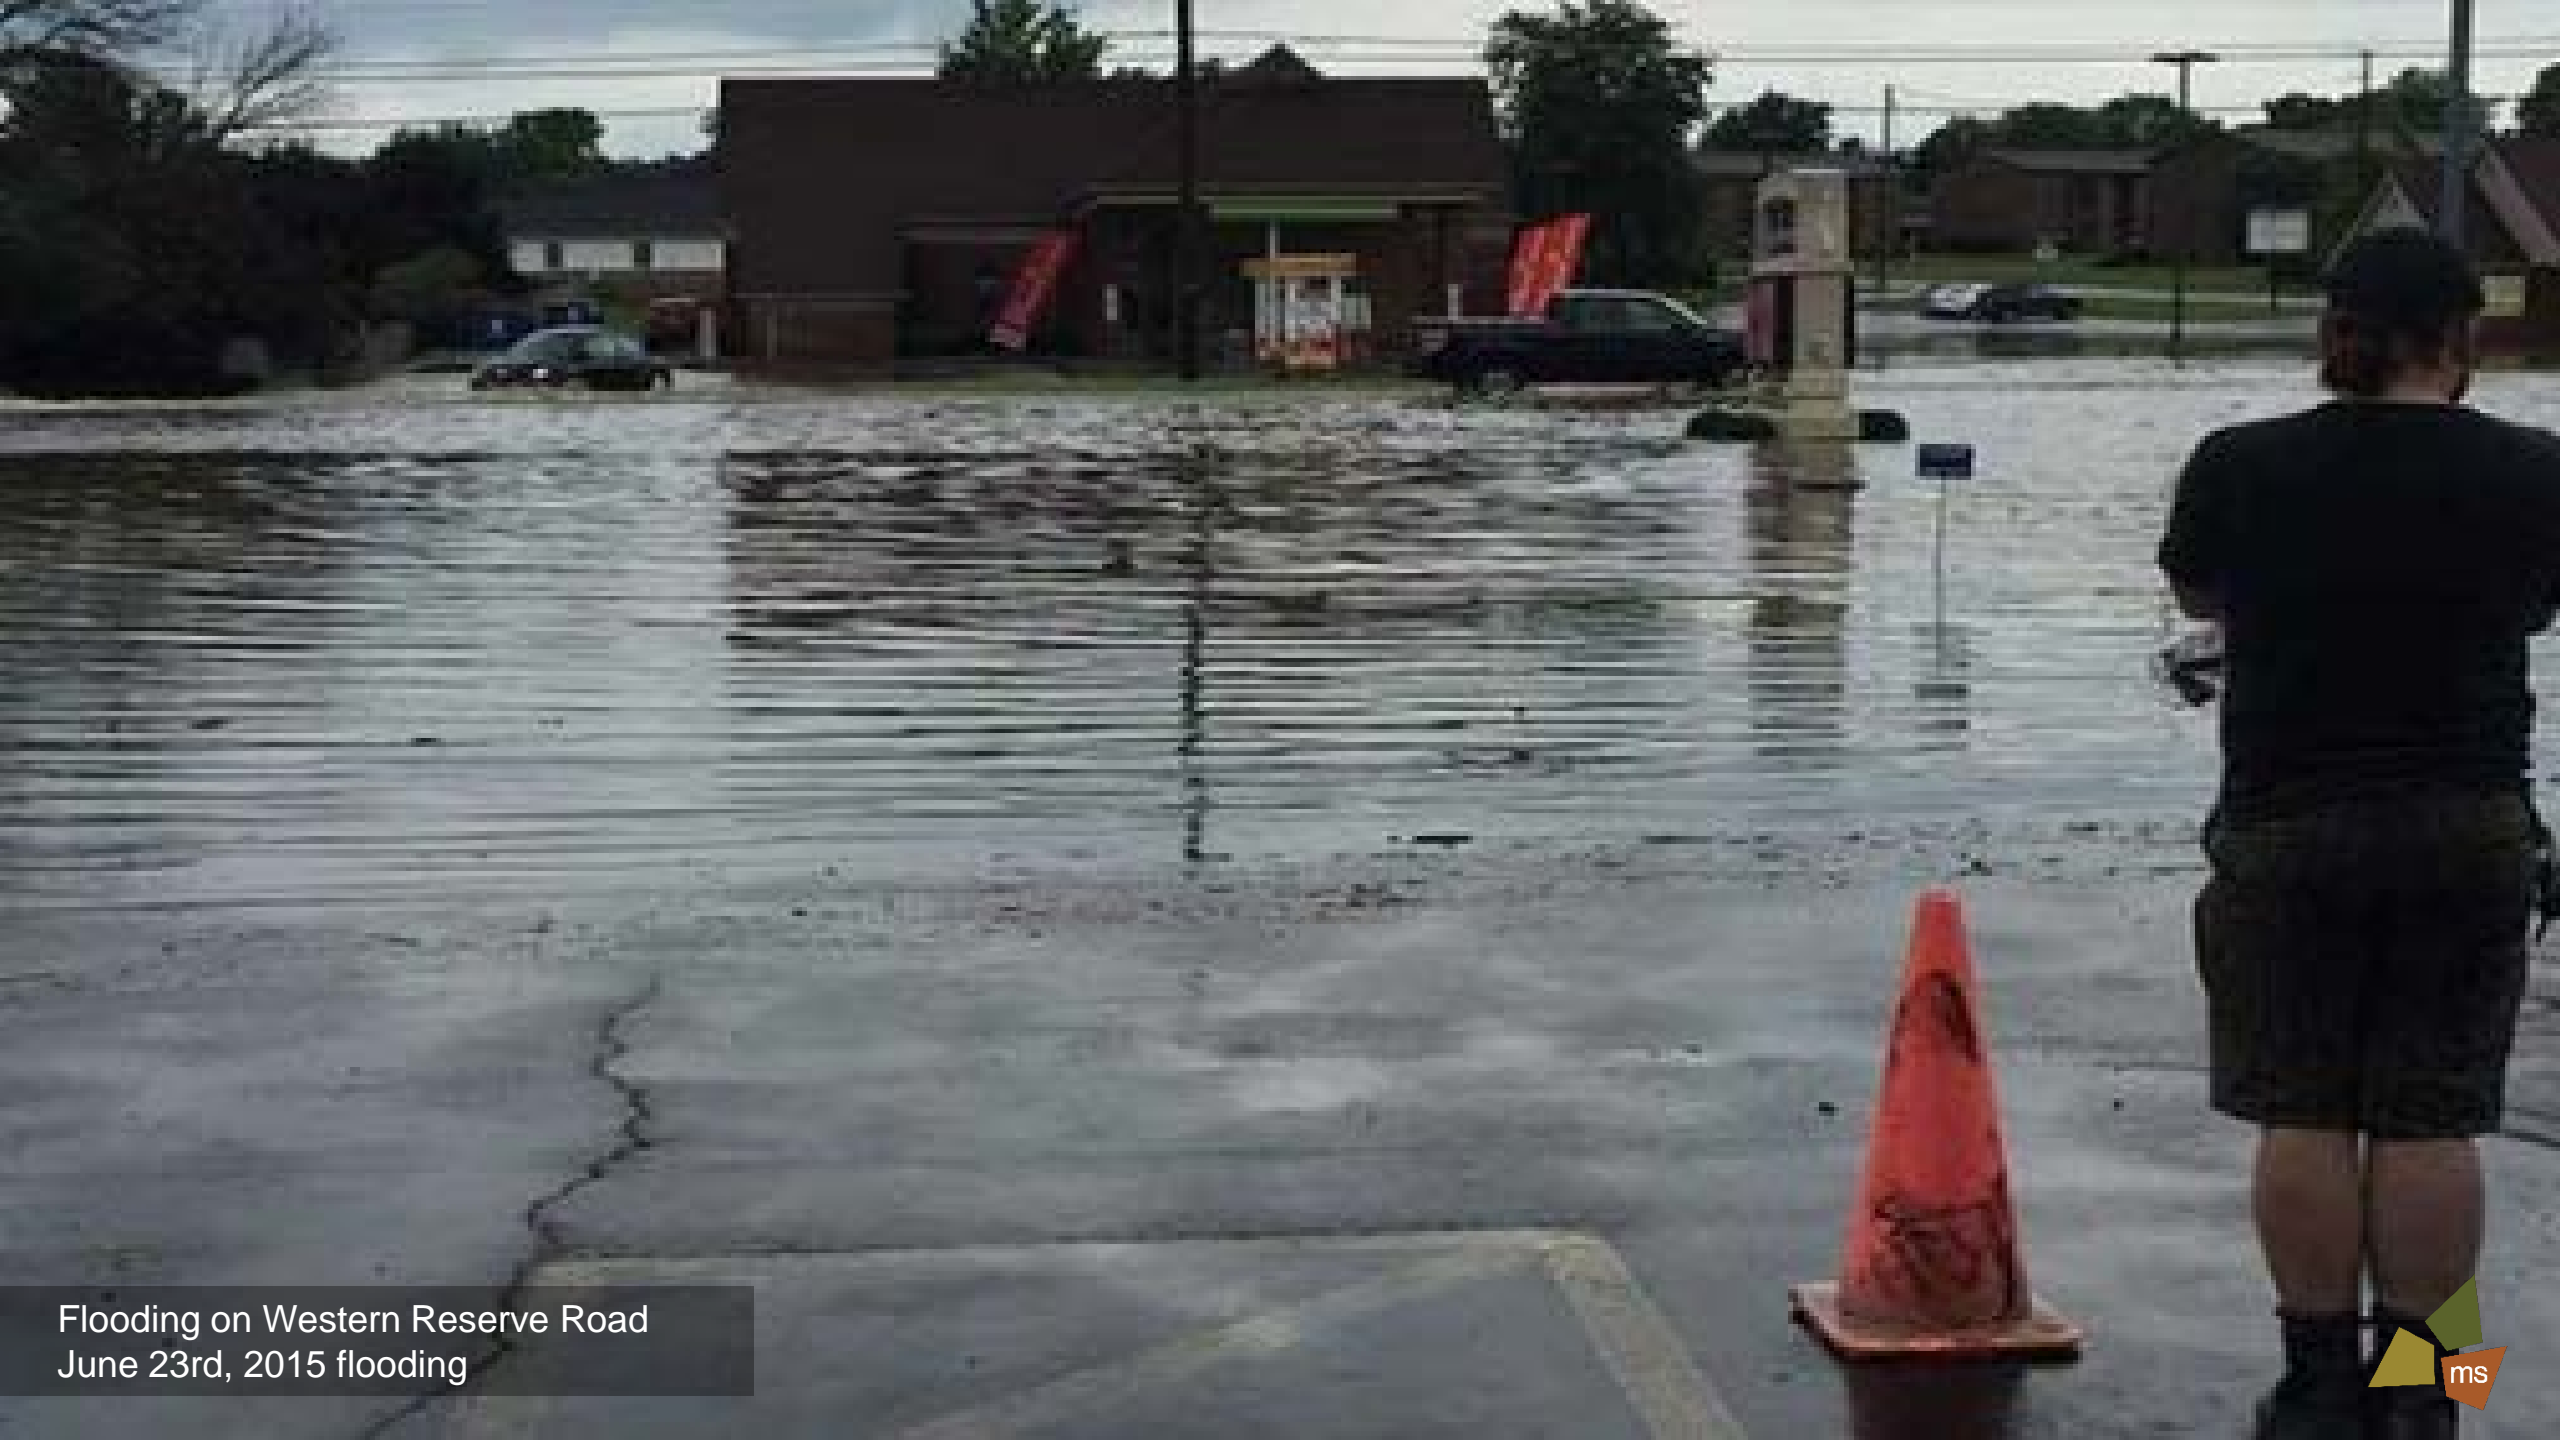
Flooding on Western Reserve Road
June 23rd, 2015 flooding

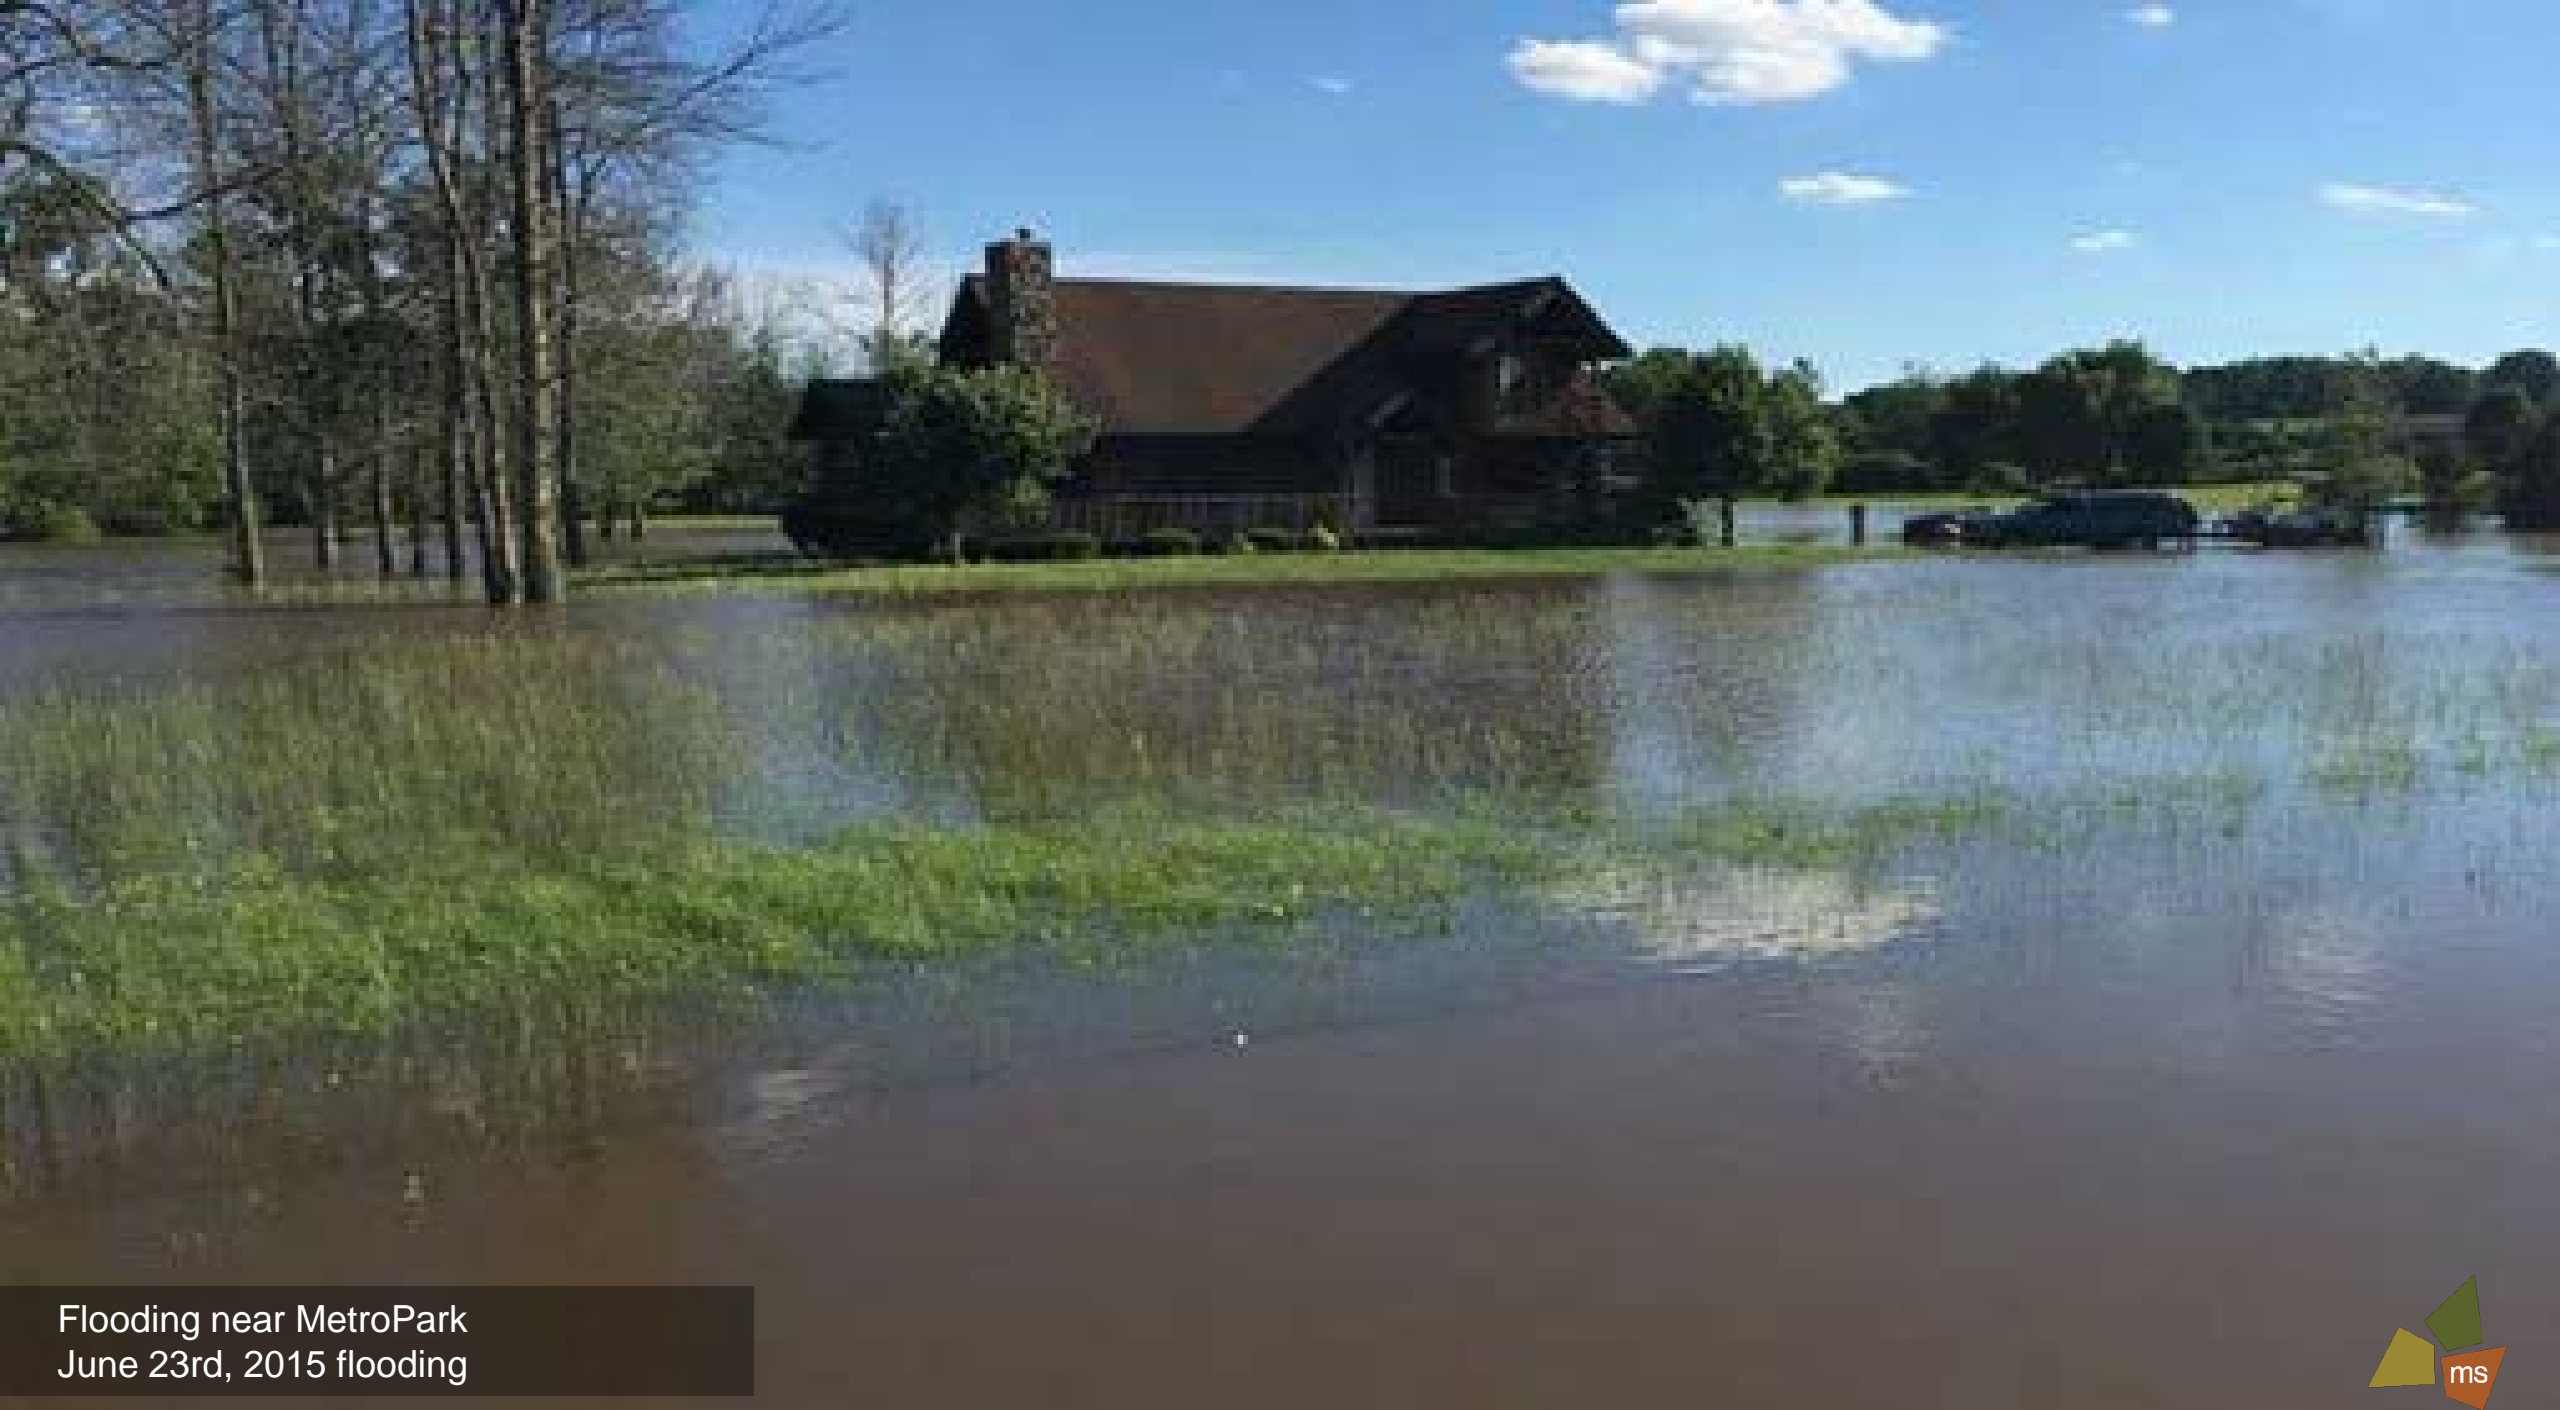
Flooding near MetroPark
June 23rd, 2015 flooding

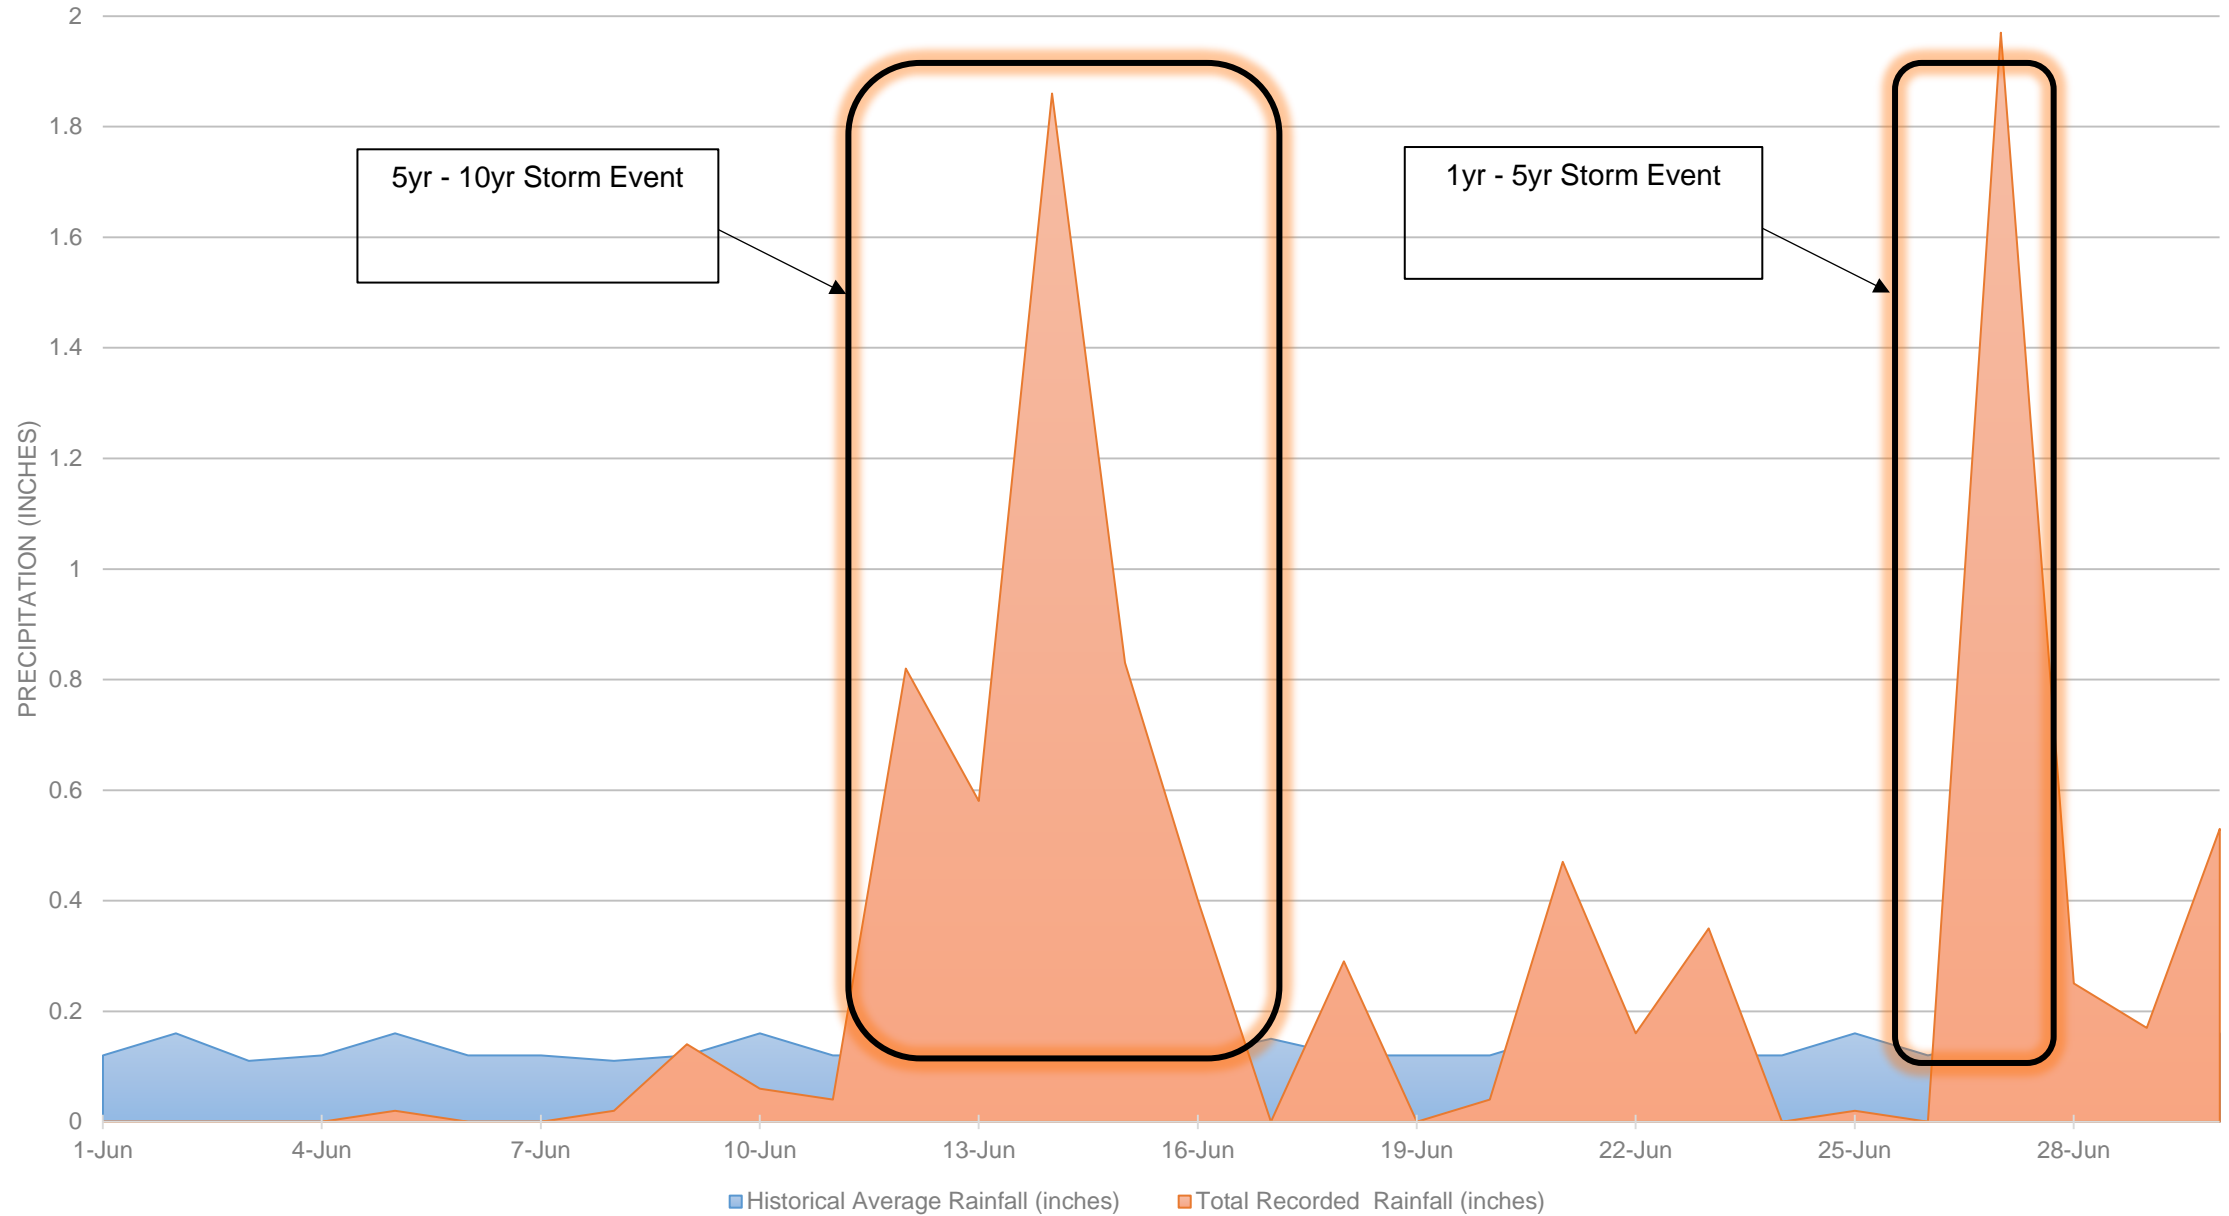
June 2015 Rainfall Data For Youngstown, Ohio

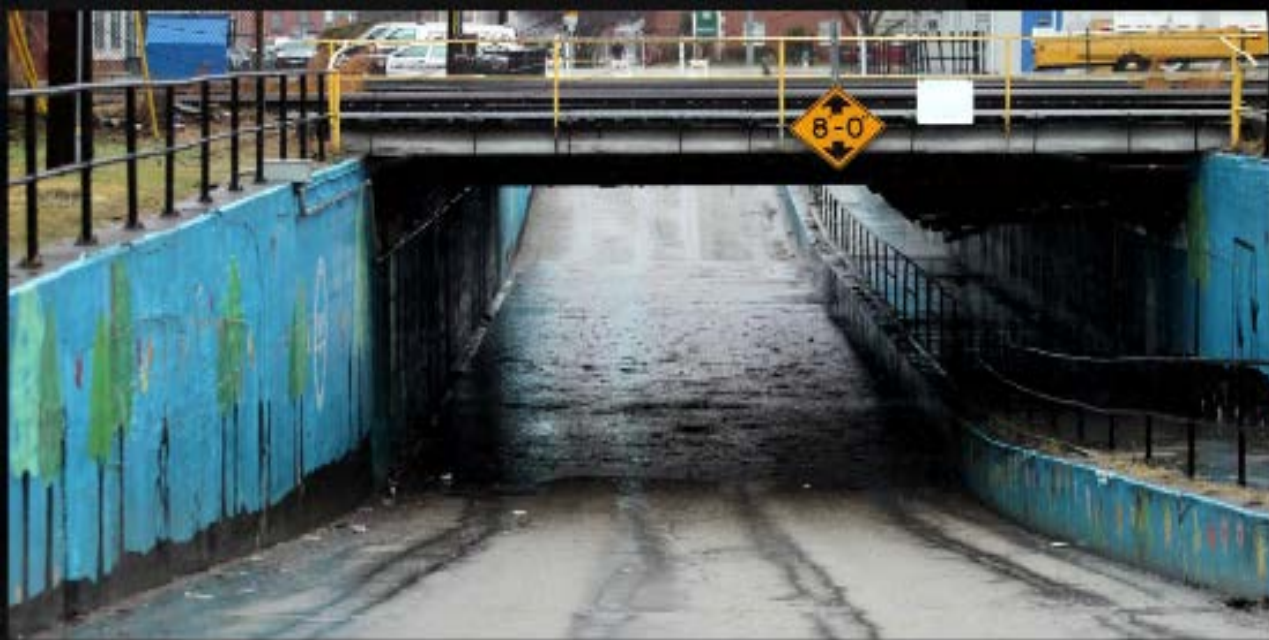
Huntington, WV, flooding
in underpasses

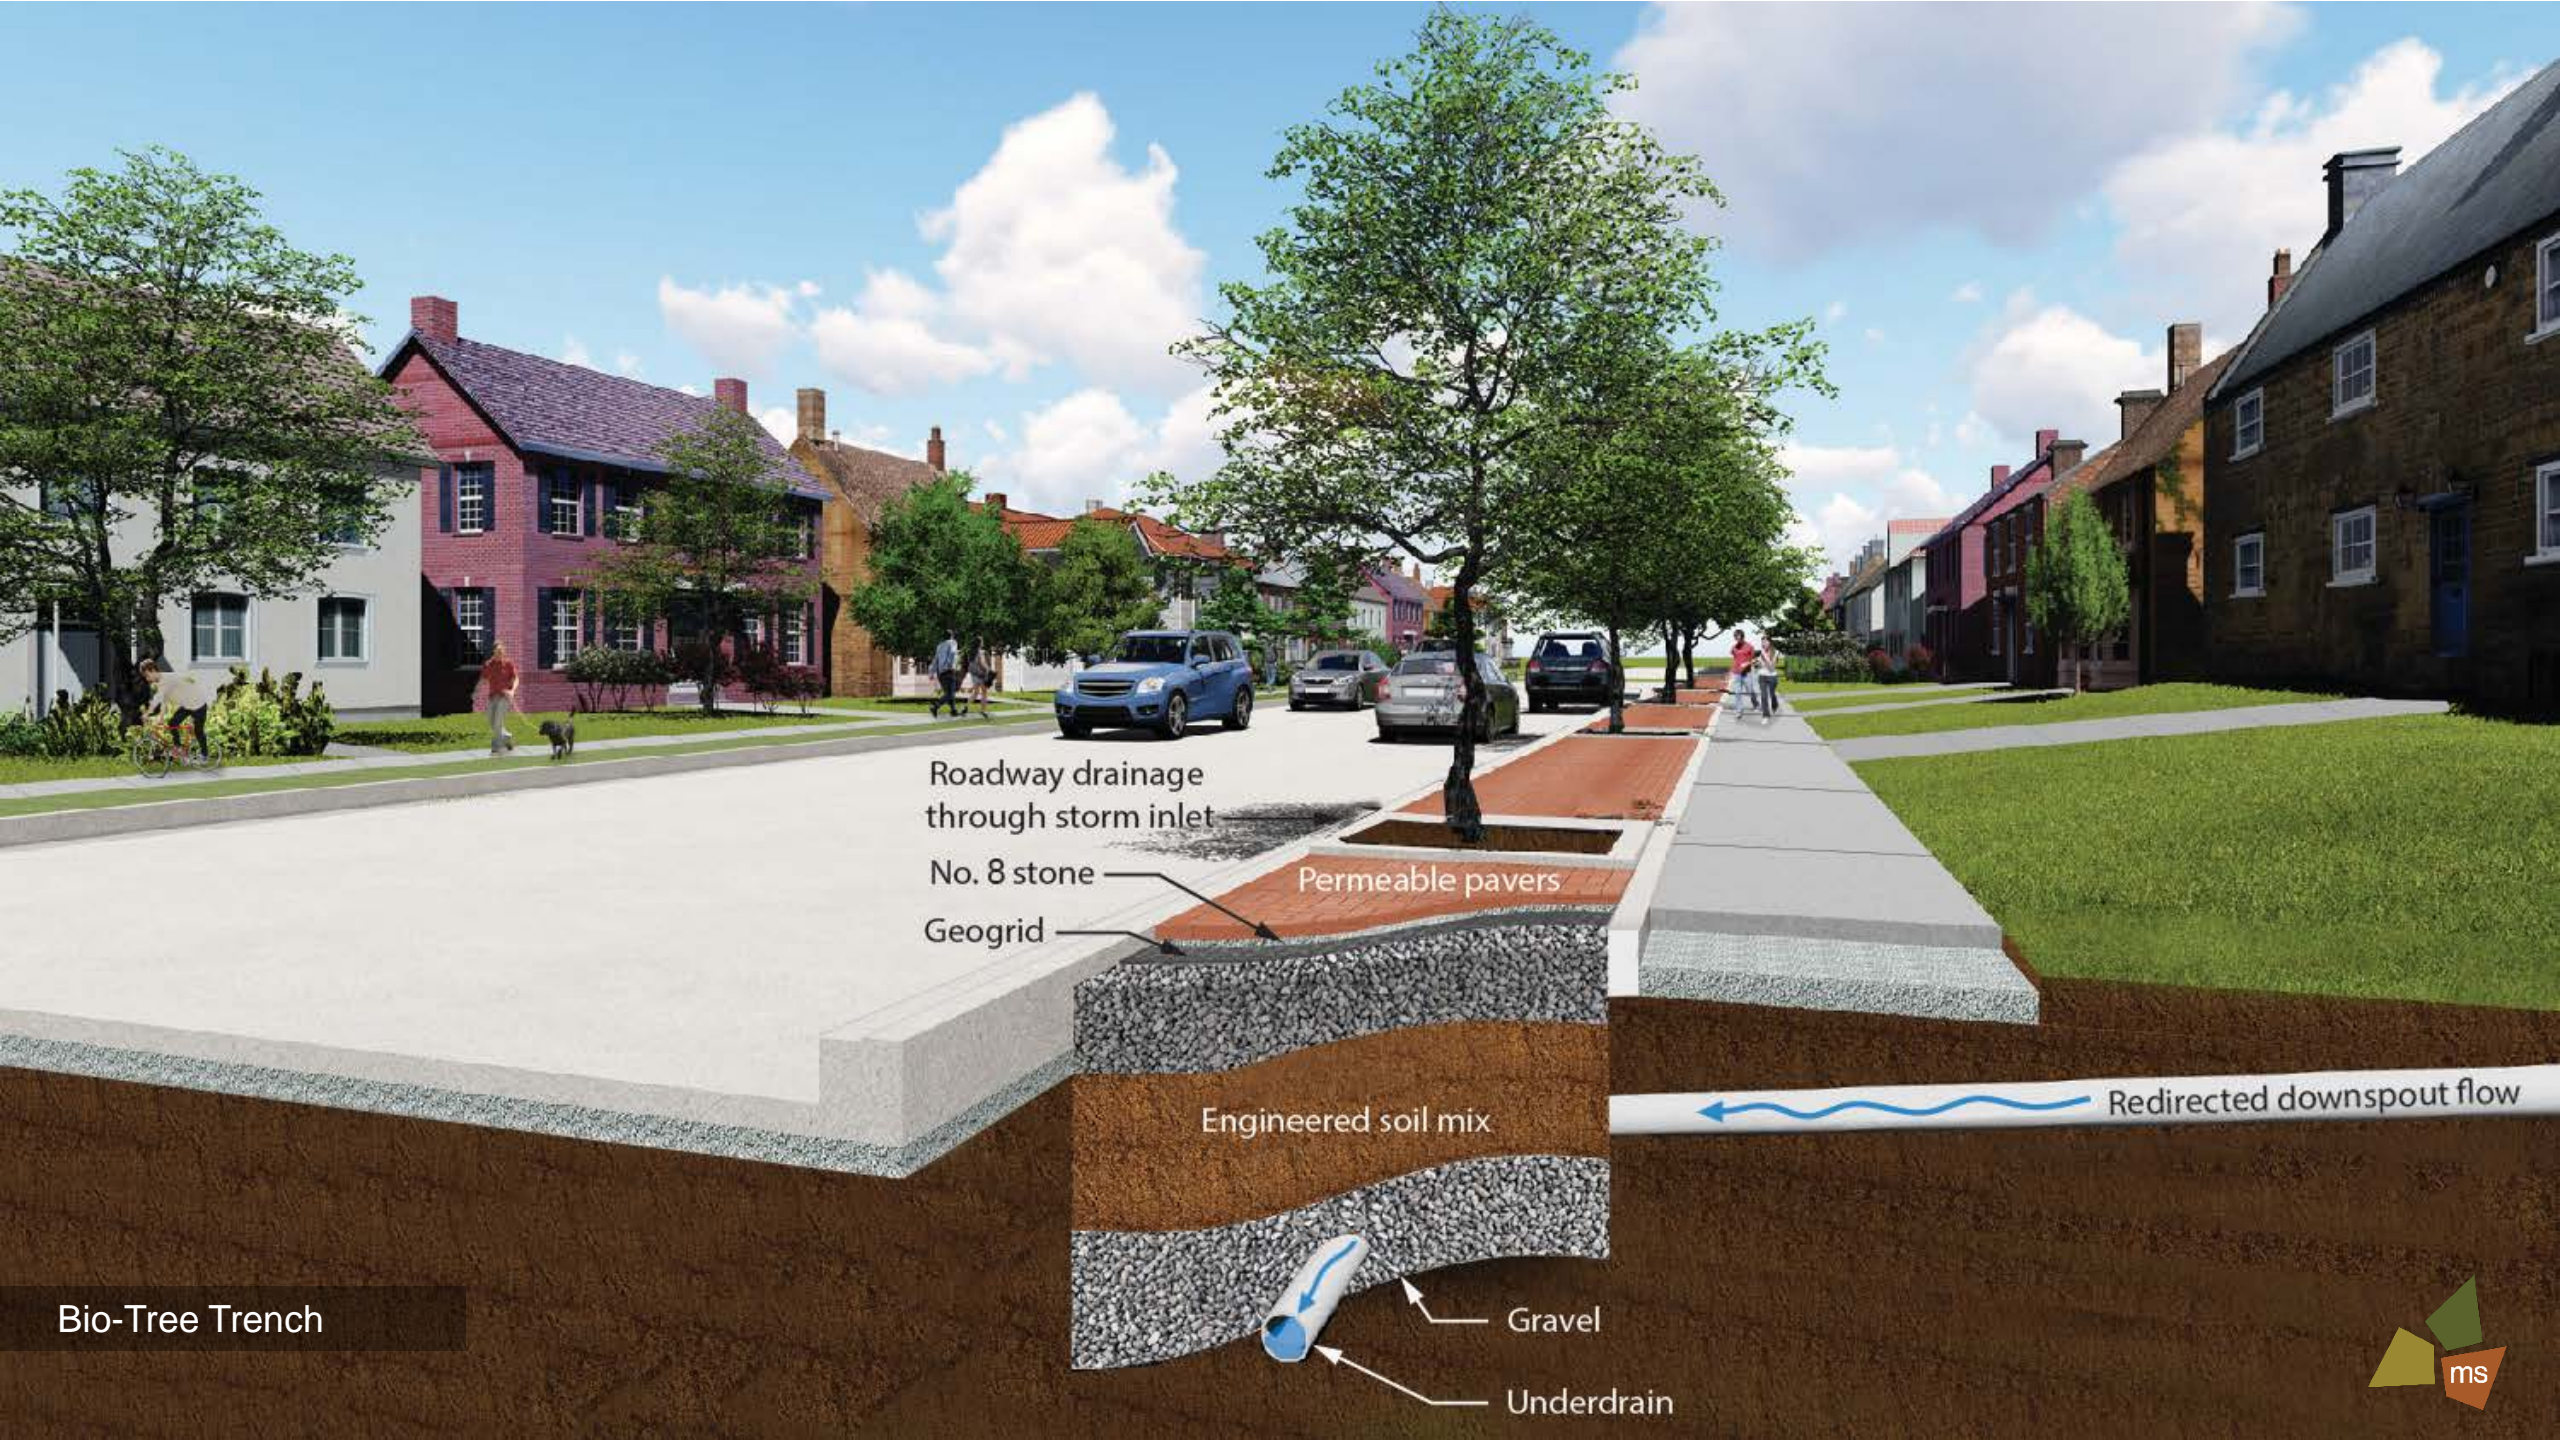
Roadway drainage
through storm inlet

No. 8 stone

Geogrid

Permeable pavers

Engineered soil mix

Redirected downspout flow

Gravel

Underdrain

Bio-Tree Trench

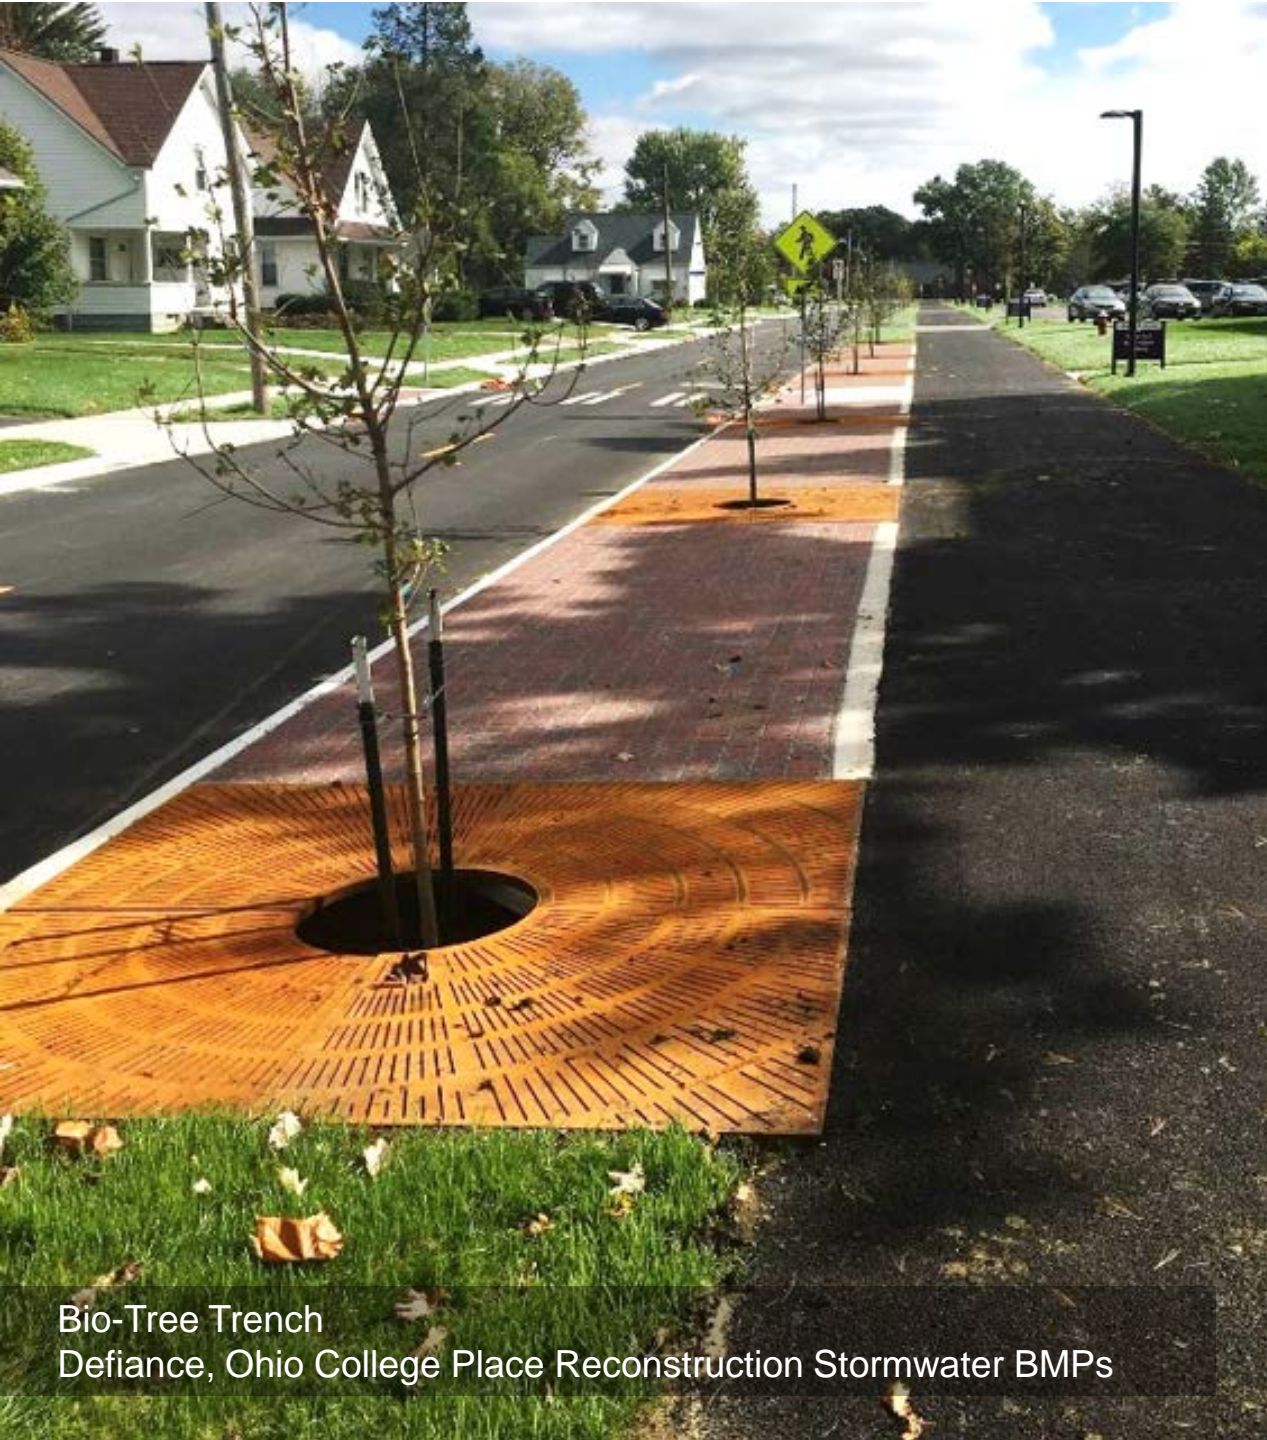
Bio-Tree Trench
Defiance, Ohio College Place Reconstruction Stormwater BMPs

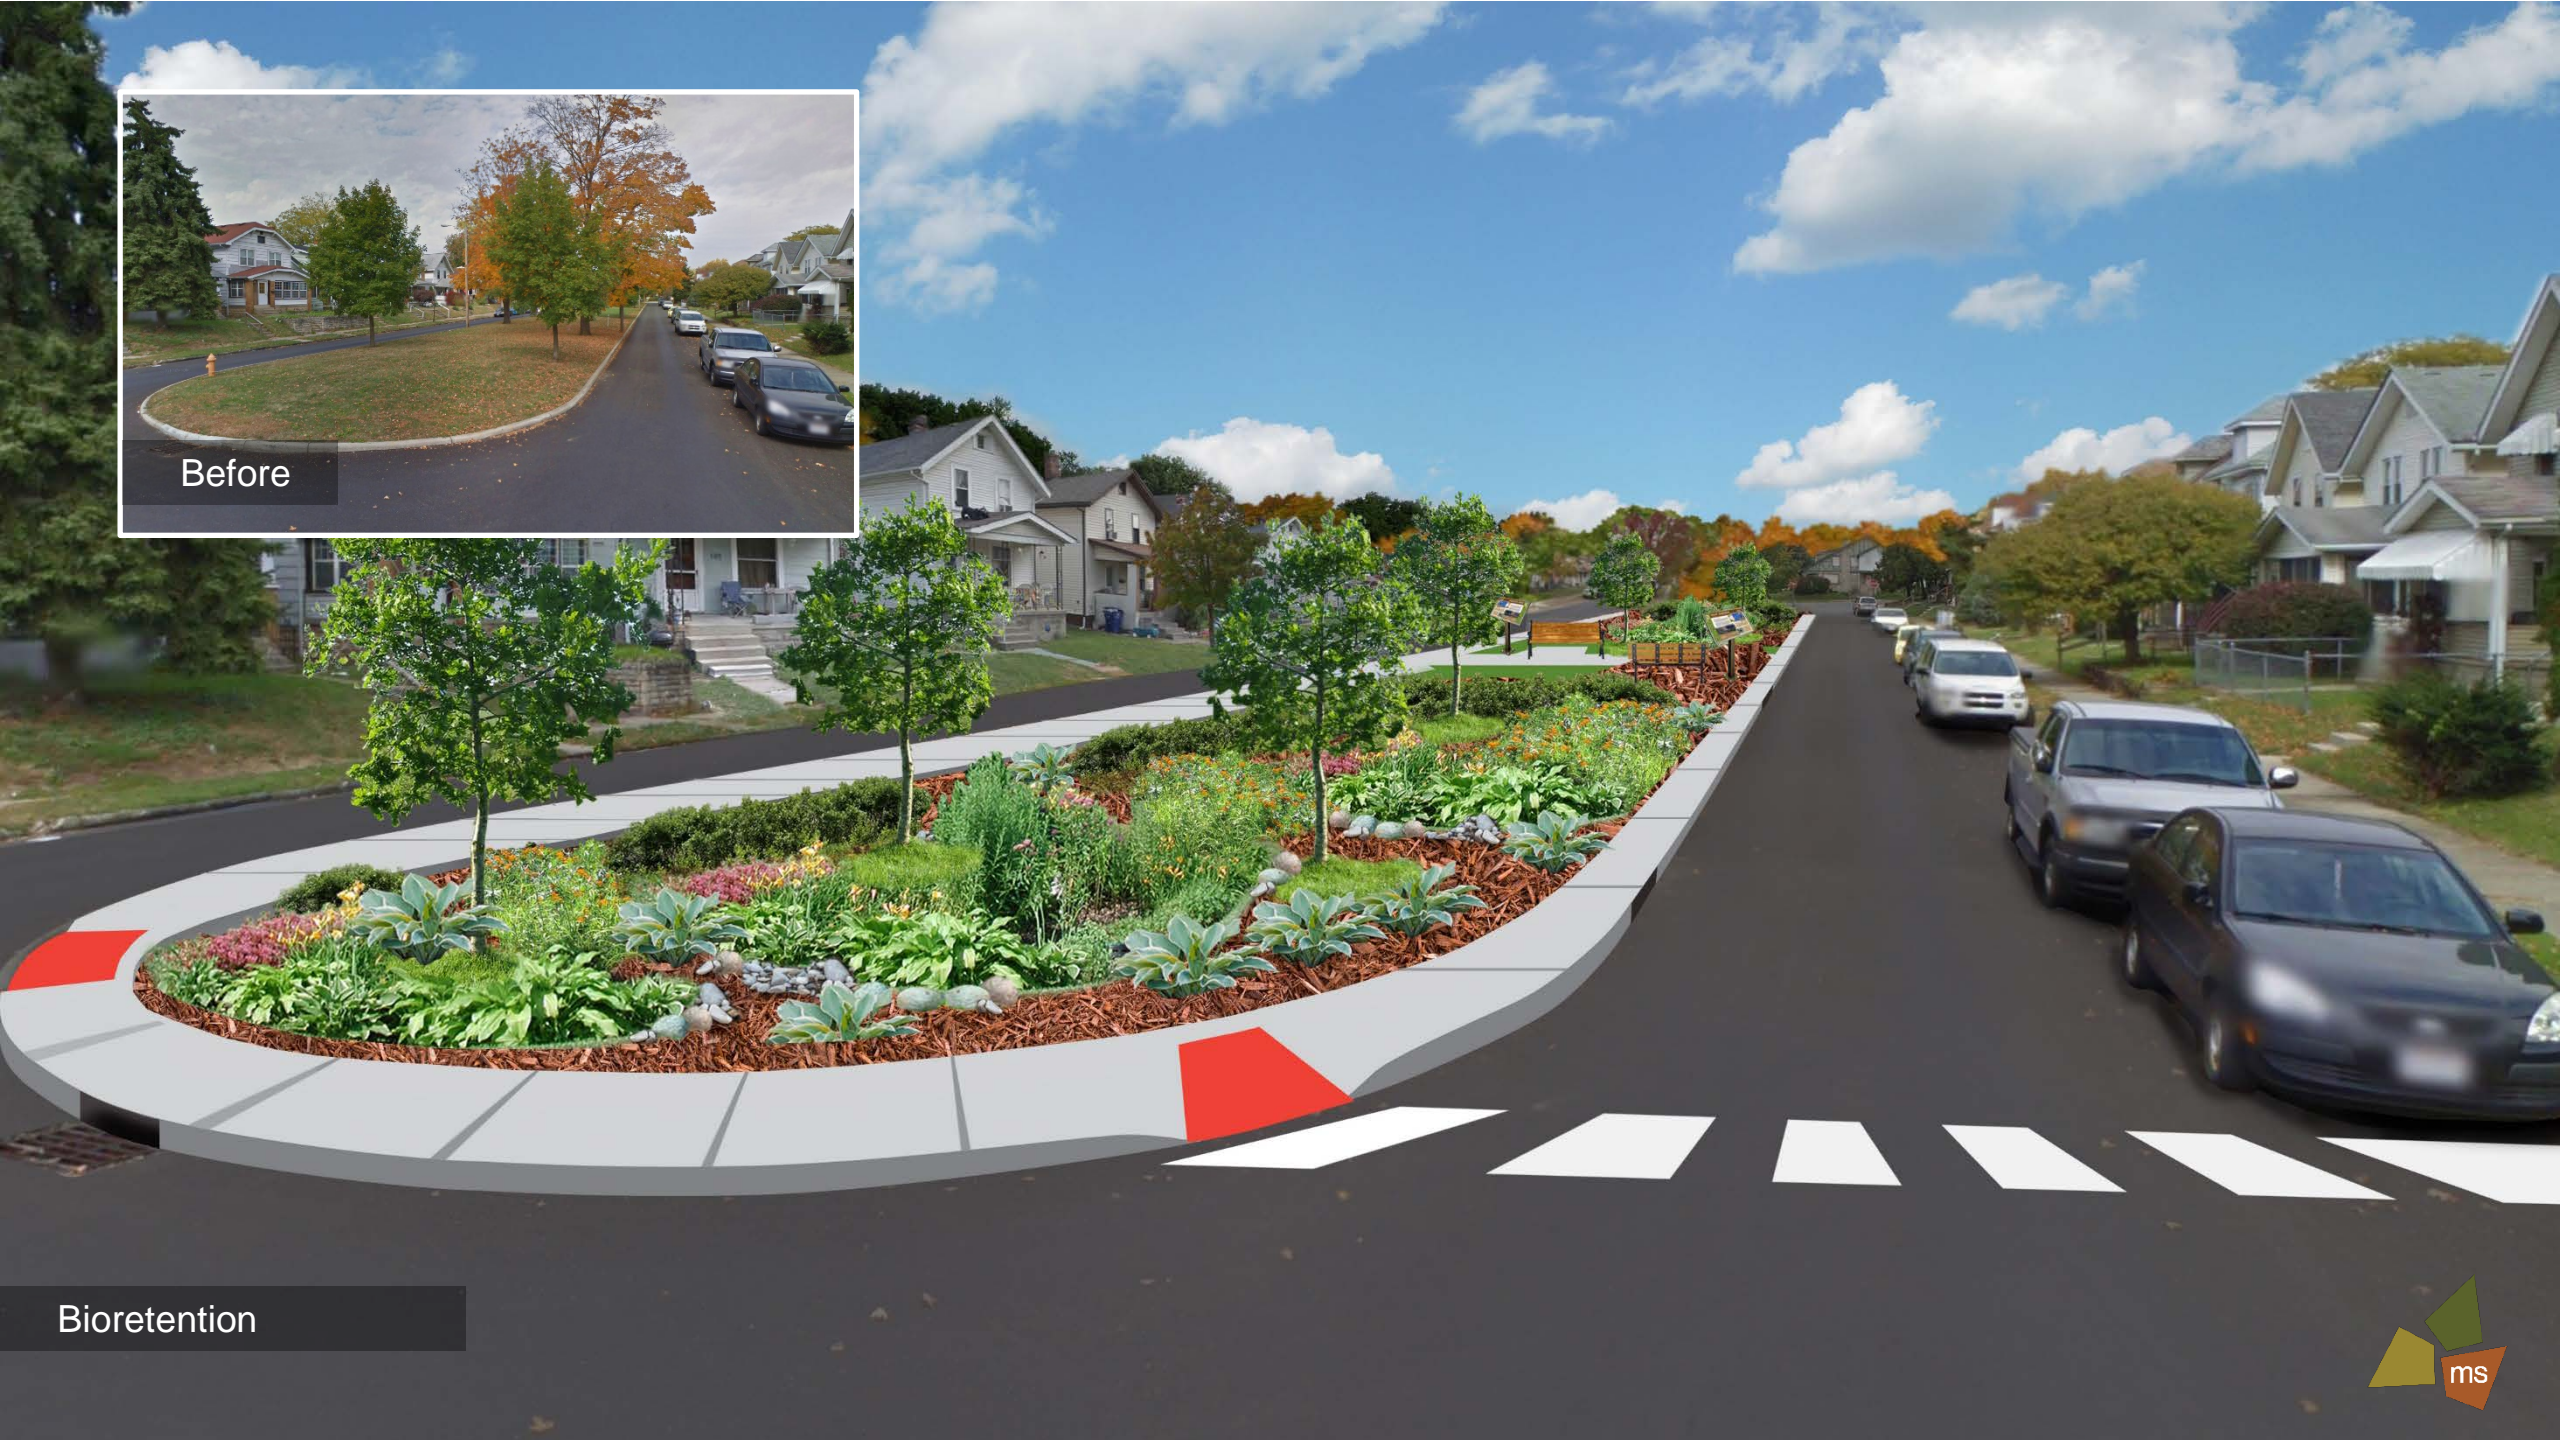
Bioretention

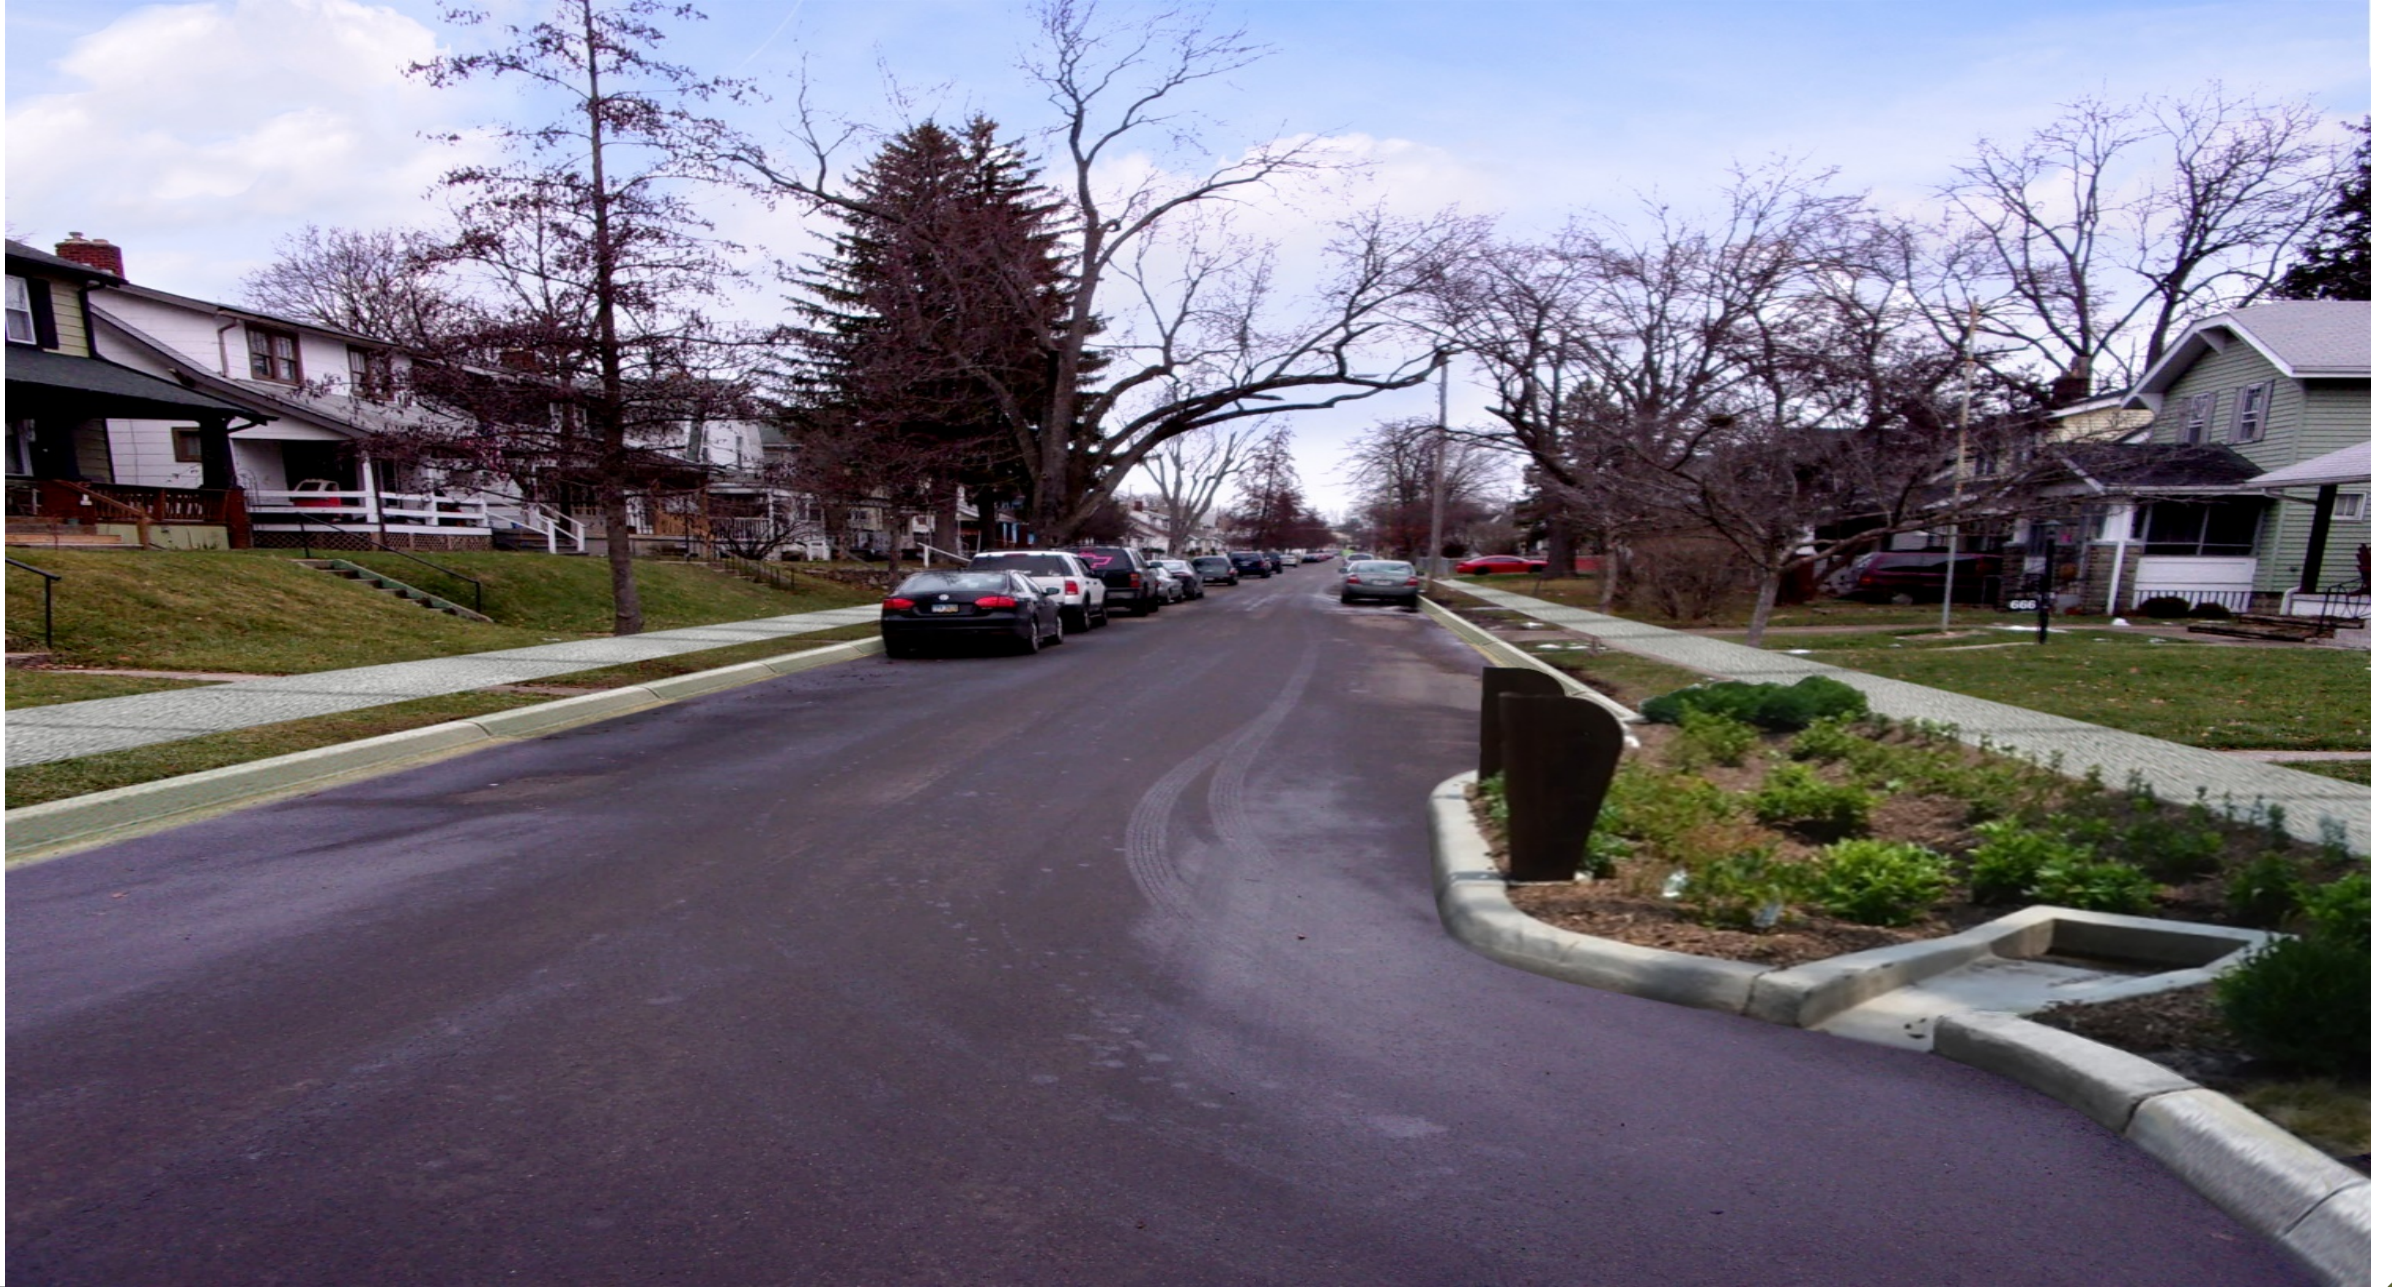
Bioretention Bumpouts
