Eureka-Fremont Flooding Pre-Clean
Corner of Broad Street and Terrace Avenue from June 2015 Rain Event

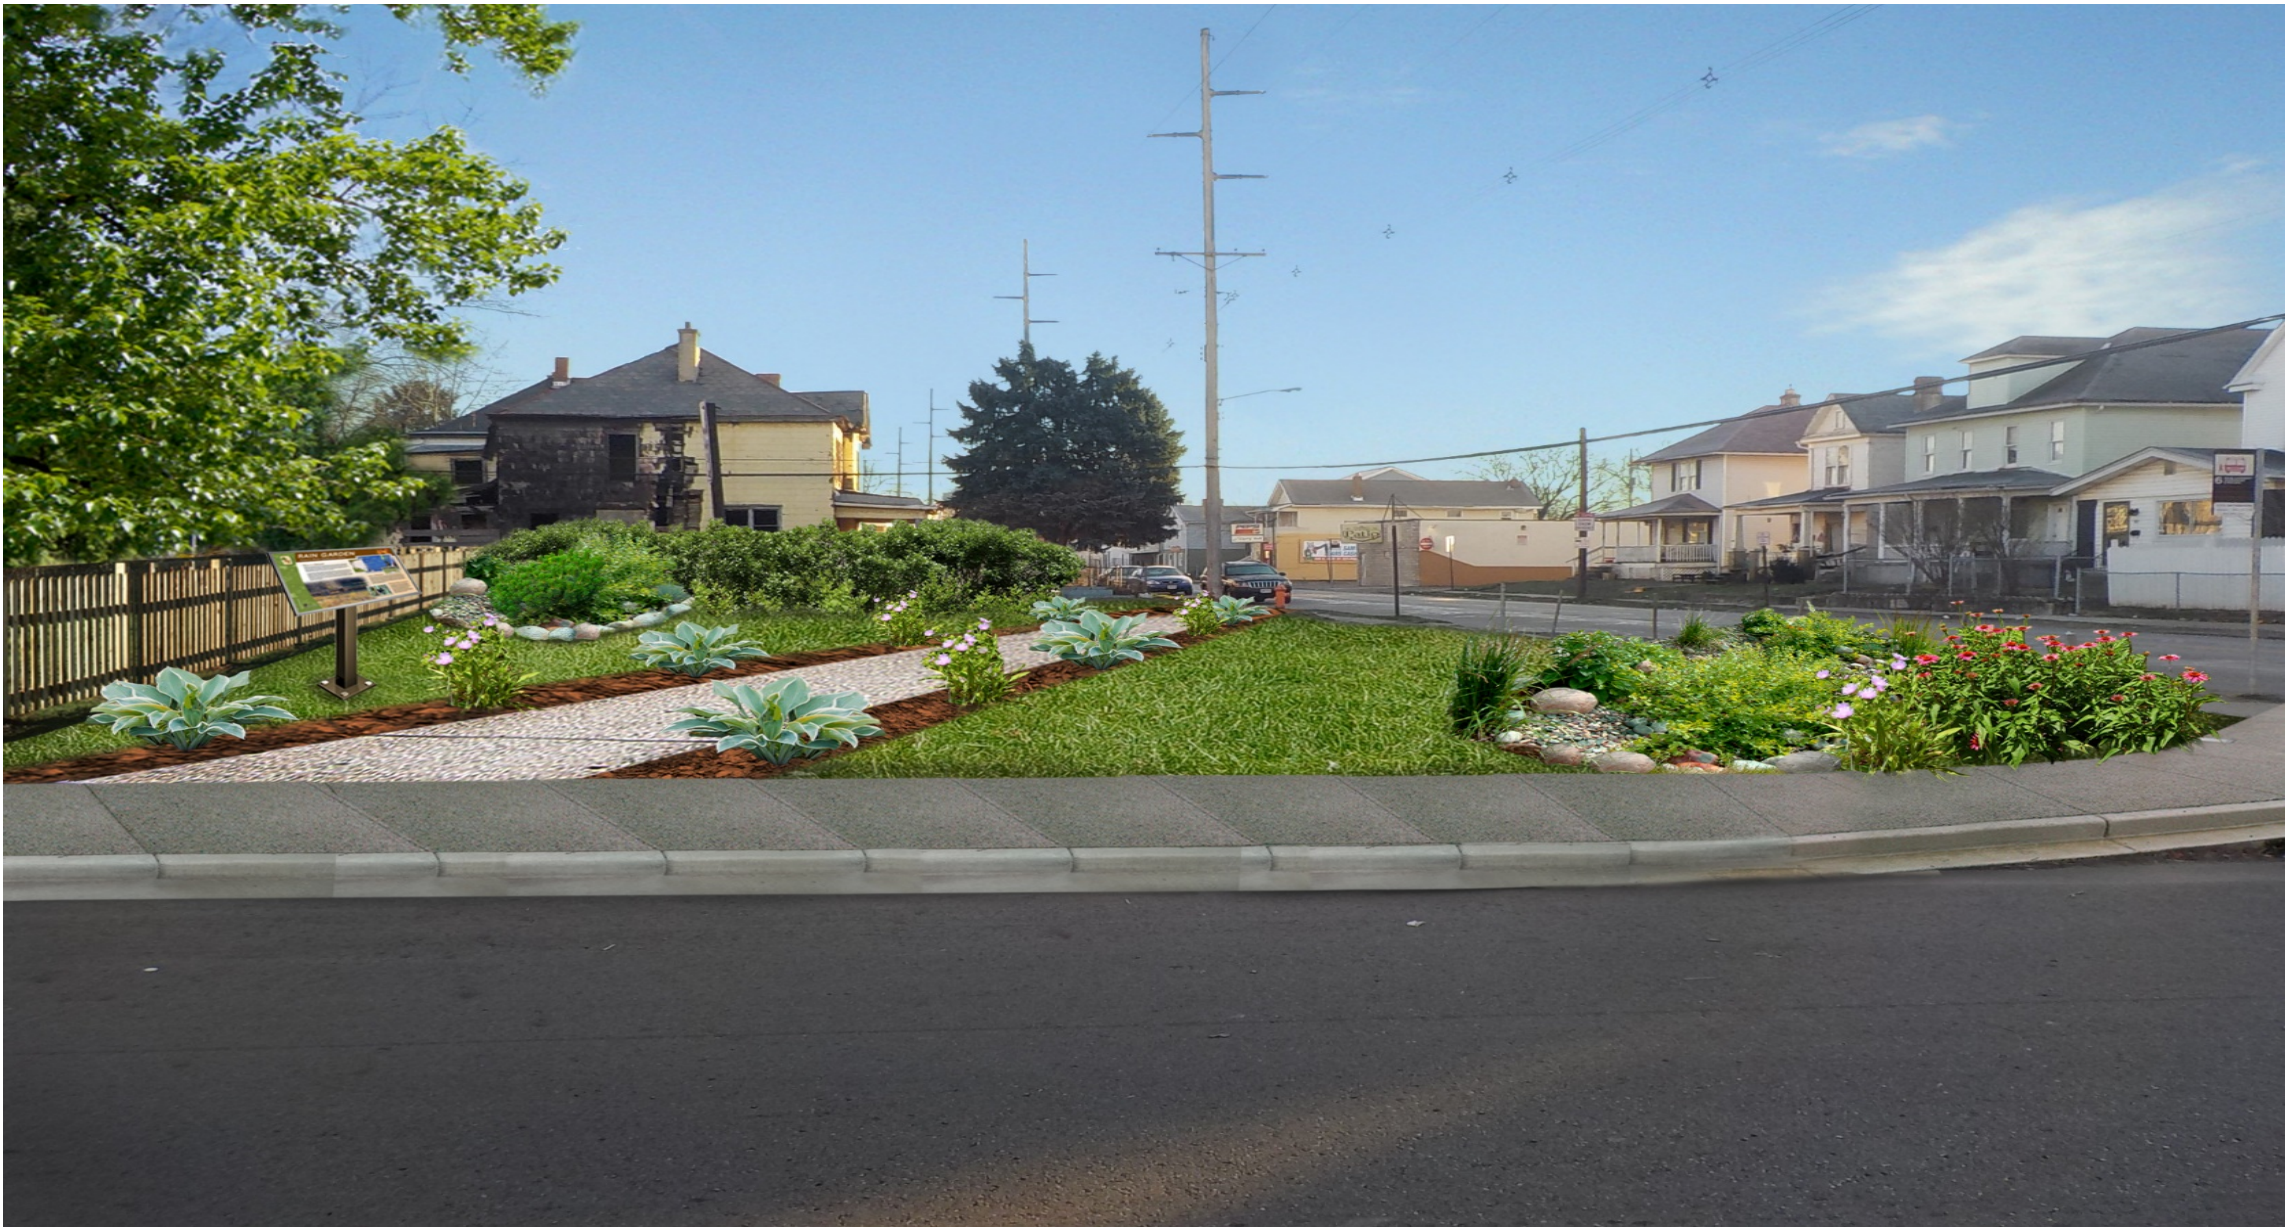
Bioretention Pocket
Parks

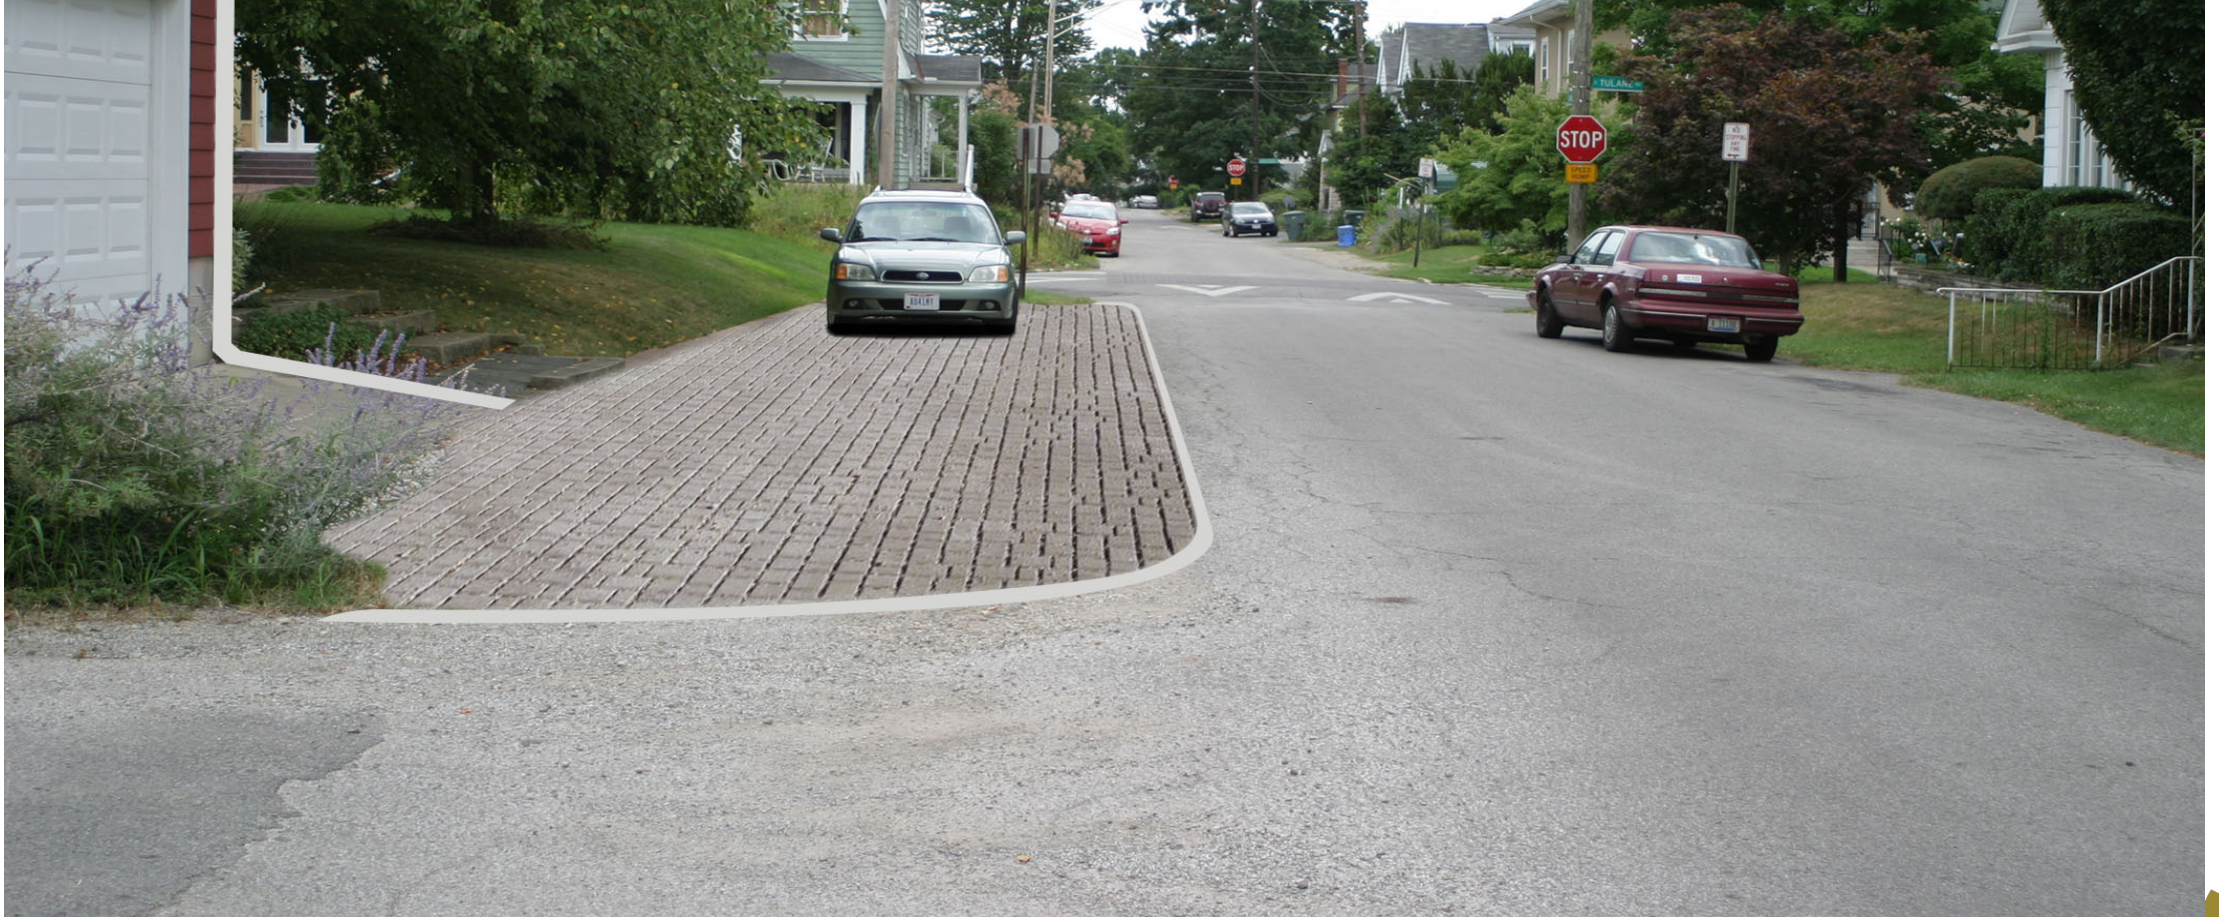
Permeable Parking

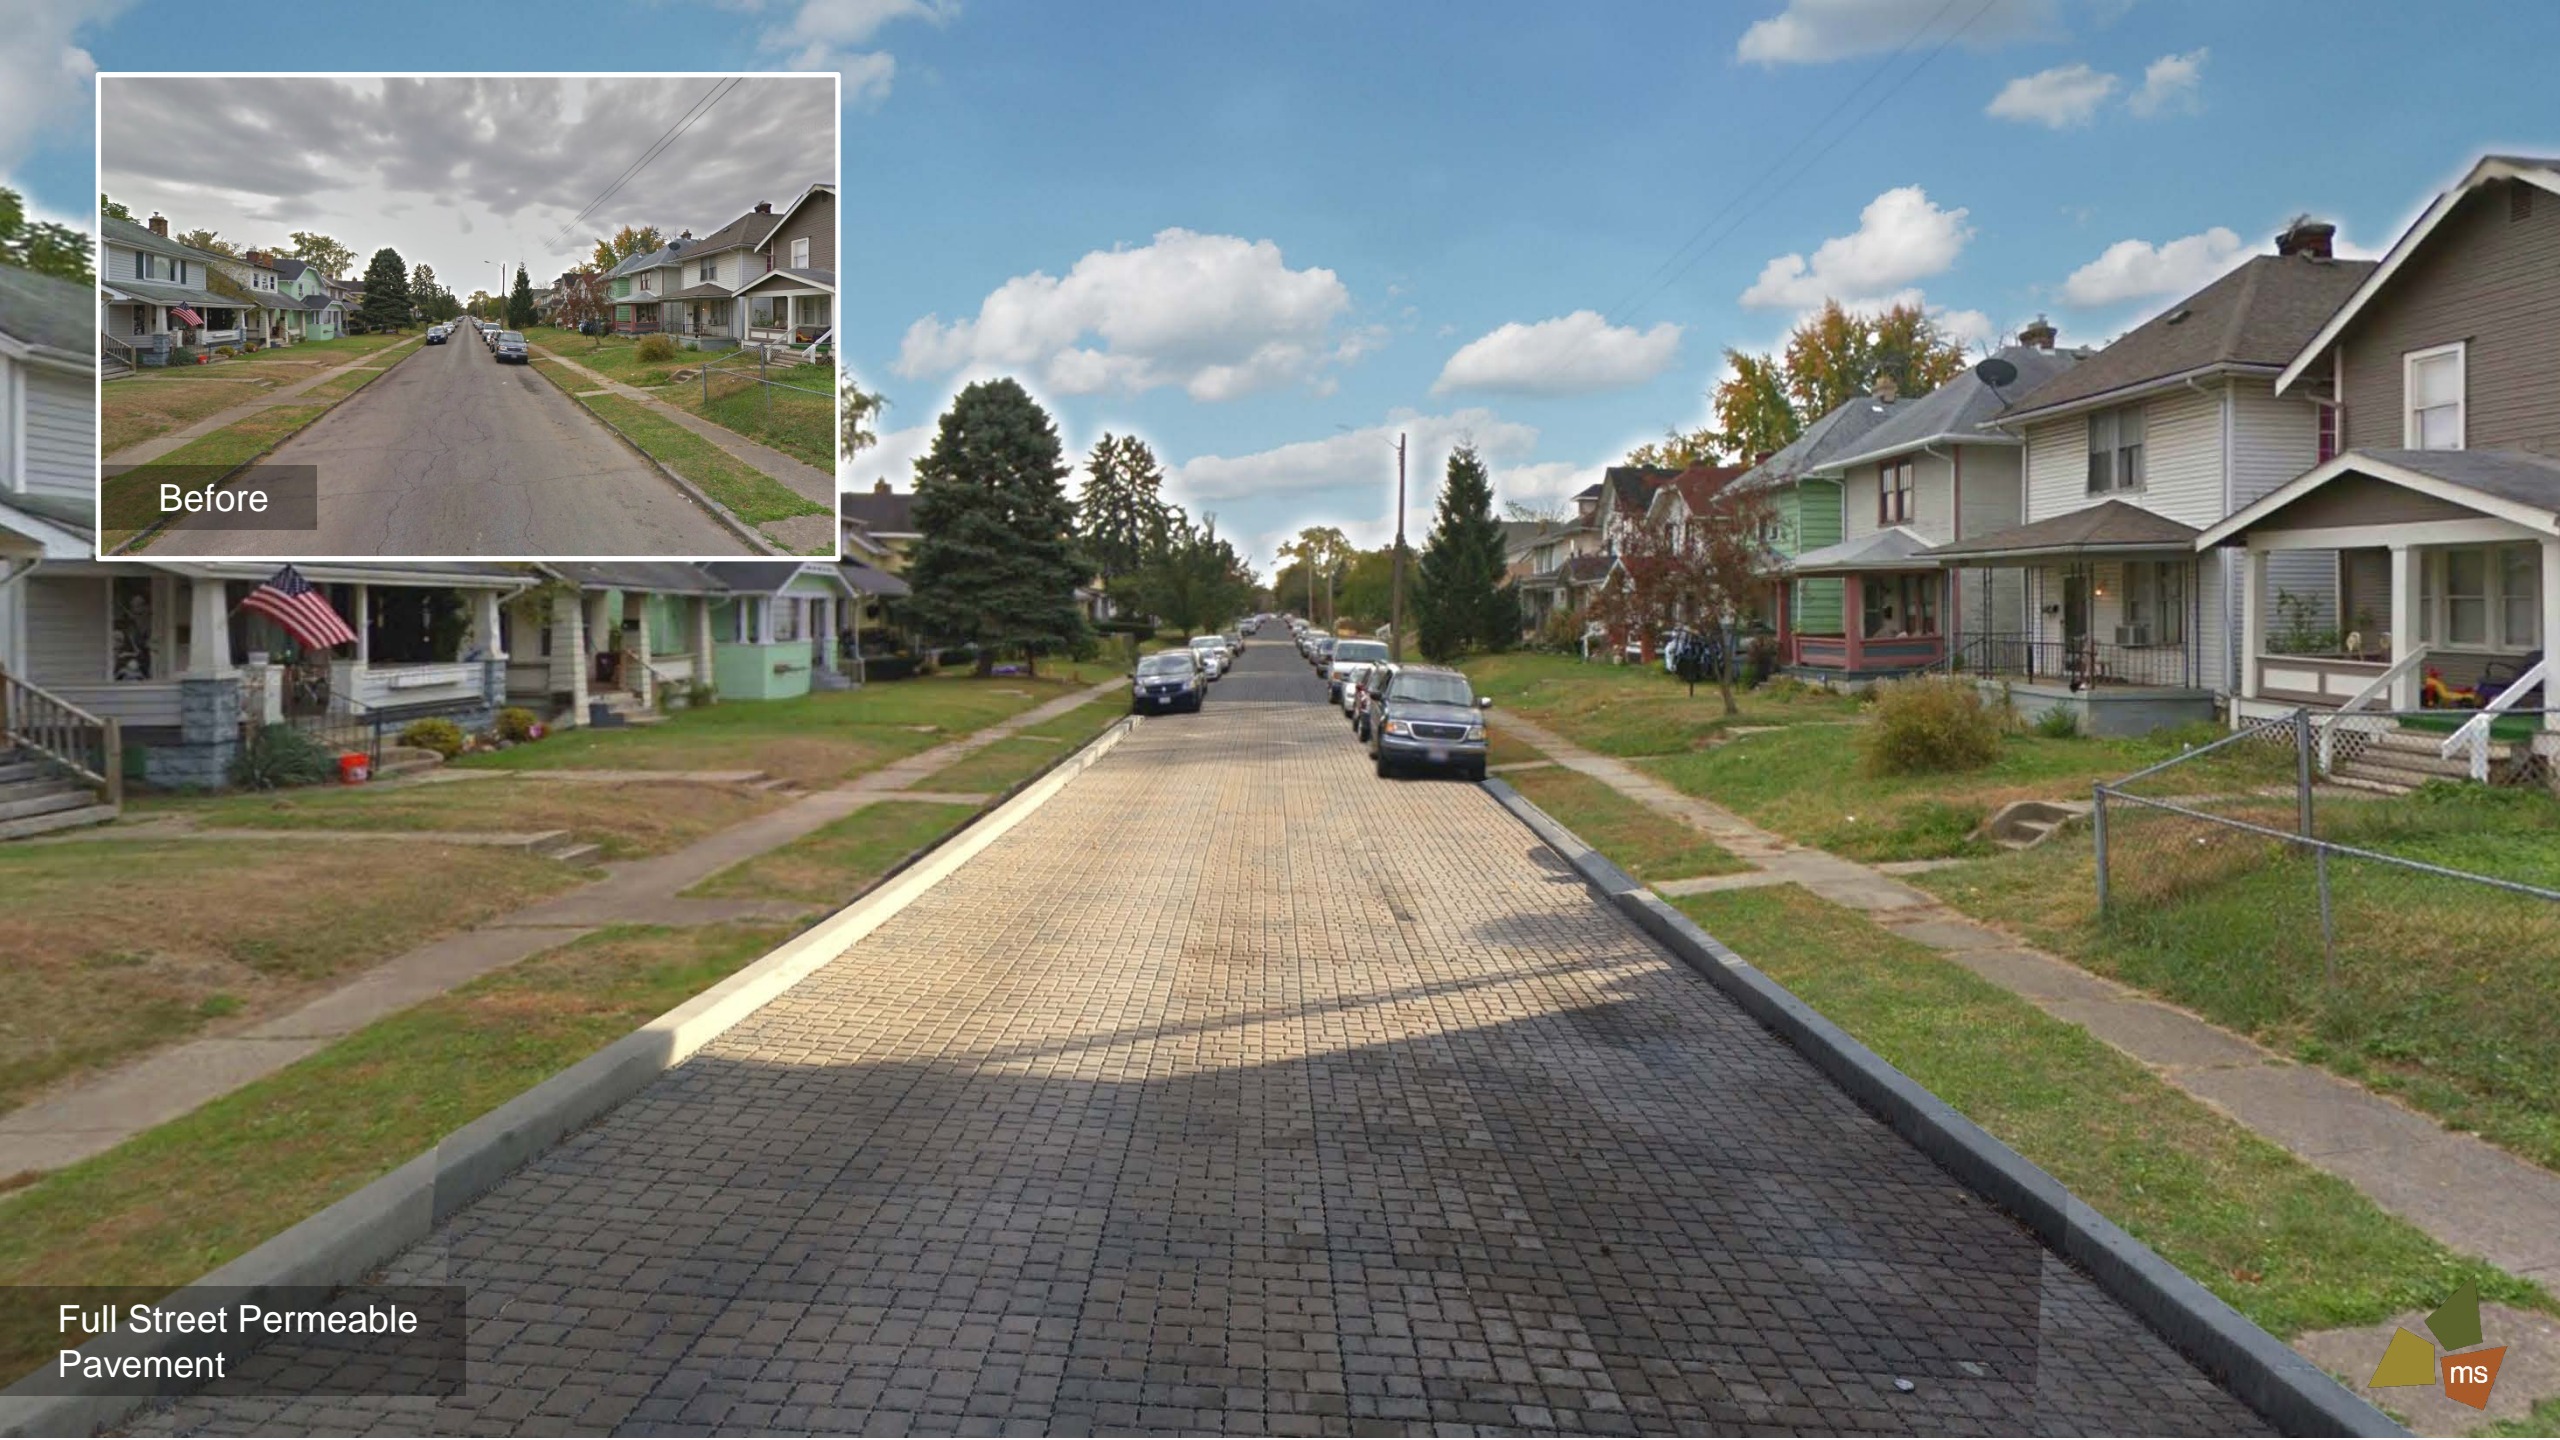
Full Street Permeable
Pavement

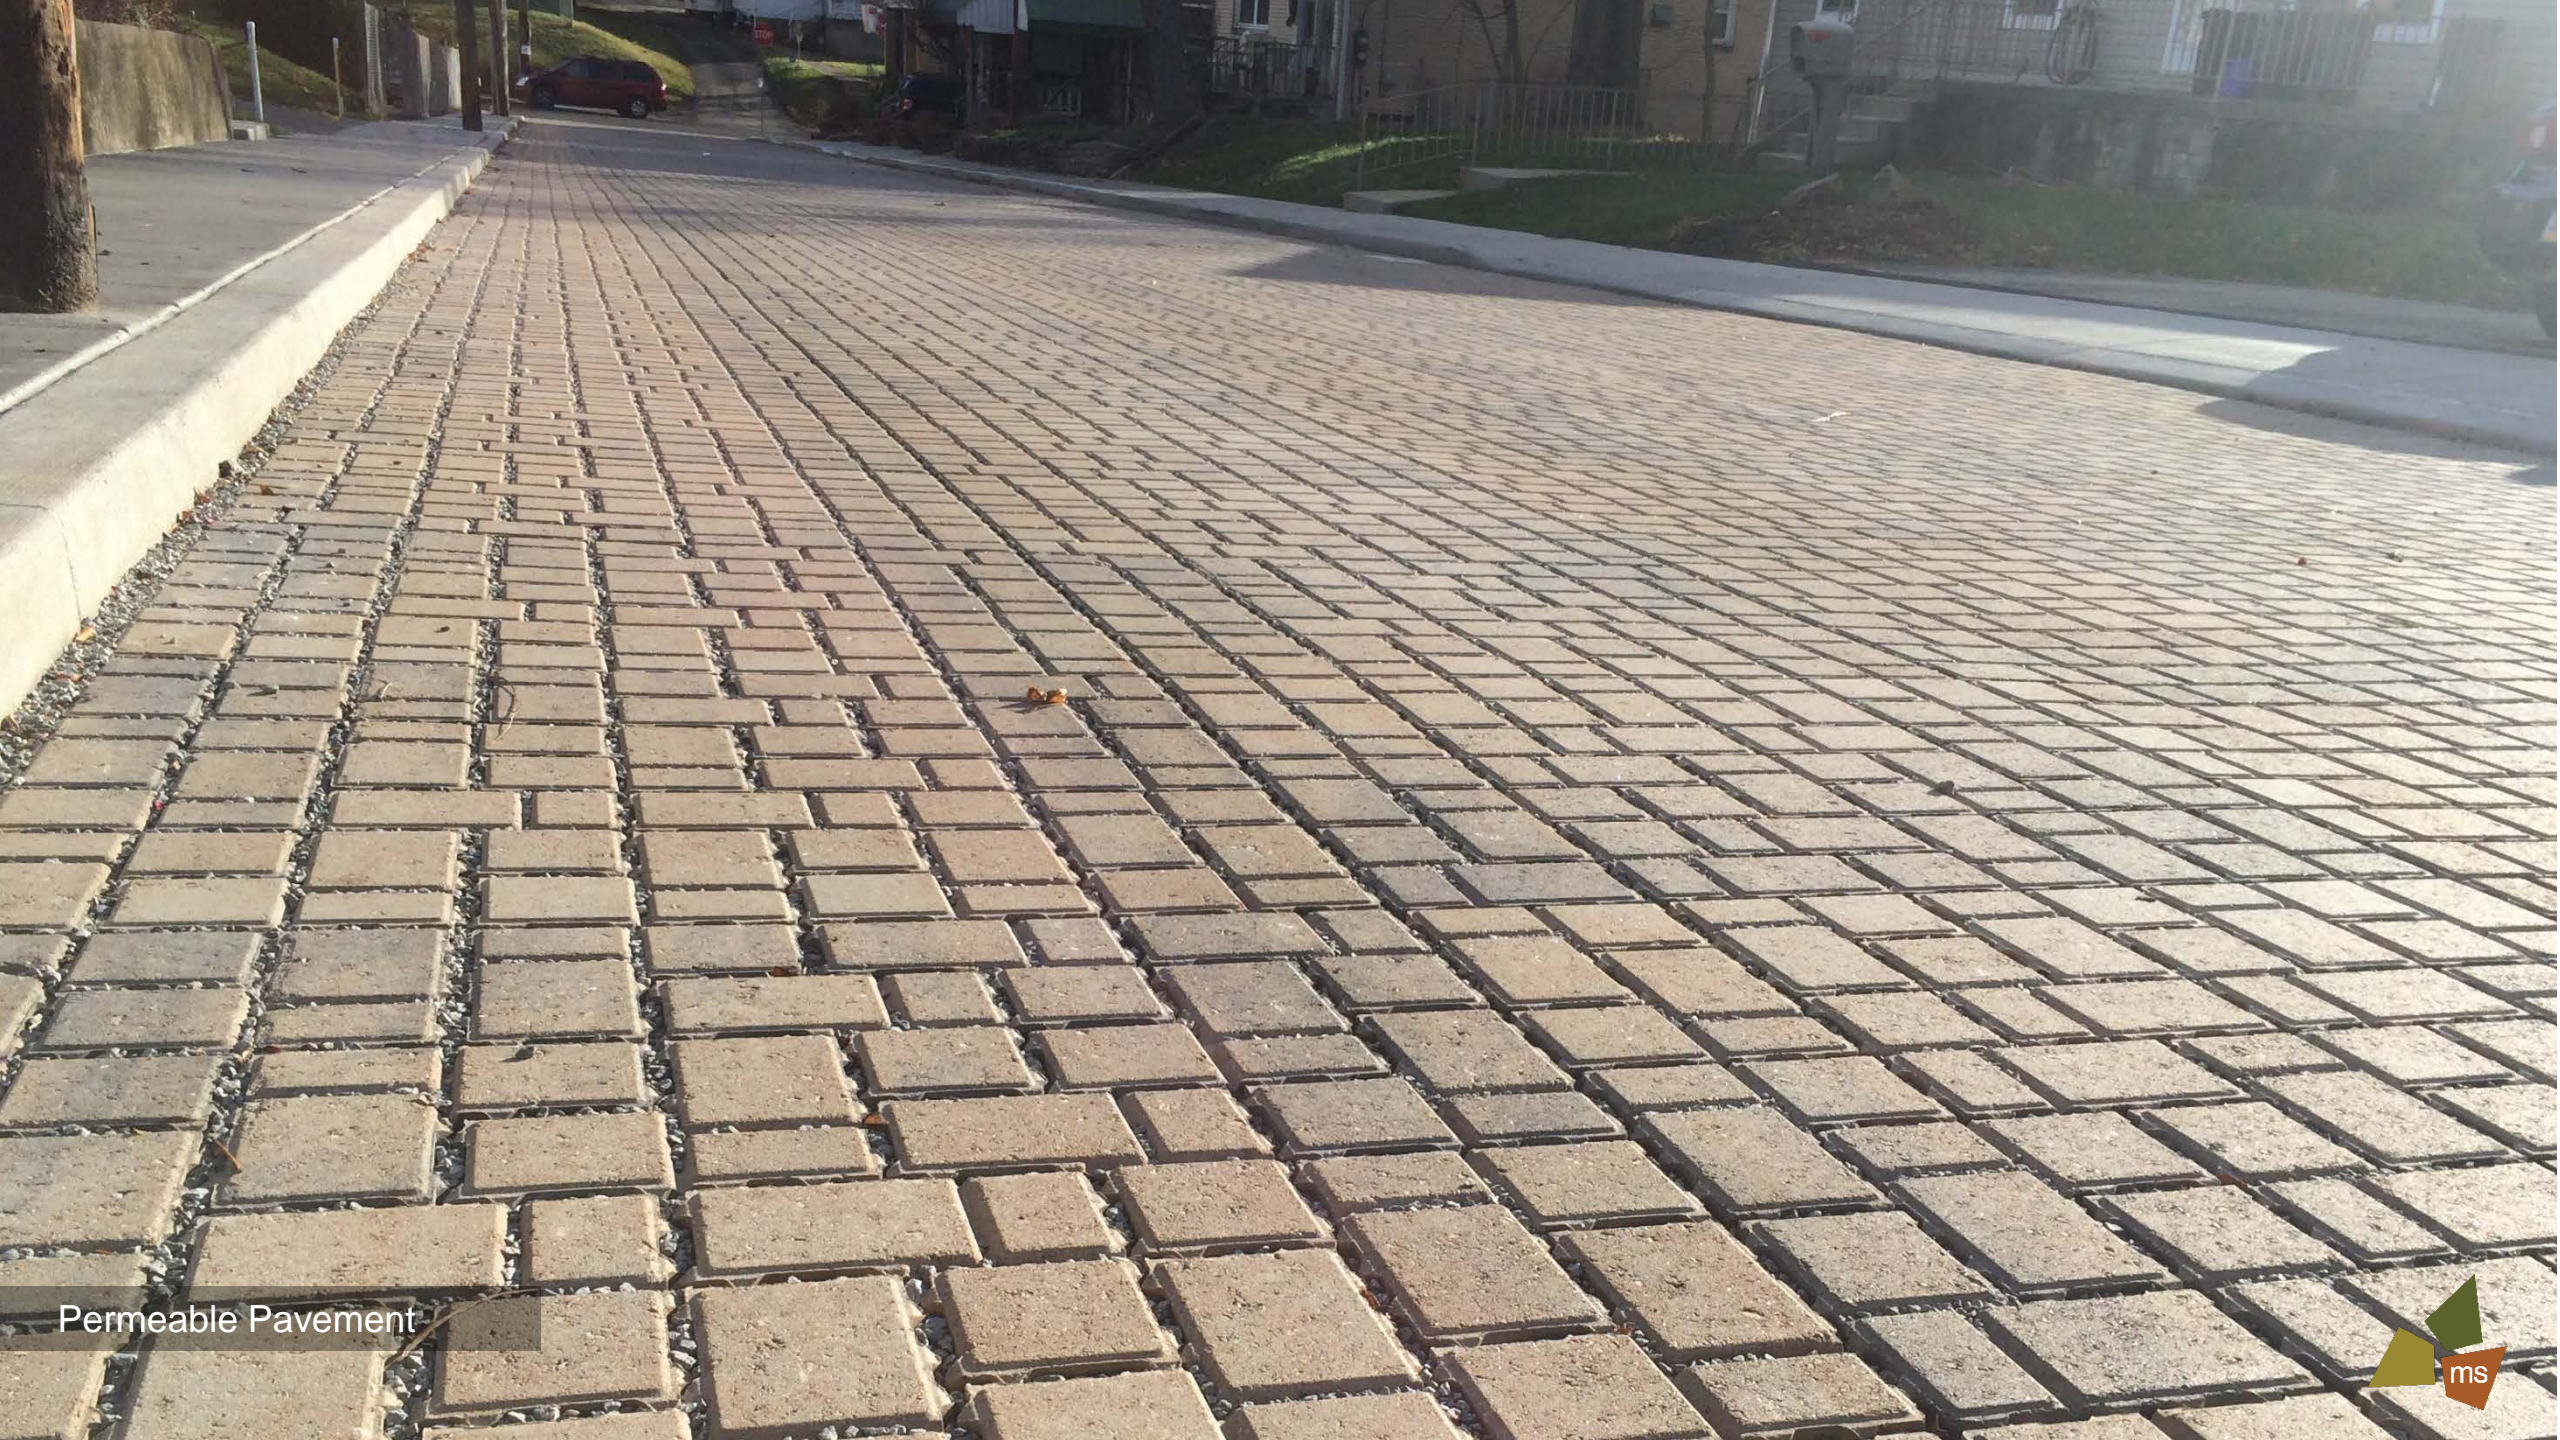
Permeable Pavement
